# **EPA Region 5 Flint Data Summit**

**January 10, 2017  
Chicago, IL**

## 5.2 Corrosion Control Treatment Optimization Evaluations

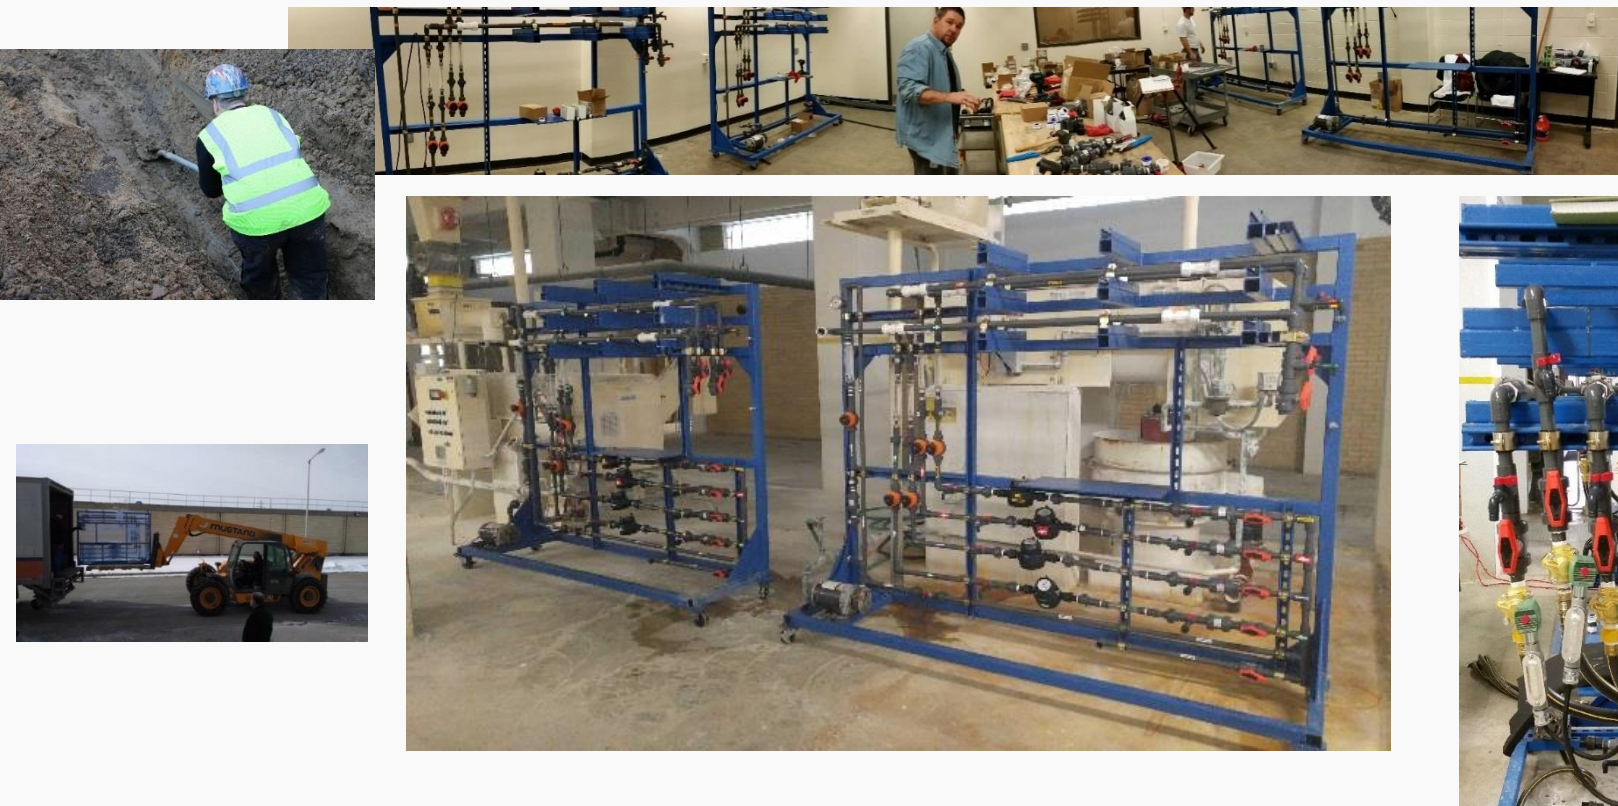
# Exhumed pipes to pipe loop rigs

- Pipe loop rigs (4) built by EPA in Cincinnati from previous work (Jan. 25-Feb. 4, 2016)
  - Constructed PVC, unistrut frame, tubing, etc..
  - Flow meters
  - Chemical feed ports
  - Lead pipe from Flint DS
- Delivered and installed (w/o lead pipe) in Flint WTP (Feb. 18 and Feb. 24, 2016)
- Location in plant gets finished water after phosphate supplementation
- Primary focus
  - Observe current CCT performance under best conditions
  - Anticipate/simulate KWA source changeover impacts in future

- Lead pipes removed from 4 different homes (March 7-18, 2016)
  - 2 homes from “high” DS chlorine zone and 2 homes from “low” DS chlorine zone
  - Pipes cut into four 4 foot long sections in field
  - Pipes sealed, transported
  - Additional sections preserved for solids/surface analysis

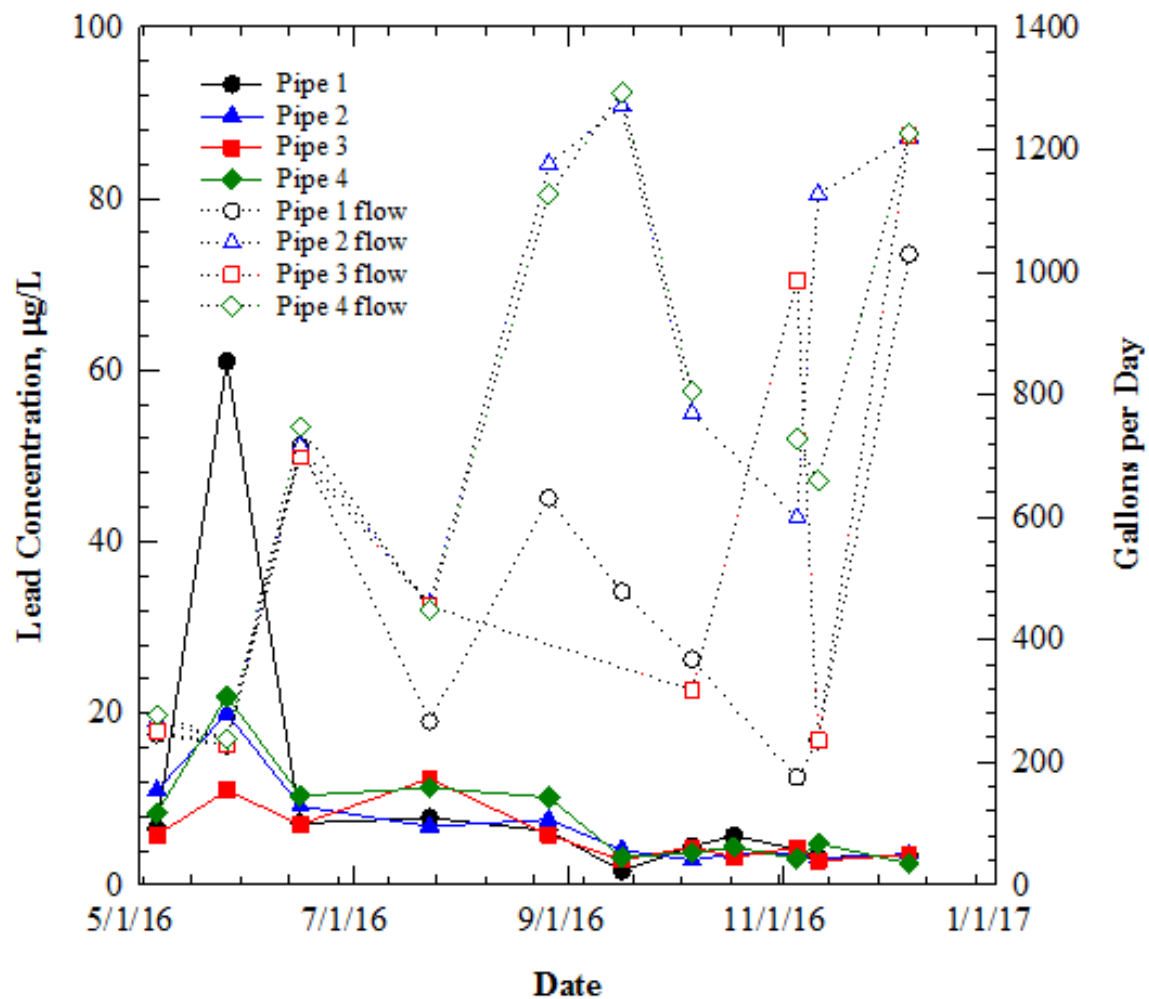
# Overlay of 8 hour stagnation total Pb/flow: Rig C

- Loops were operated under continuous flow
  - Solenoids installed on each pipe (April 18-19, 2016)
  - On/off cycling (6 cycles)
- Target total run time 3.5 hours at 1 gpm (210 gpd)
- 8 hour stagnation time
- Periodic sampling started in May

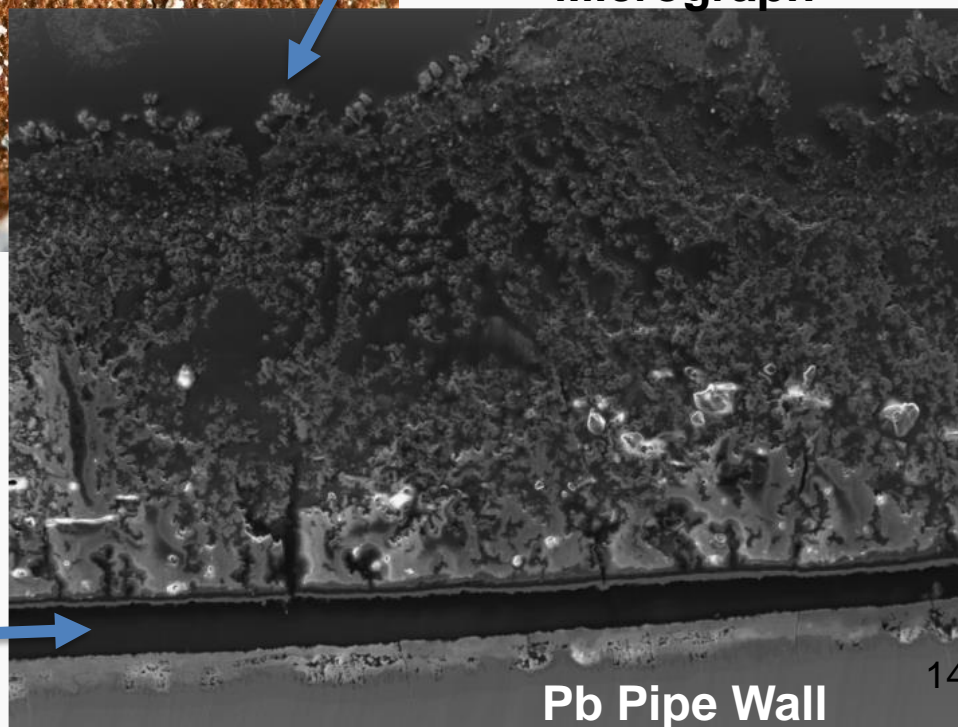
**Pb Pipe Wall**

**Scale Surface**

**Micrograph**

**Macro Photo**

**Void filled with epoxy**
