REMEDIAL ACTION COMPLETION REPORT
FINAL

GREAT LAKES LEGACY ACT
LOWER MENOMINEE RIVER TYCO SITE

Great Lakes National Program
Office Cleanup Services (GLNPOCS)
Contract No. EP-R5-11-04
Task Order No. 0005

December 14, 2015

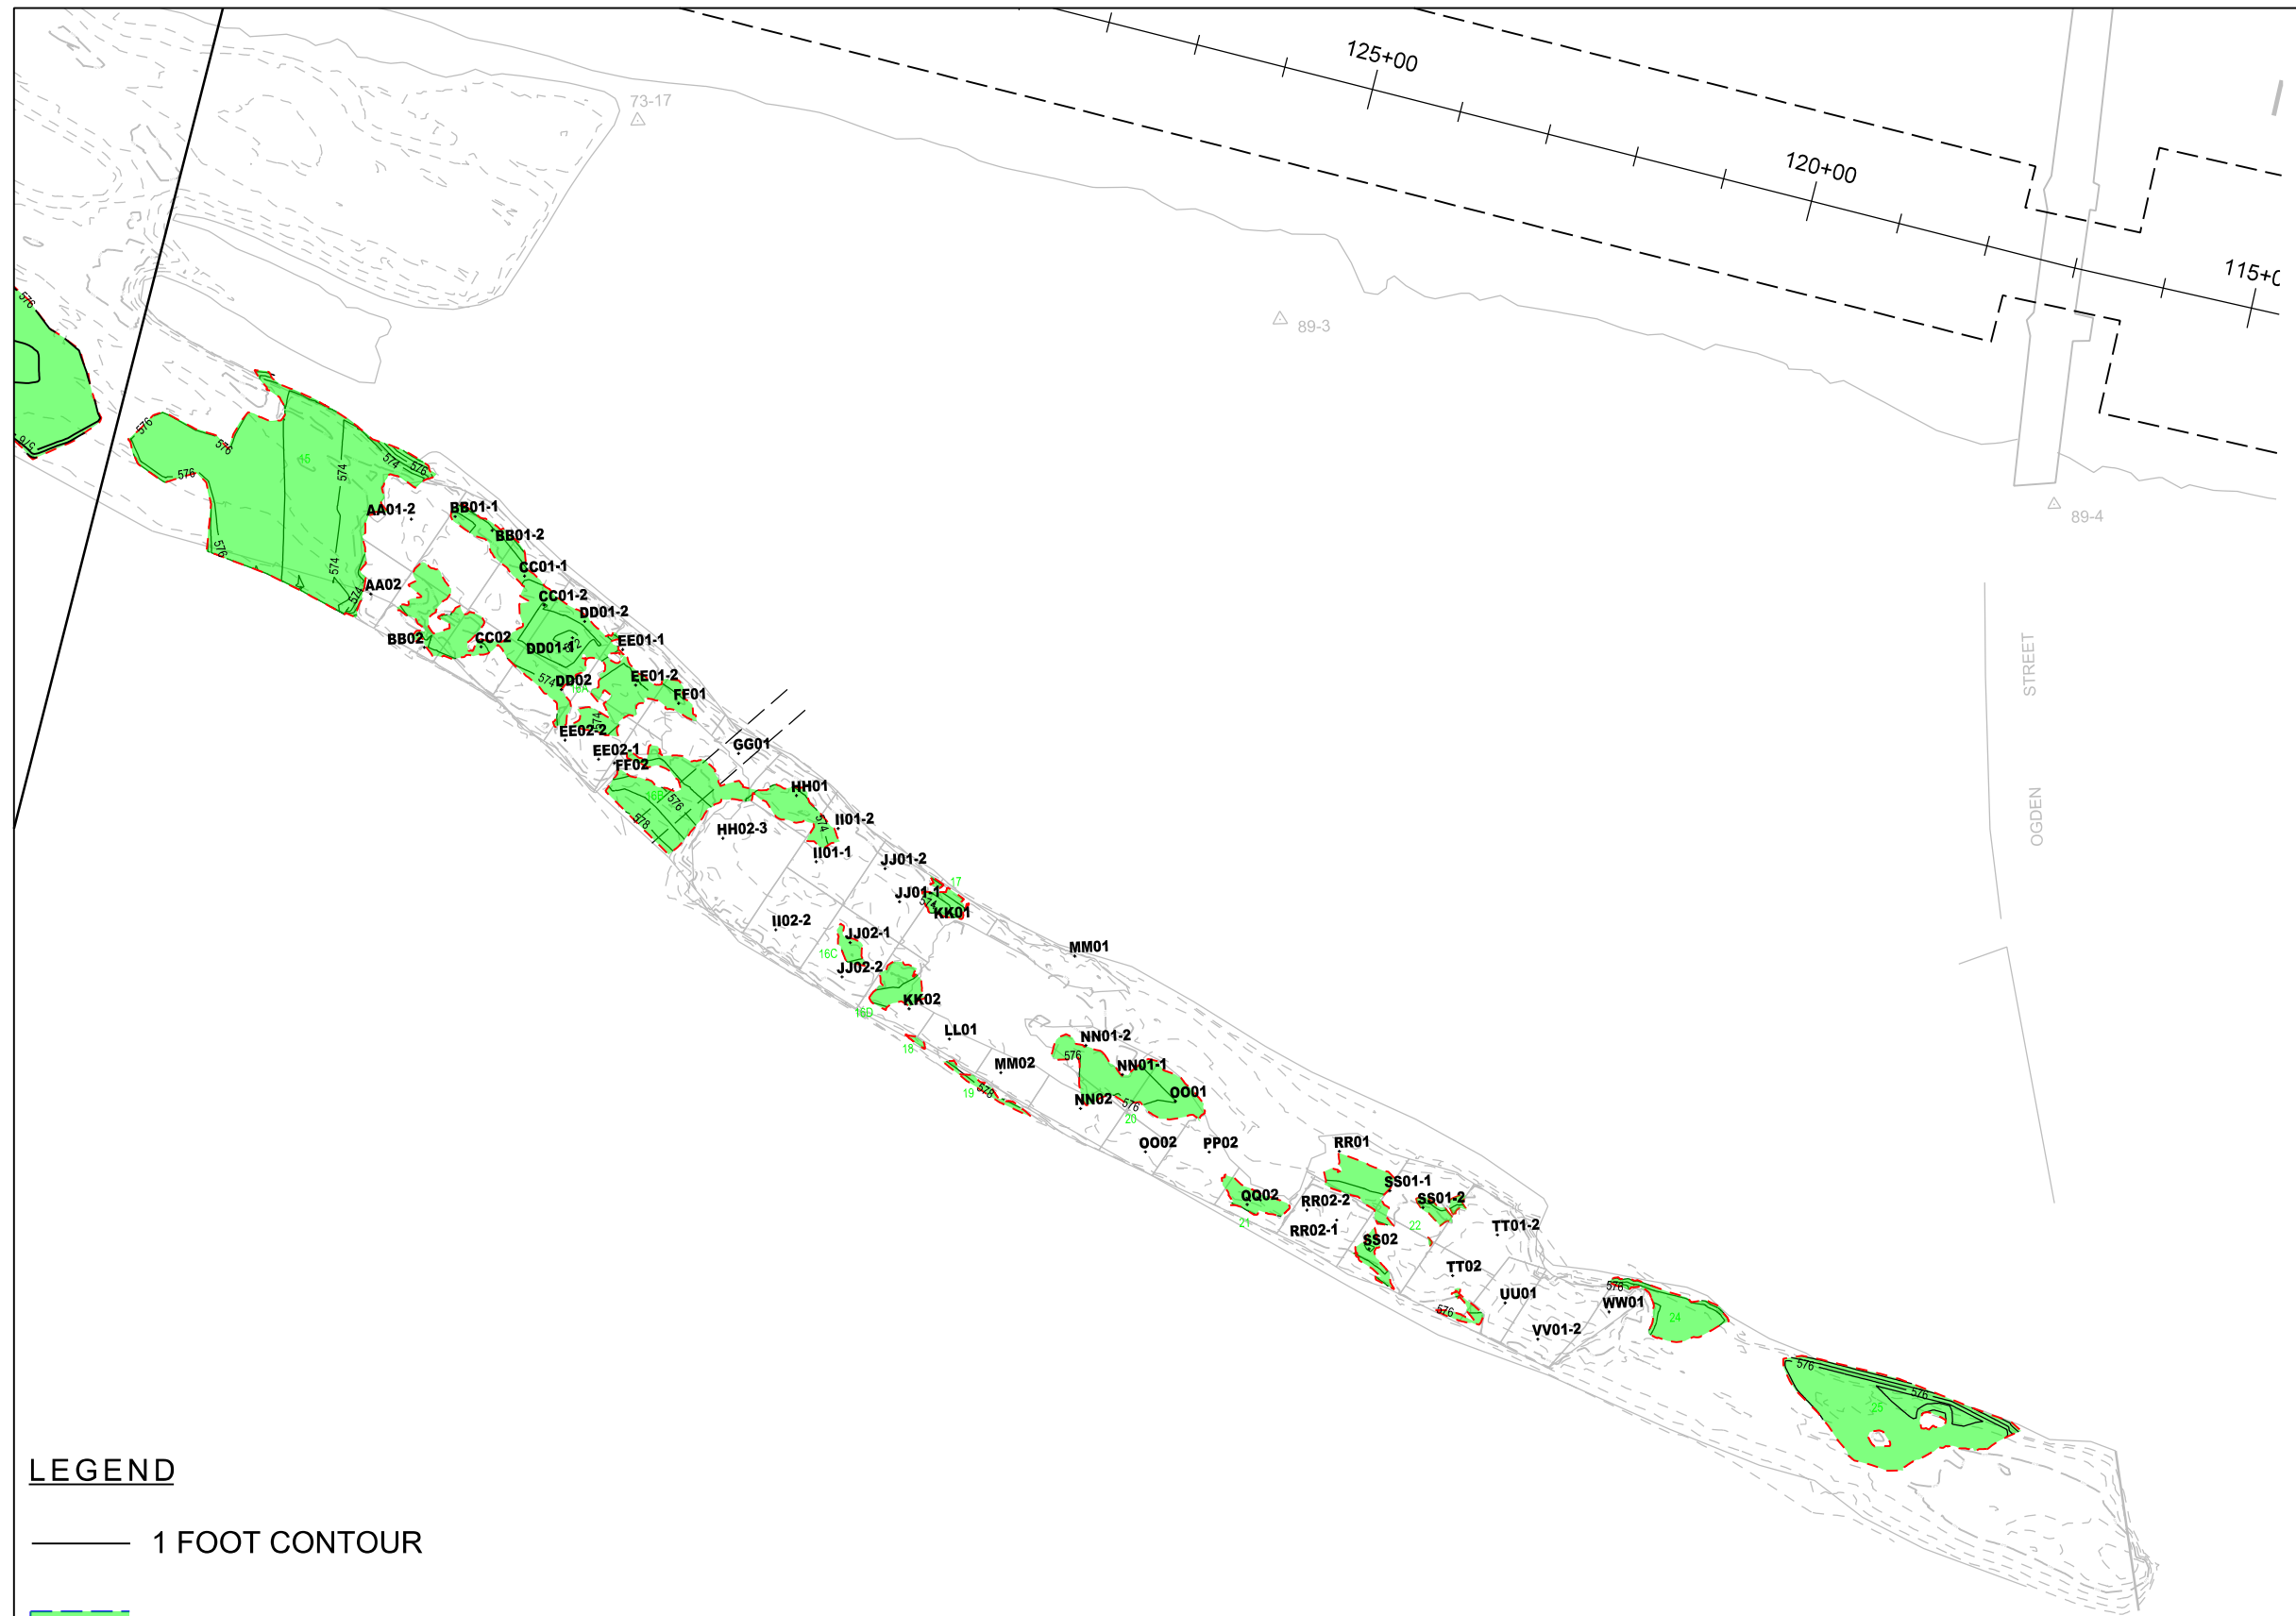
**FIGURE 5B
SOUTH CHANNEL AREA
SOFT SEDIMENT 20ppm DREDGE ELEVATIONS
GREAT LAKES LEGACY ACT
LOWER MENOMINEE RIVER TYCO SITE**

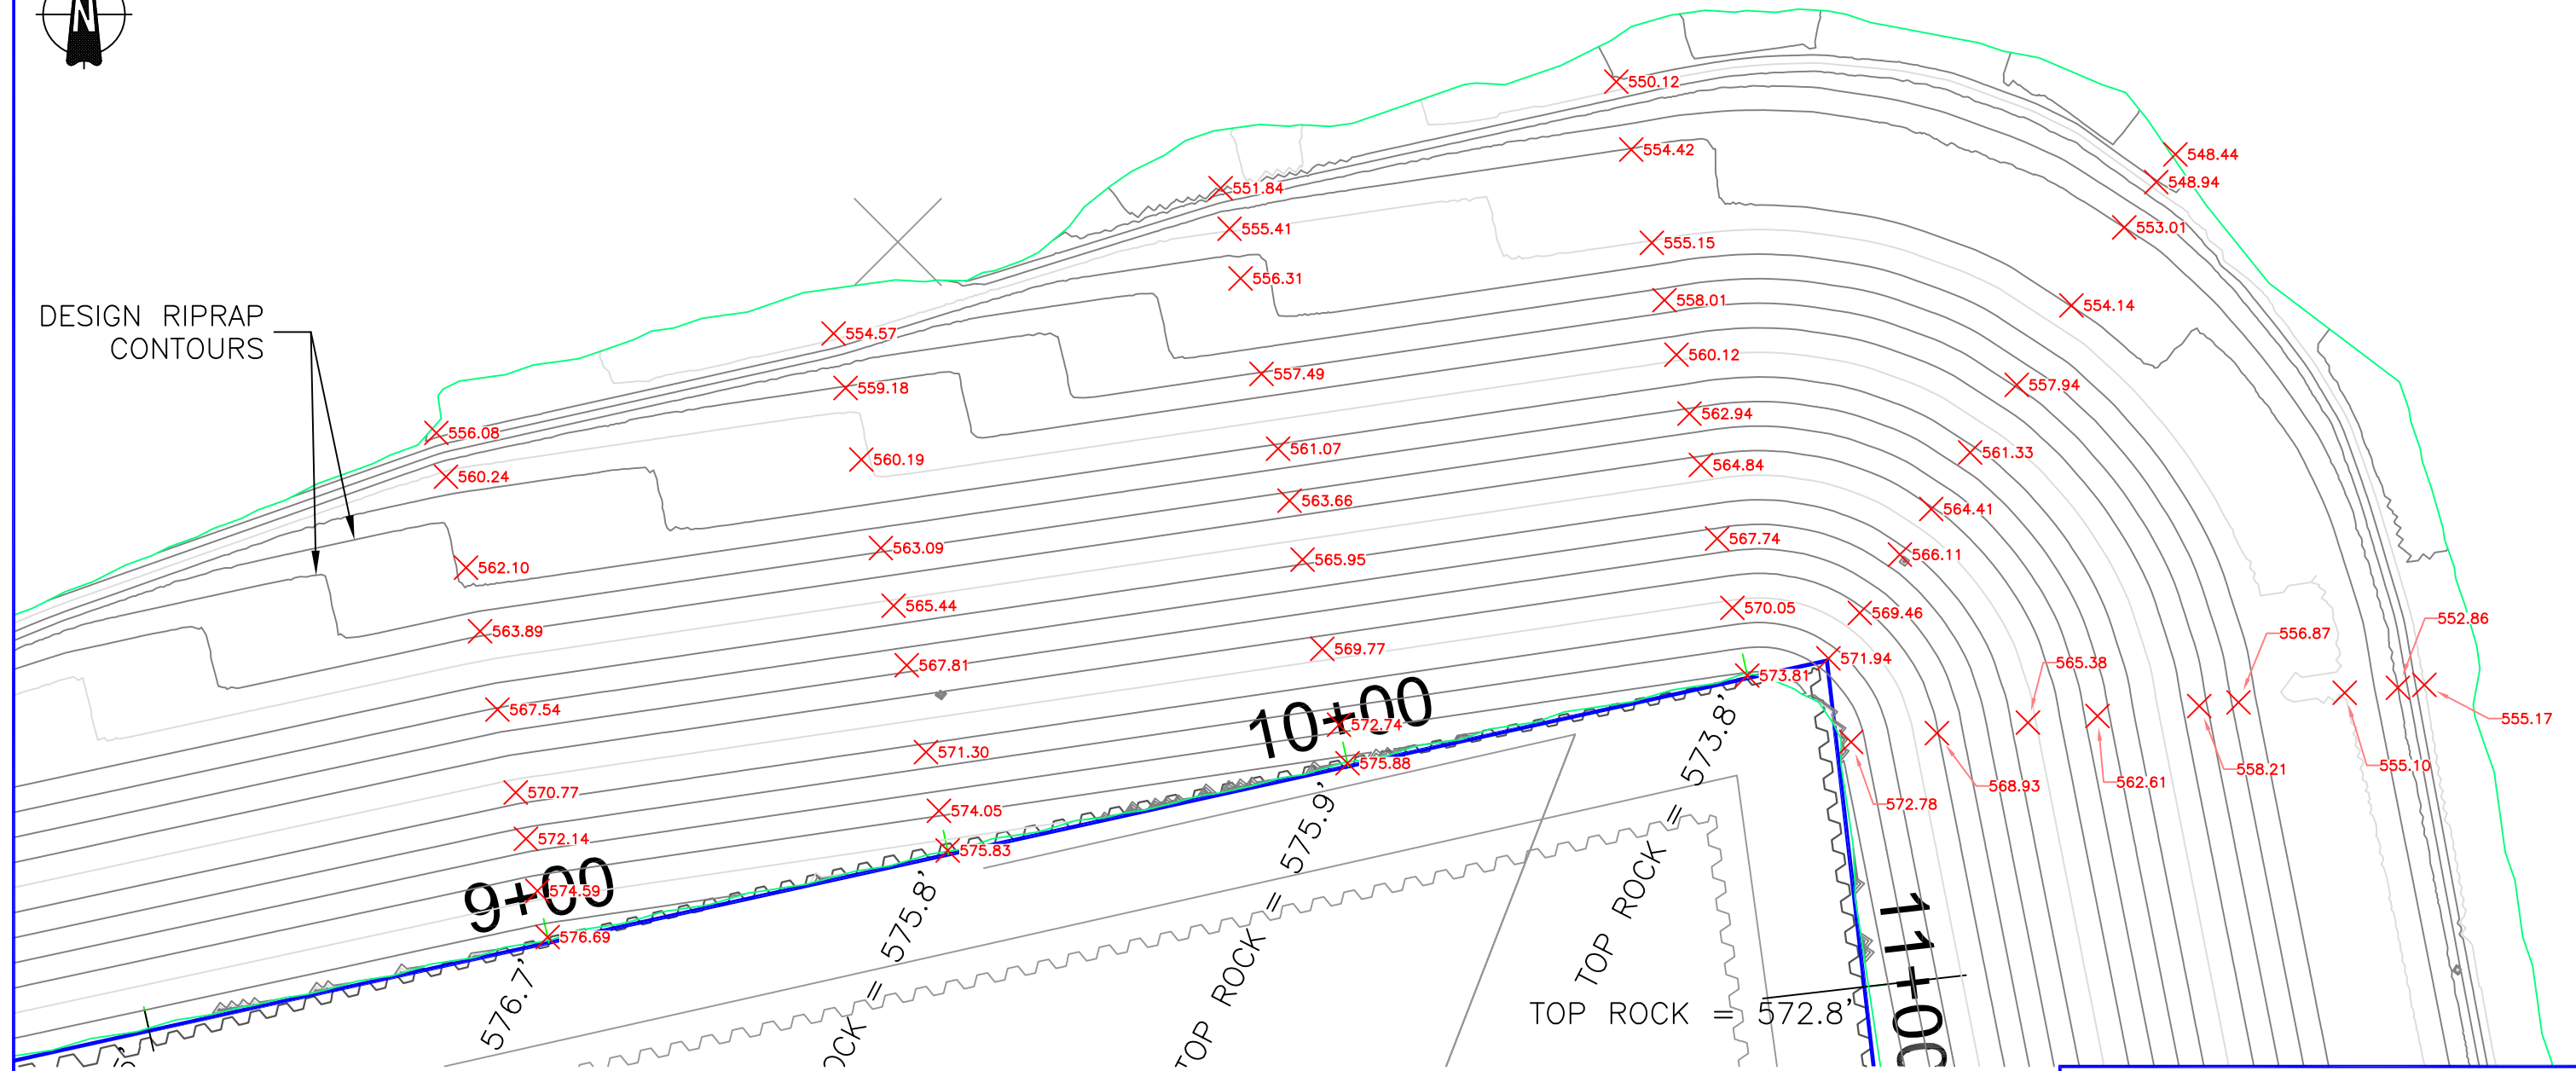
Figure 7. Rip Rap Placement

2015 RIP RAP PLACEMENT TOP OF ROCK ELEVATIONS

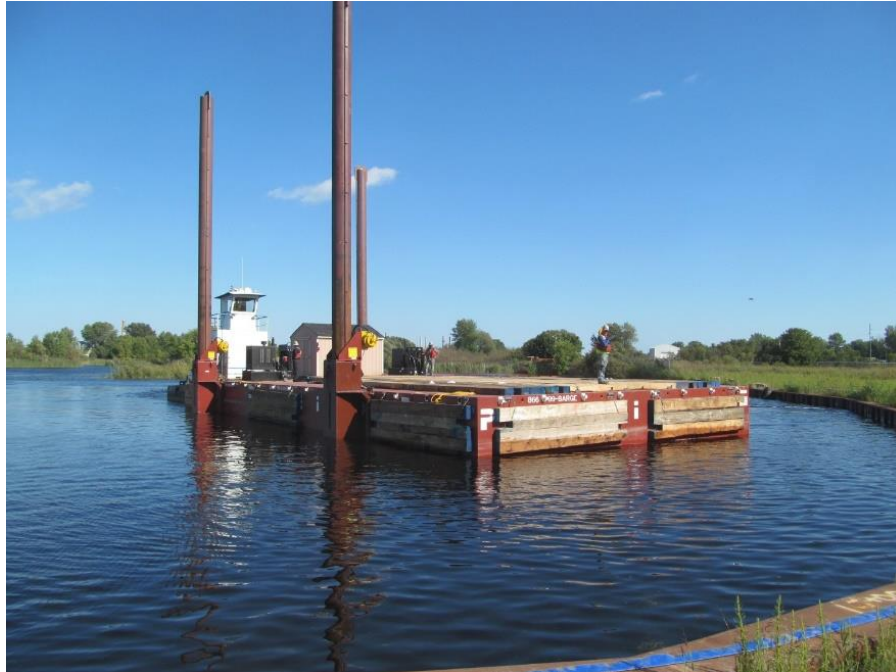
Photo 1. Mobilization of the dredging barge

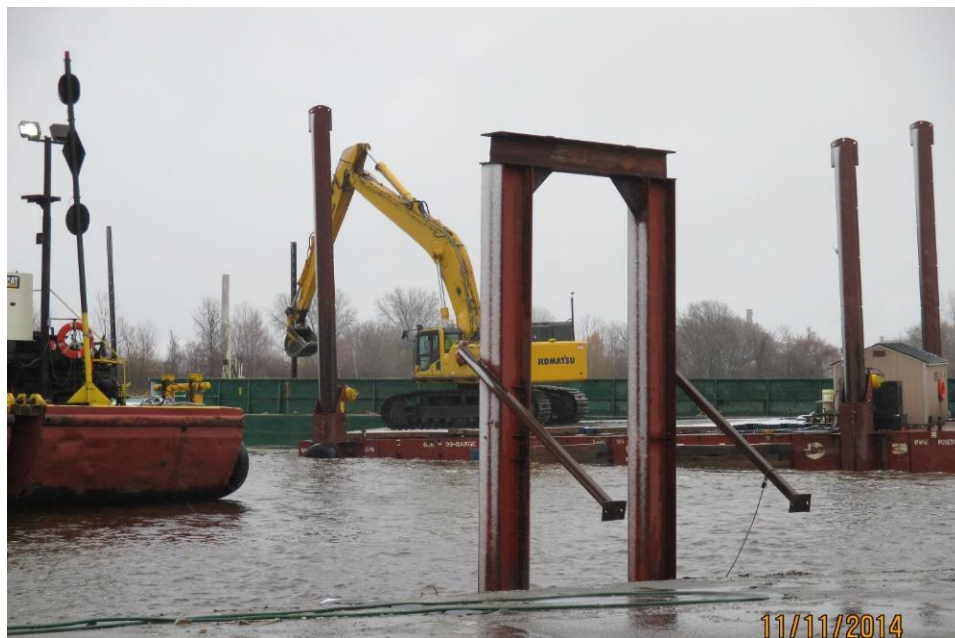
Photo 5. Re-dredging in L8

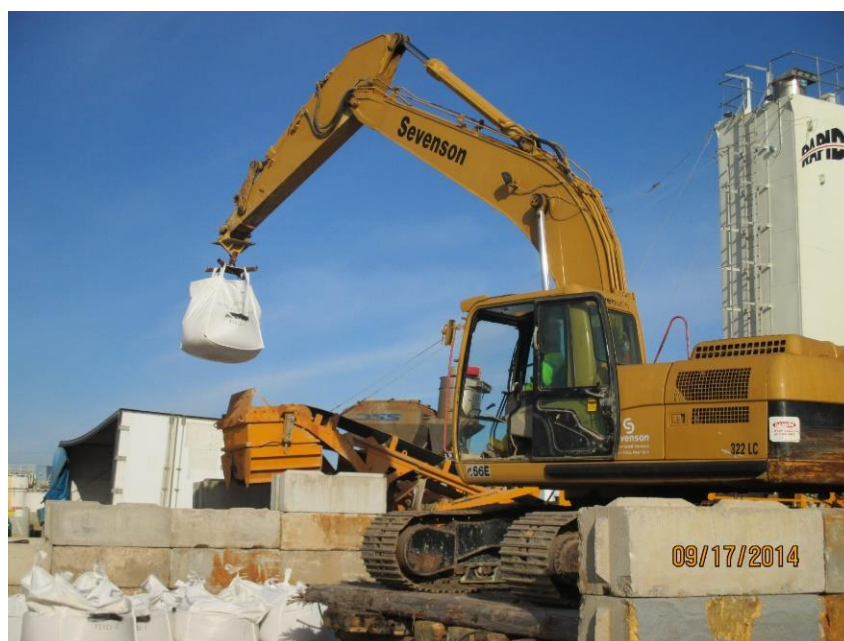
Photo 12. Dry ferric being loaded into the hopper

As noted previously, the contaminated sediment was solidified using proper dosages of Portland cement, dry ferric sulfate, and liquid ferric sulfate. Both pug mill systems had two bulk silos that held the Portland cement reagent. Each pug mill system also had chemical feed pumps for ferric sulfate solution dosing. Upon completion of pug mill usage, the pug mills were fully restored to pre-legacy season working order at no cost to Tyco and turned over to Tyco for sale and recovery of market value. The projects teams' familiarity with the proper and effective operation of pug mills at the Tyco site and other similar sediment processing sites ensured that the sediment processing operation and general project schedule was not adversely impacted by this critical operation.

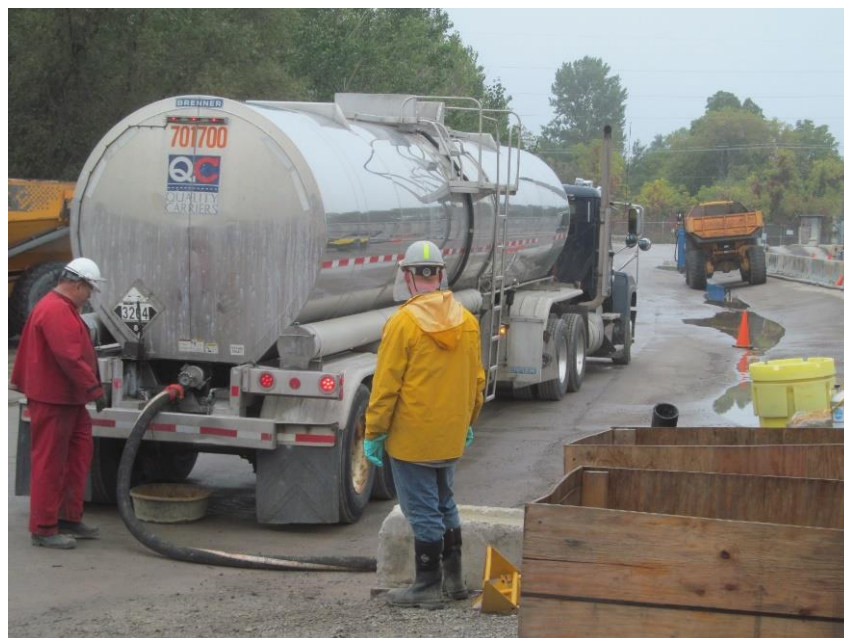
Photo 14. Offloading Liquid Ferric

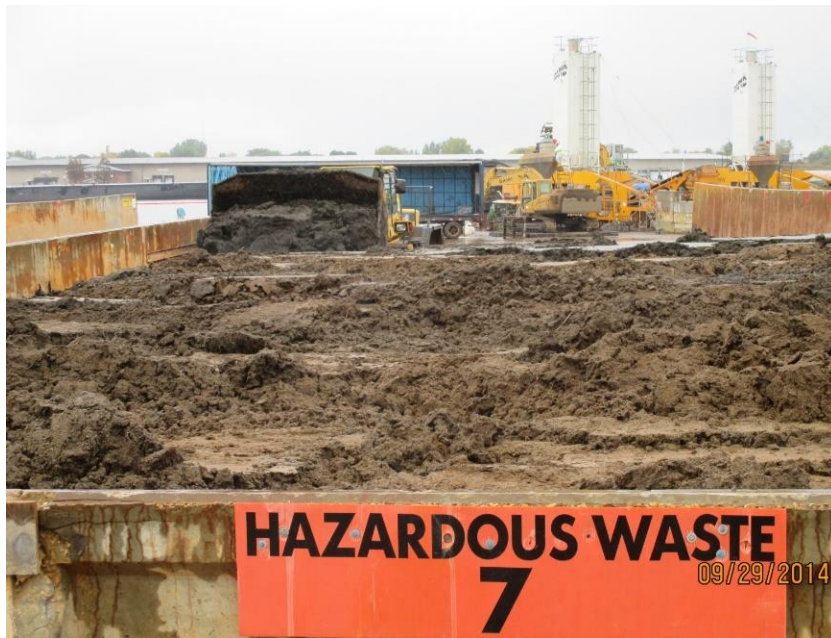
Photo 15. Processing sediment to bin

Processed sediment material was stockpiled at the end of the pug mill conveyor where a Komatsu 450 front-end loader transported the materials from the pug mill discharge to the curing bins. Ten (10) curing bins were operated for the processed sediment material and one bin was dedicated to temporary debris storage and process area access, as shown on the contract drawings and detailed in the Hazardous Waste Variance. The bins were approximately 8 feet tall and were contained on 3 sides. The entrance had a wide curb to contain any wet materials and was open for the loaders to deliver the treated sediment. The bins were regularly inspected, sealed, and repaired as necessary to ensure proper containment of the processed sediment. Photographs 15 and 16 show processed sediment being loaded into a bin and the first load of sediment processed.

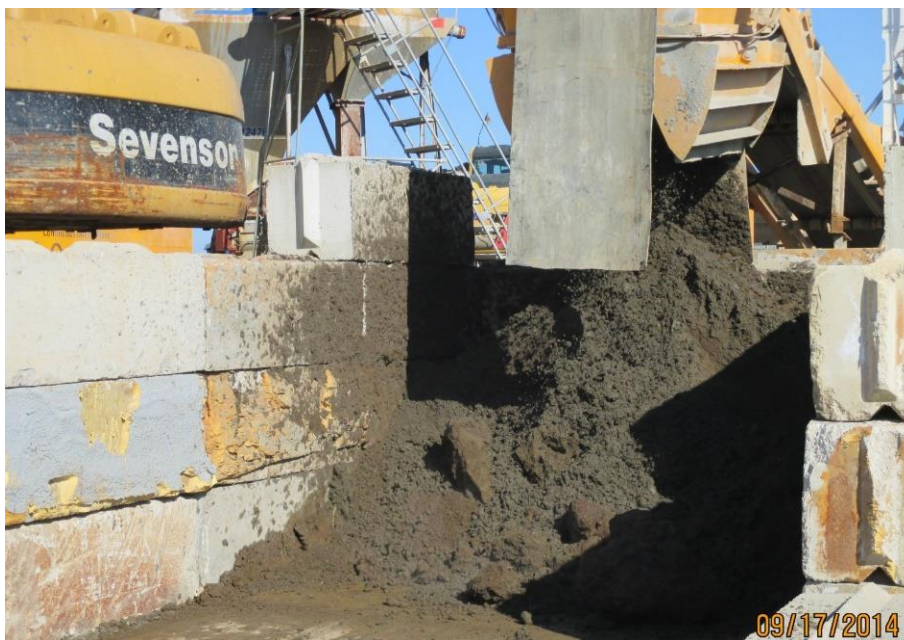
Photo 16. First load of sediment processed

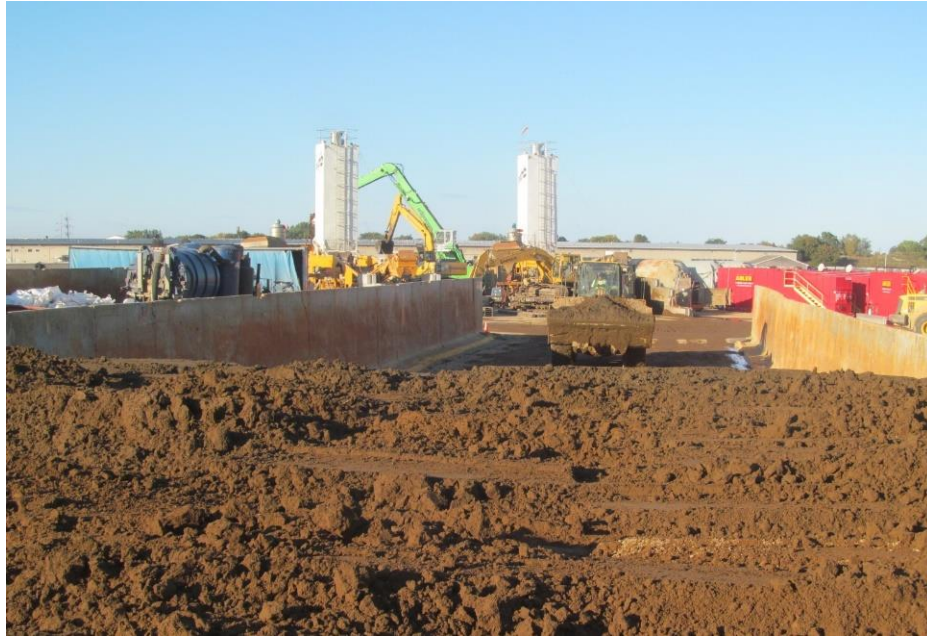
Photo 17. Curing Process

disposal. All treated material samples met the performance criteria for non-hazardous disposal, and therefore retreatment was not necessary. Based on experience at the Tyco site and similar sites, it was determined that a curing time of ½ to 4 days was required to complete the stabilization reaction and to meet the Hazardous Waste Variance and landfill disposal requirements. The materials in the bins were tracked on a white board within the on-site trailer and on a spreadsheet that was updated with the Daily Work Reports. CH2M Hill used the information on the board and in the Daily Reports to provide EPA and Tyco with an independent spreadsheet form for tracking the materials in the bins. This information was reviewed daily by on-site personnel during the daily work meetings. Photographs 17 and 18 demonstrate the curing process. The final quantities of processed sediment material that were transported and disposed of at the Menominee Waste Management offsite disposal landfill are provided in section 3.11.

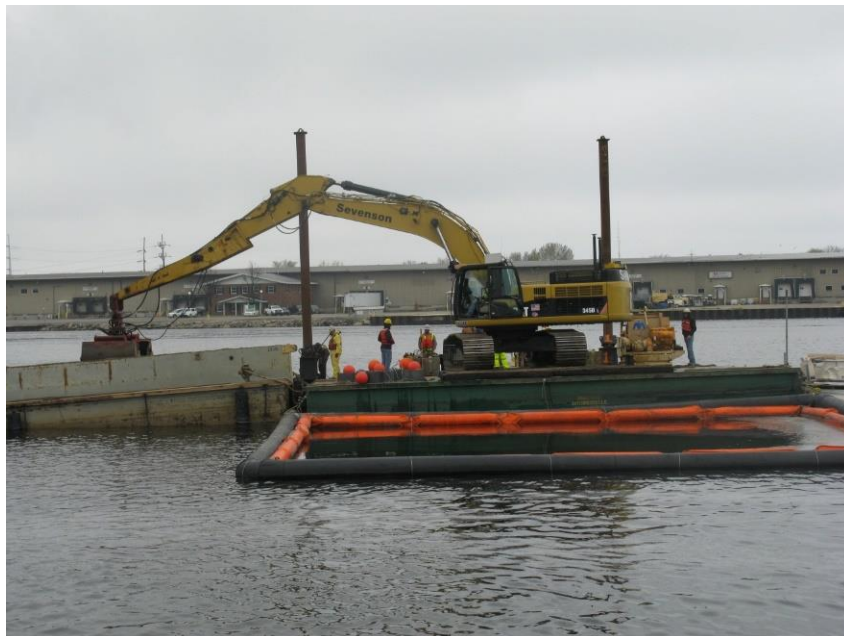
Photo 23. Moon Pool used during cover placement

- The operator controls the speed of the material entering the water by slowly opening the bucket and releasing the material.
- Cover material was not placed during heavy thunderstorms or high wind events because these events and related changes in river conditions (i.e., flow rate and volume) may increase turbidity levels and the migration of cover materials outside of the cover placement work area.

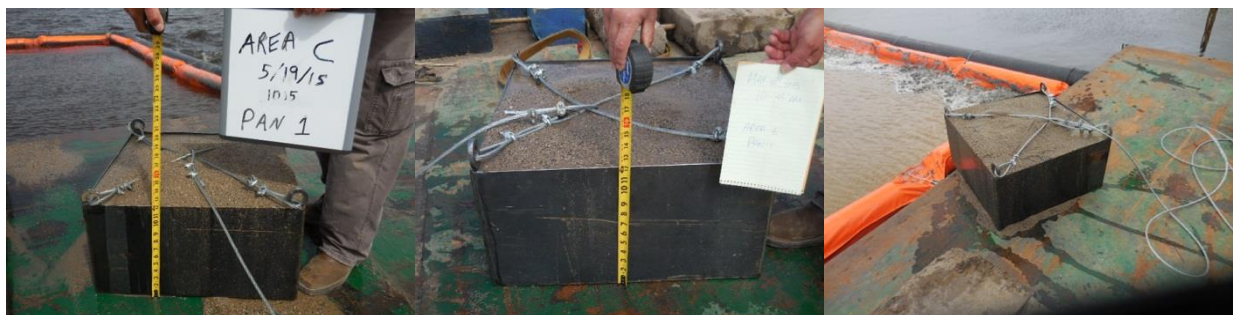
Photo 27a, 27b, 27c. Pan Testing

The extent and thickness of the final cover was further verified by comparing the pre-placement bathymetric survey and the post-placement bathymetric survey results and correlating these results to the pan method results. The pre-cover bathymetric survey was completed by Hydrographics. As noted above, actual cover placement work began in early May, and continued through early June. Interim surveys were taken by SES in May 2015. Initial cover placement was completed in early June and a post placement survey was conducted on 6/2/15 by SES. All bathymetric survey data and the data from the supplemental thickness measurement techniques

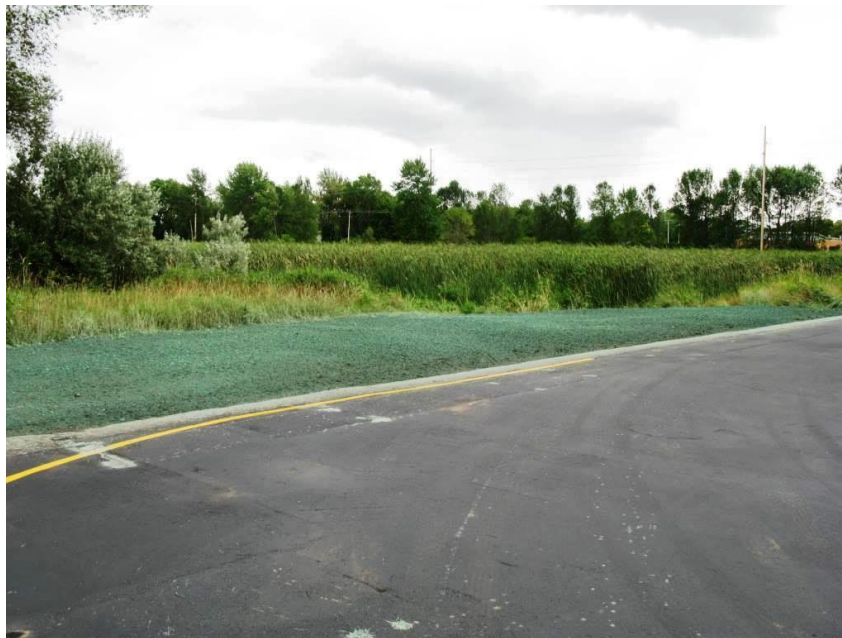
Photo 30. Site Restoration: Hydroseeding at 6th Street

- Graded and seeded areas on west, north, and southwest of parking lot, see Photograph 30
- Patched and filled cracks in asphalt paving in areas needing repair as outlined by the City of Marinette

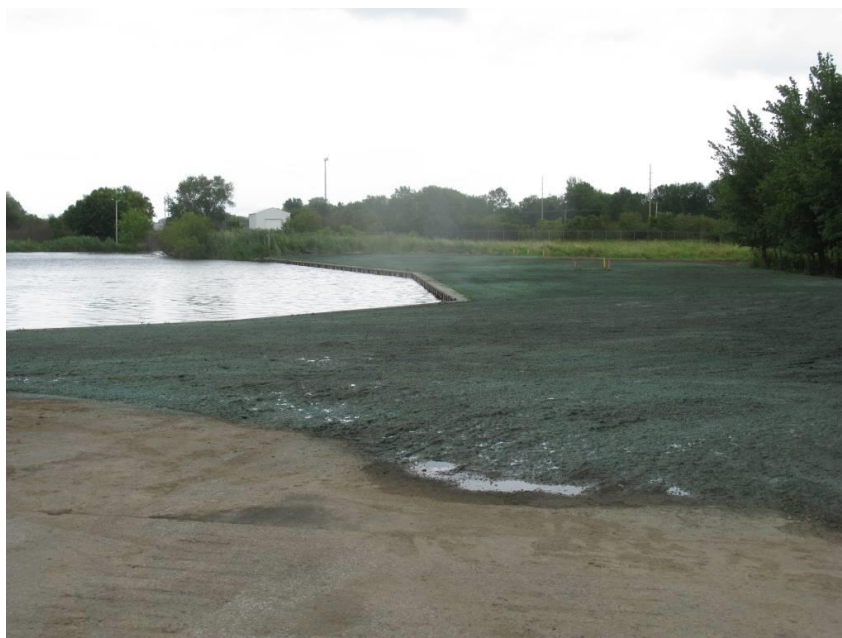
Photo 31. Site Restoration: Wetlands Hydroseeding

- Repaired wetlands area including grading and hydroseeding, see Photograph 31
- Installed fencing along sea wall (wetlands, truck turnaround, and salt vault riverfront area)

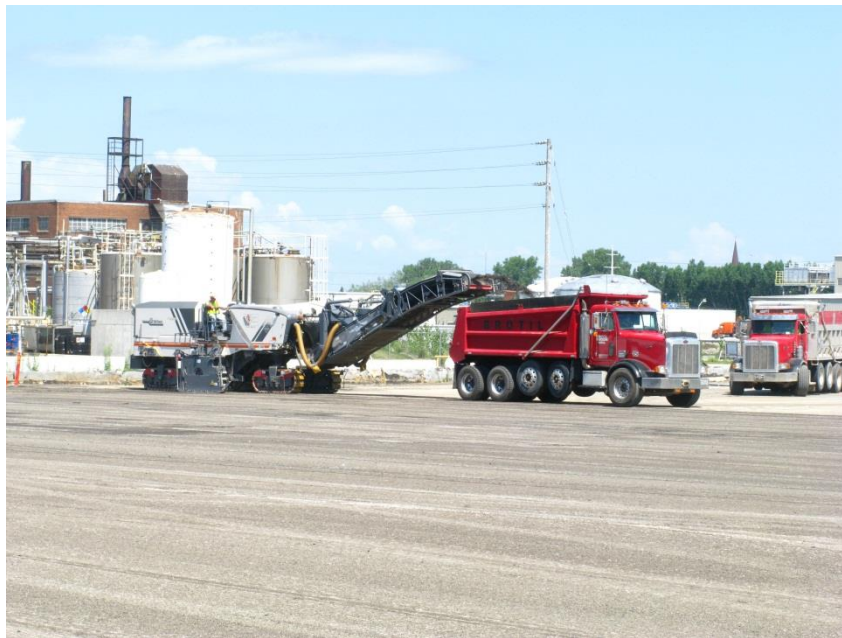
Photo 32. Milling Process Pad

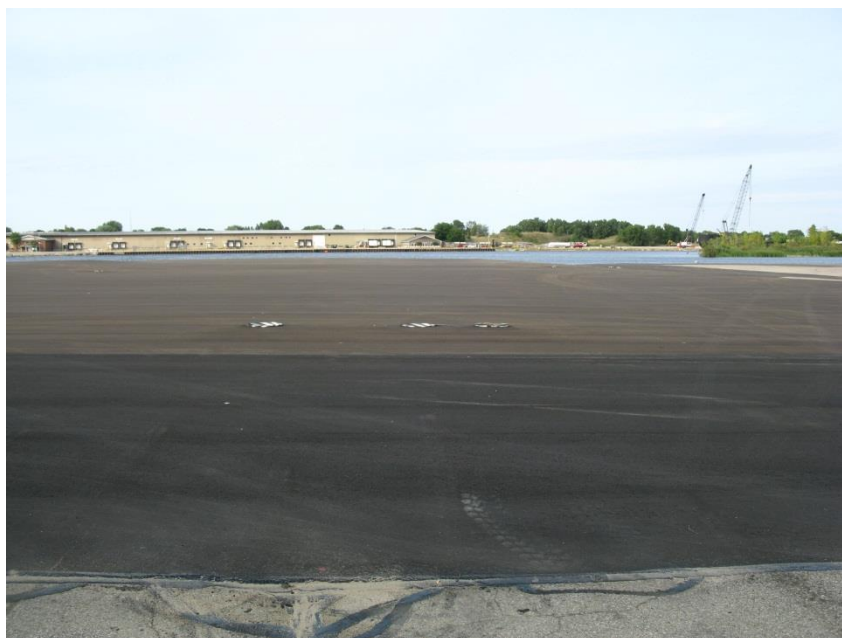
Photo 33. Asphalt Paving Complete

Prior to beginning work, a site walk was conducted to review the work areas, scope, schedule and the work performance requirements and expectations. All phases of work were inspected daily by EQM, Tyco and the project engineer prior to the start of the next stage of work. Work progress and work quality were reviewed with EPA during regularly scheduled conference calls. Written and photographic documentation of work was provided with the Daily Project Reports and Monthly Project Reports. A final site walk and inspection was conducted with EPA, WDNR, and Tyco, and the final asphalt repair and restoration work was approved by all involved parties.

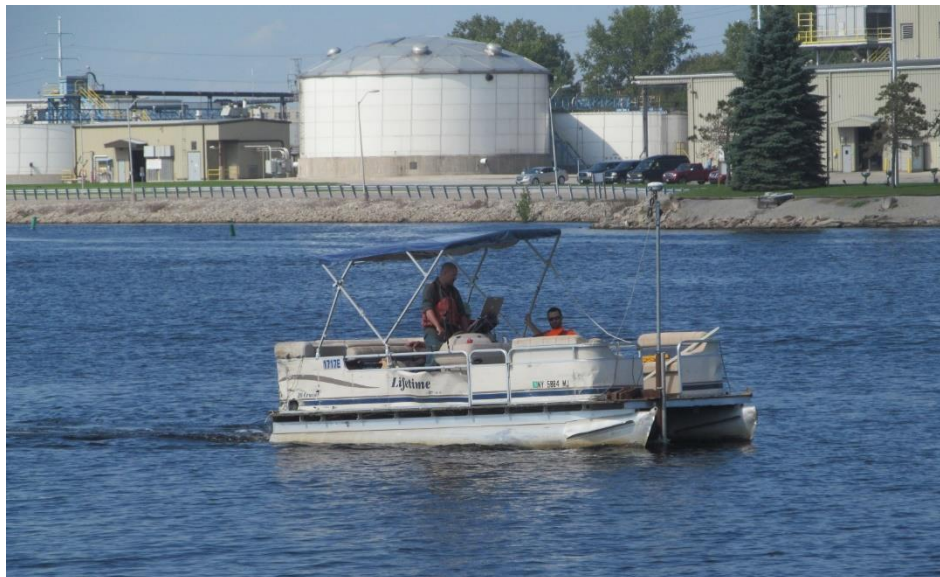
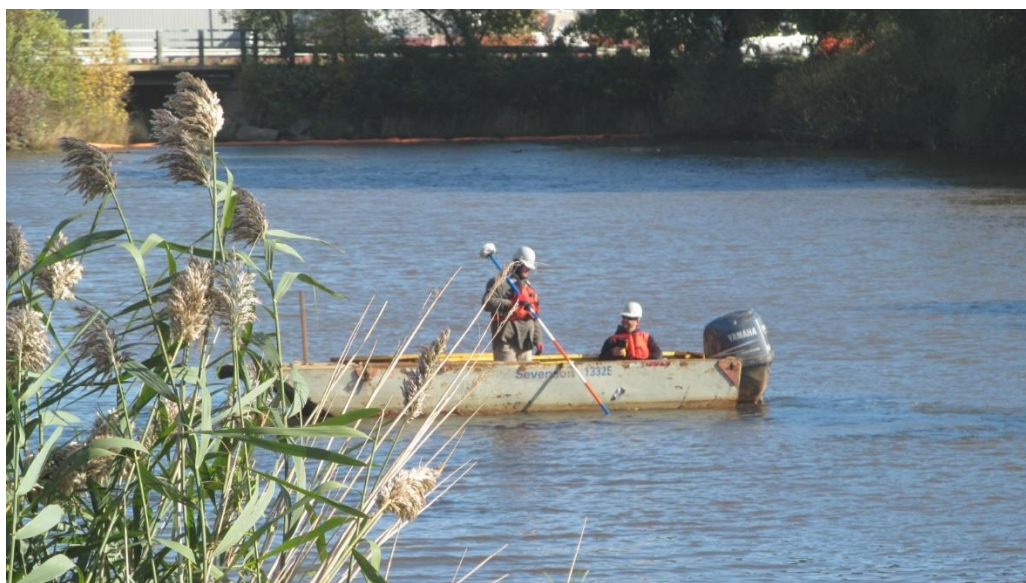
Photo 34. QC Survey

Photo 35. QC Survey

Bathymetric surveys were generally performed without USACE oversight. The bathymetric surveyor reported any deviations or concerns noted during surveying activity. The EQM/SES On-site CQC Officer provided daily monitoring and documentation for EPA review and QA/QC verification. All survey-related data was transferred to the TOCOR for sediment volume verification. A calculation check was performed by the onsite engineer, CH2M Hill. EQM’s independent surveyor and Project CQC Officer were available to EPA to review, discuss, and reconcile all data related to cover thickness measurements. Details regarding the bathymetric surveys were discussed previously in sections 3.6 and 3.13. Photographs 34 and 35 illustrate the QC surveys.
