April 15, 2014

Subject: **RCRA 3008(h) Administrative Order on Consent (RCRA-05-2010-0012) –  
Tecumseh Products Company  
First Quarter 2014 Progress Report – MID 005-049-440**

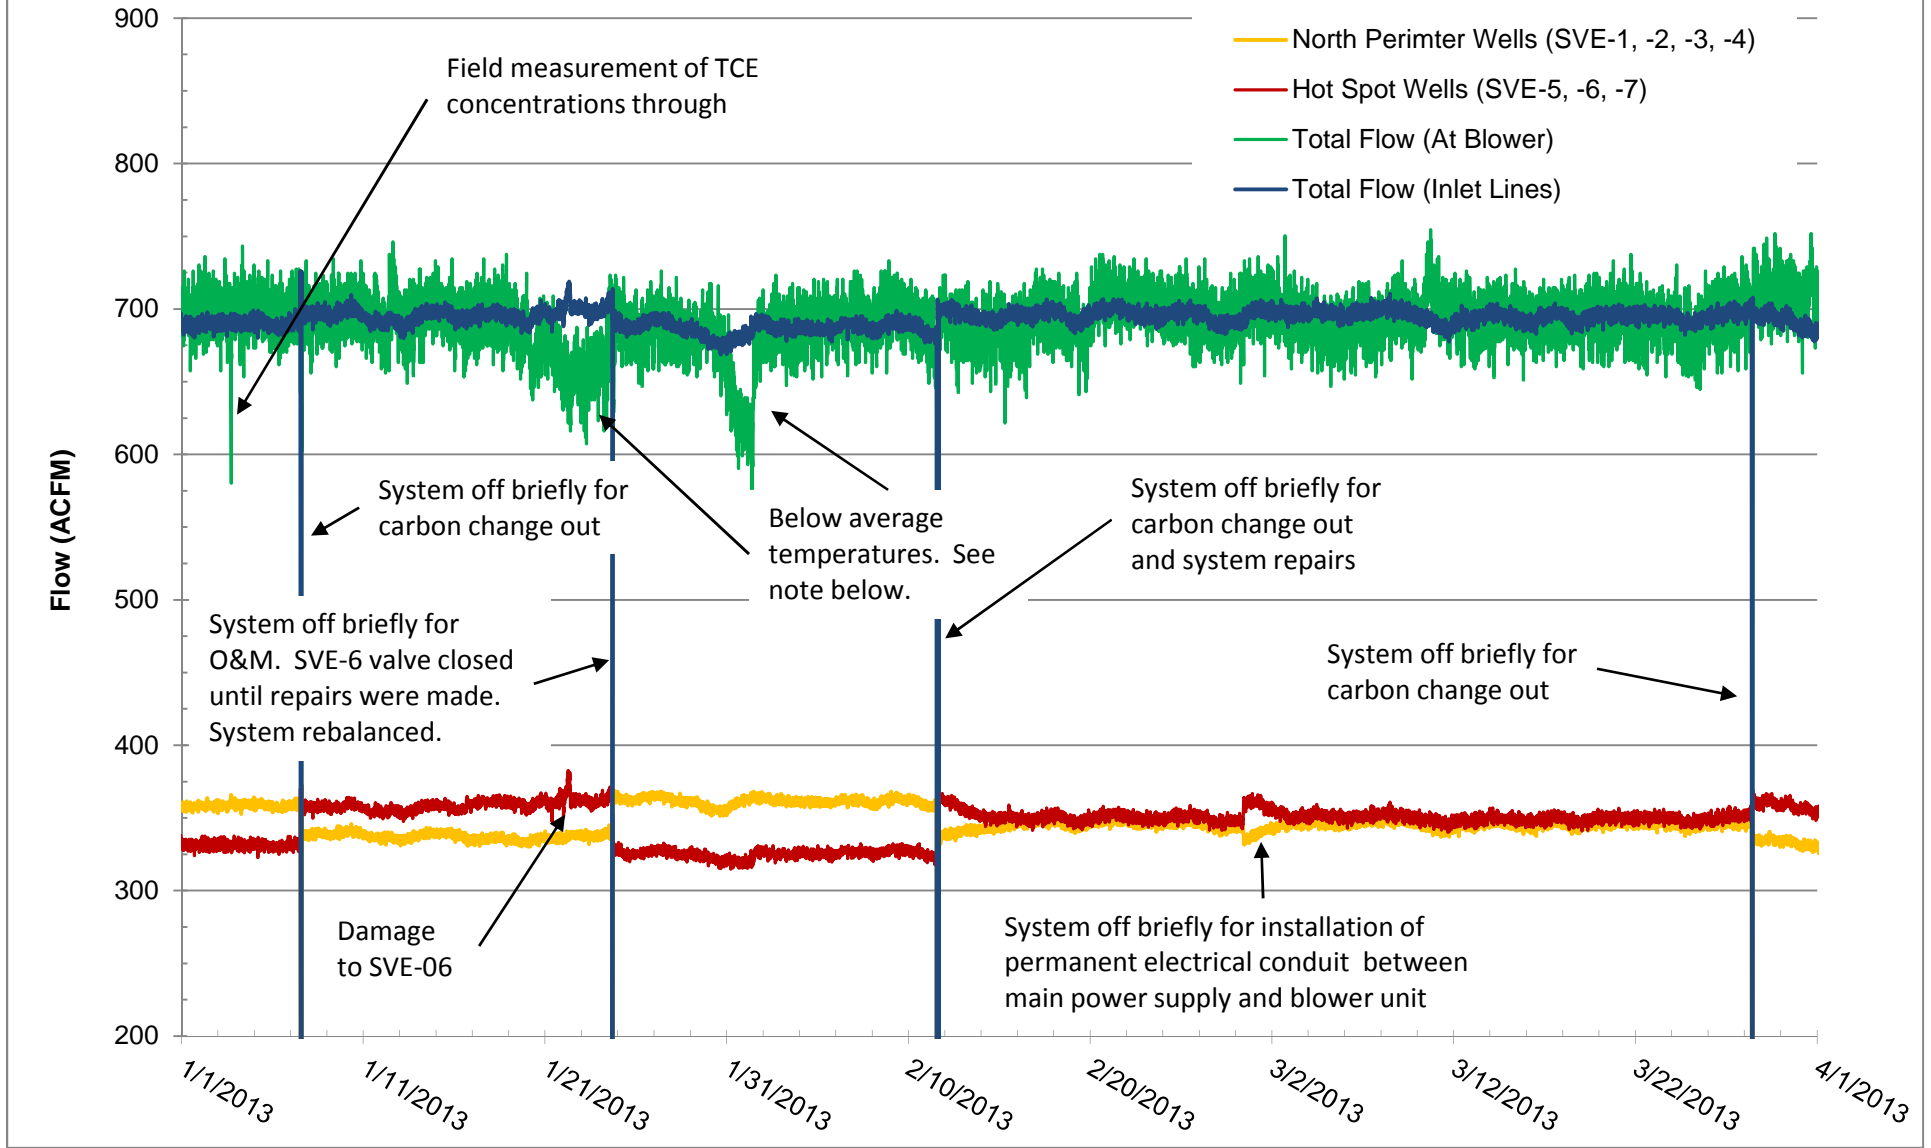
### Chart 1 - SVE System Flow Measurements First Quarter 2013

Note: System flow rate measurements do not account for changes in air density with changes in temperature. Constant subsurface temperatures result in stable inlet flow rates, but flow rates at the blower reflect changes in ambient air temperature.

- As noted on Charts 1 through 4, several apparent anomalies in system flow are evident. However these anomalies can be explained by changes in ambient conditions and/or on-site system maintenance activities. Evaluation of remote flow data did not find any unexplained anomalies requiring further evaluation or repair activities.

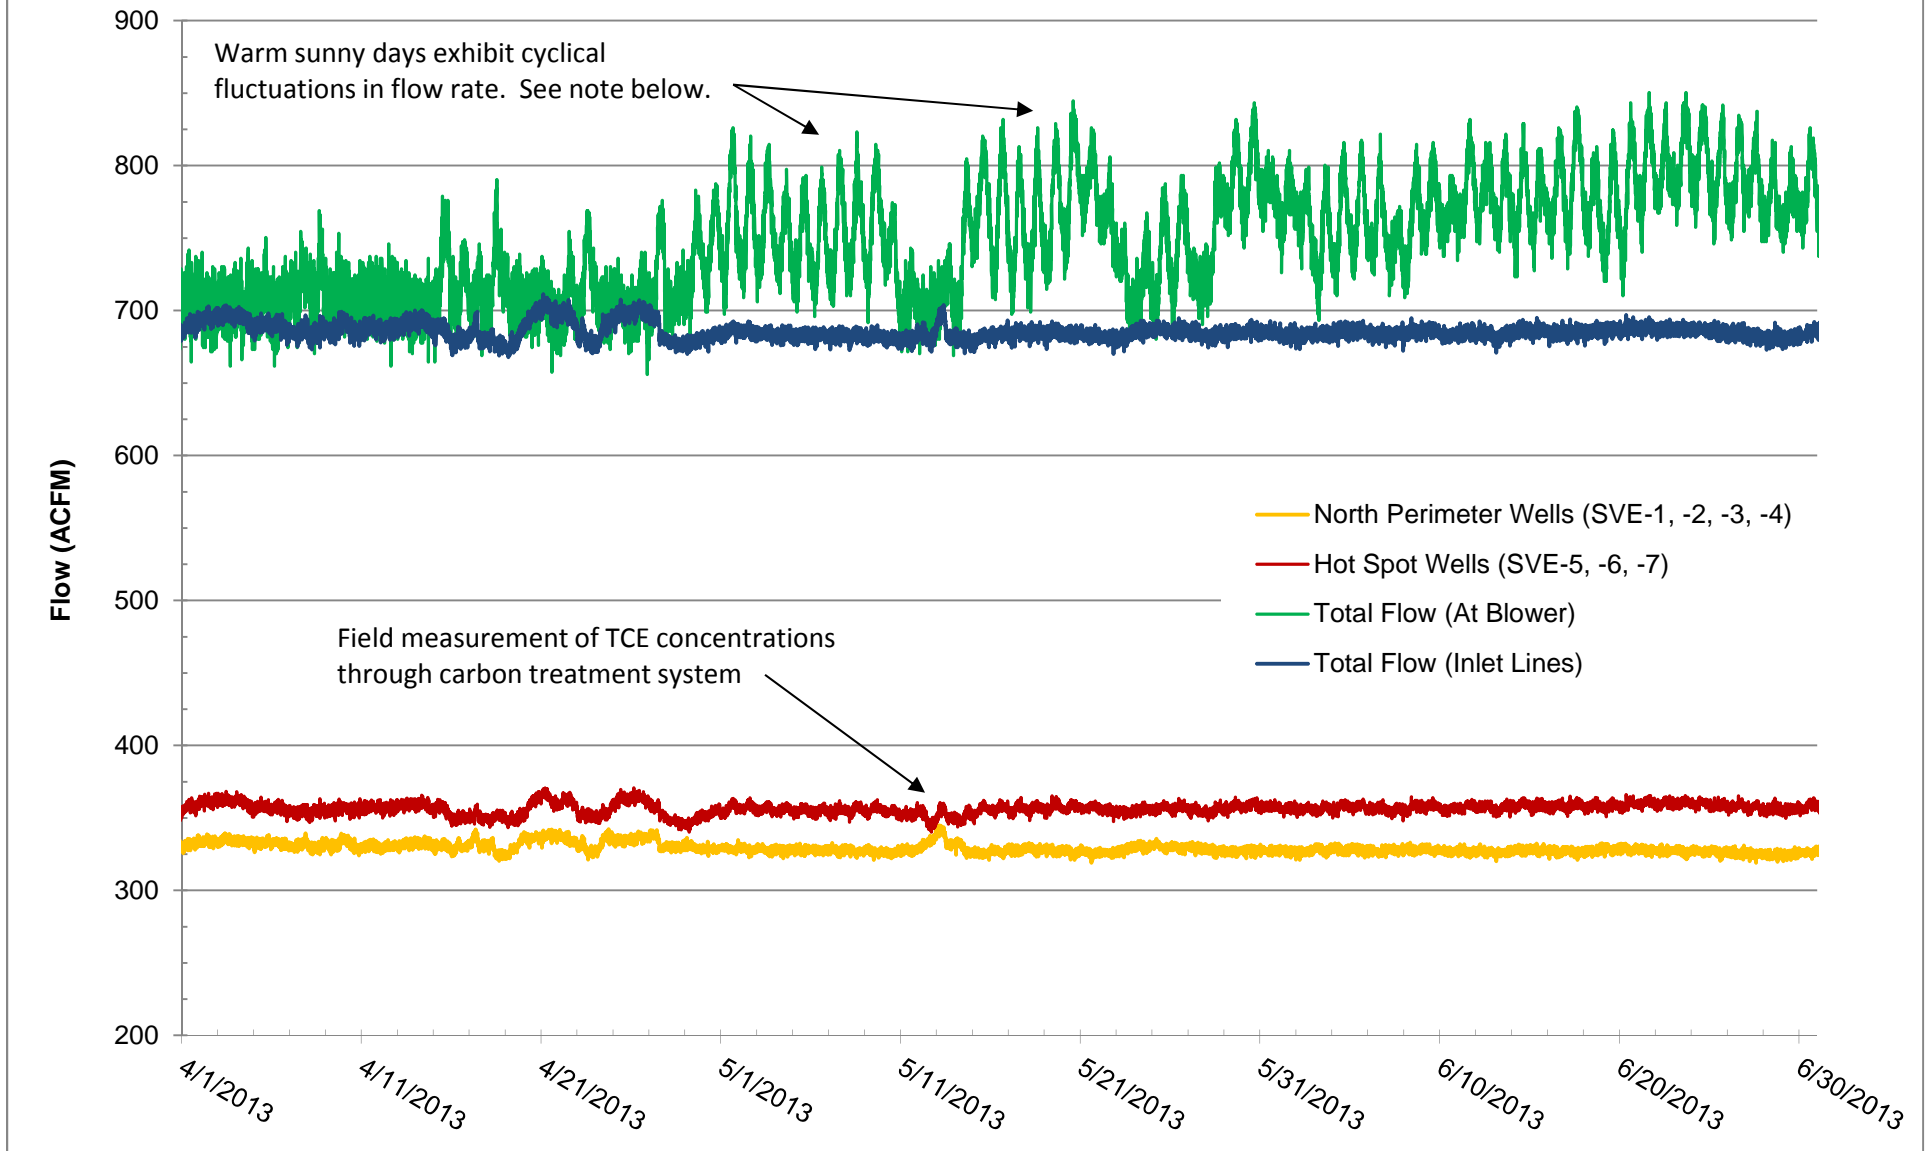
### Chart 2 - SVE System Flow Measurements Second Quarter 2013

Note: System flow rate measurements do not account for changes in air density with changes in temperature. Constant subsurface temperatures result in stable inlet flow rates, but flow rates at the blower reflect changes in ambient air temperature.

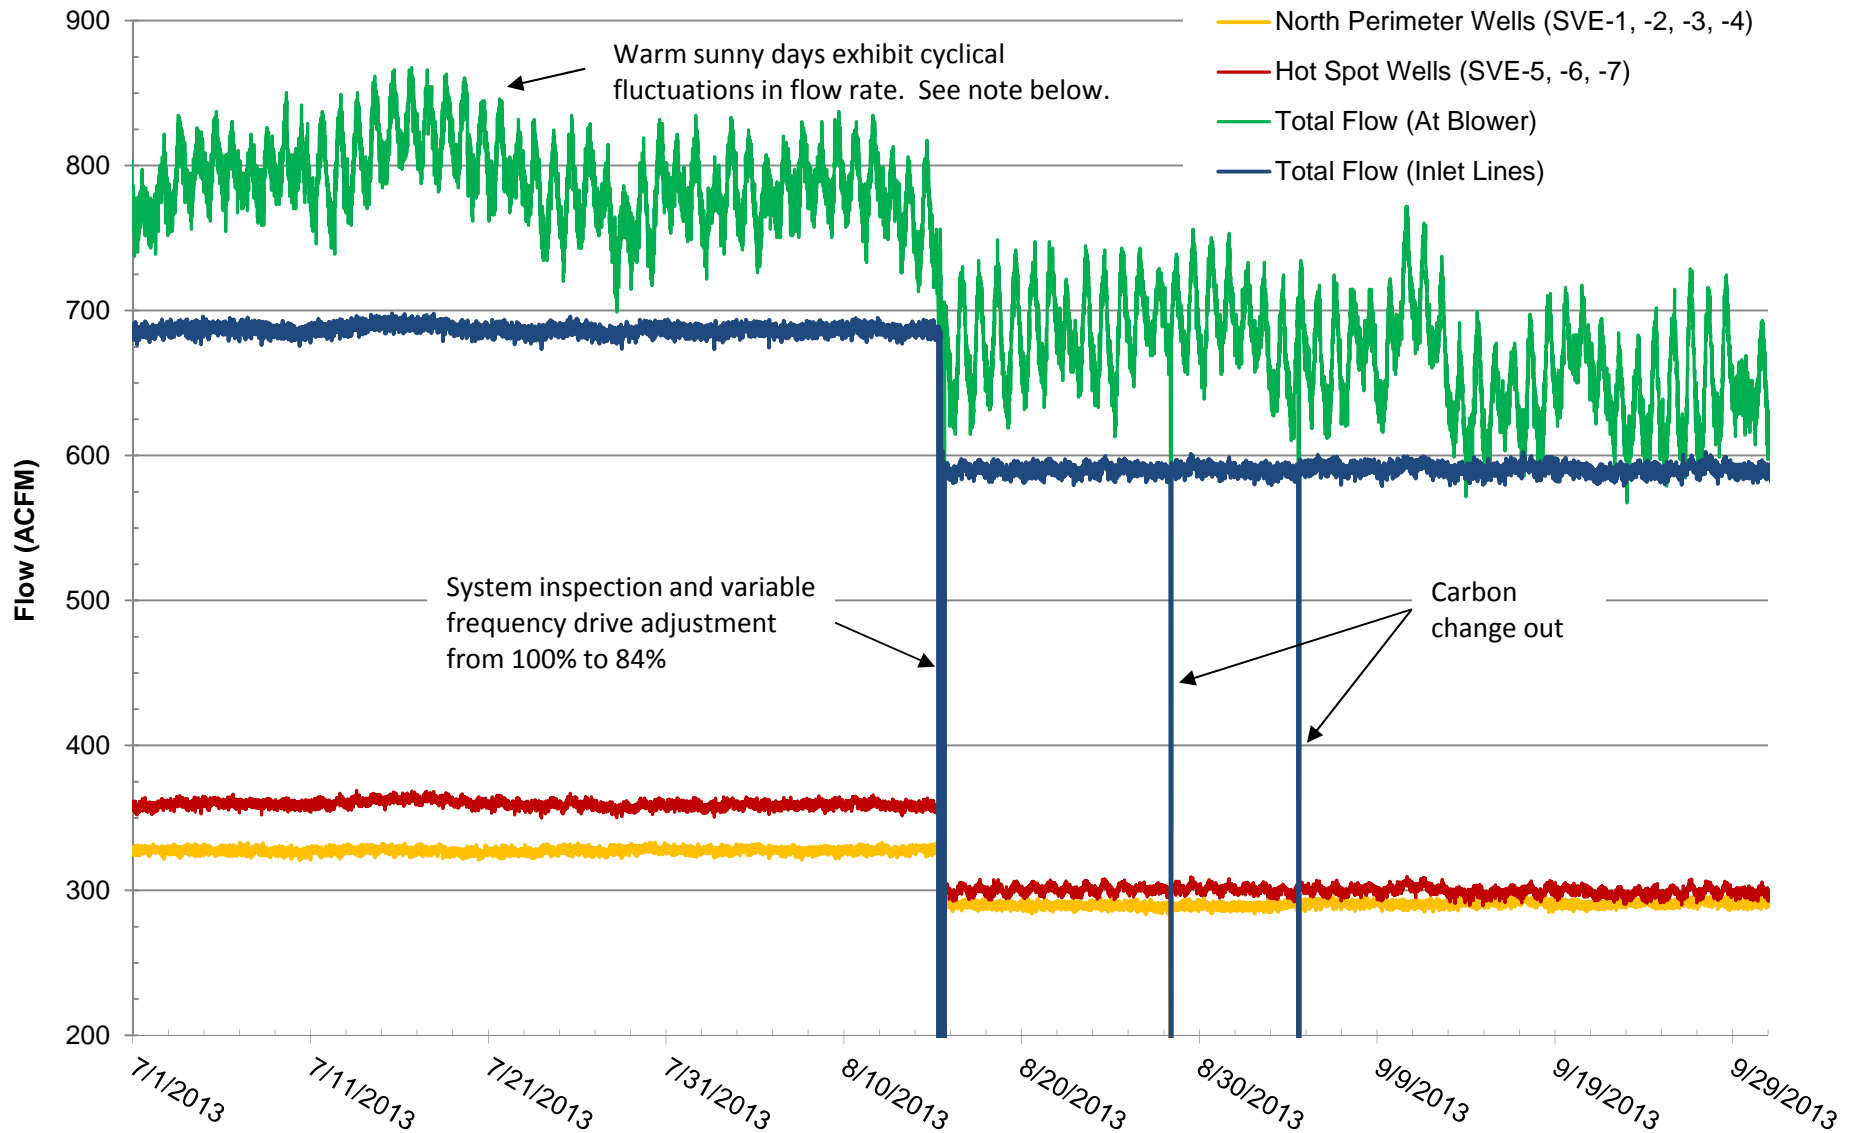
### Chart 3 - SVE System Flow Measurements Third Quarter 2013

Note: System flow rate measurements do not account for changes in air density with changes in temperature. Constant subsurface temperatures result in stable inlet flow rates, but flow rates at the blower reflect changes in ambient air temperature.

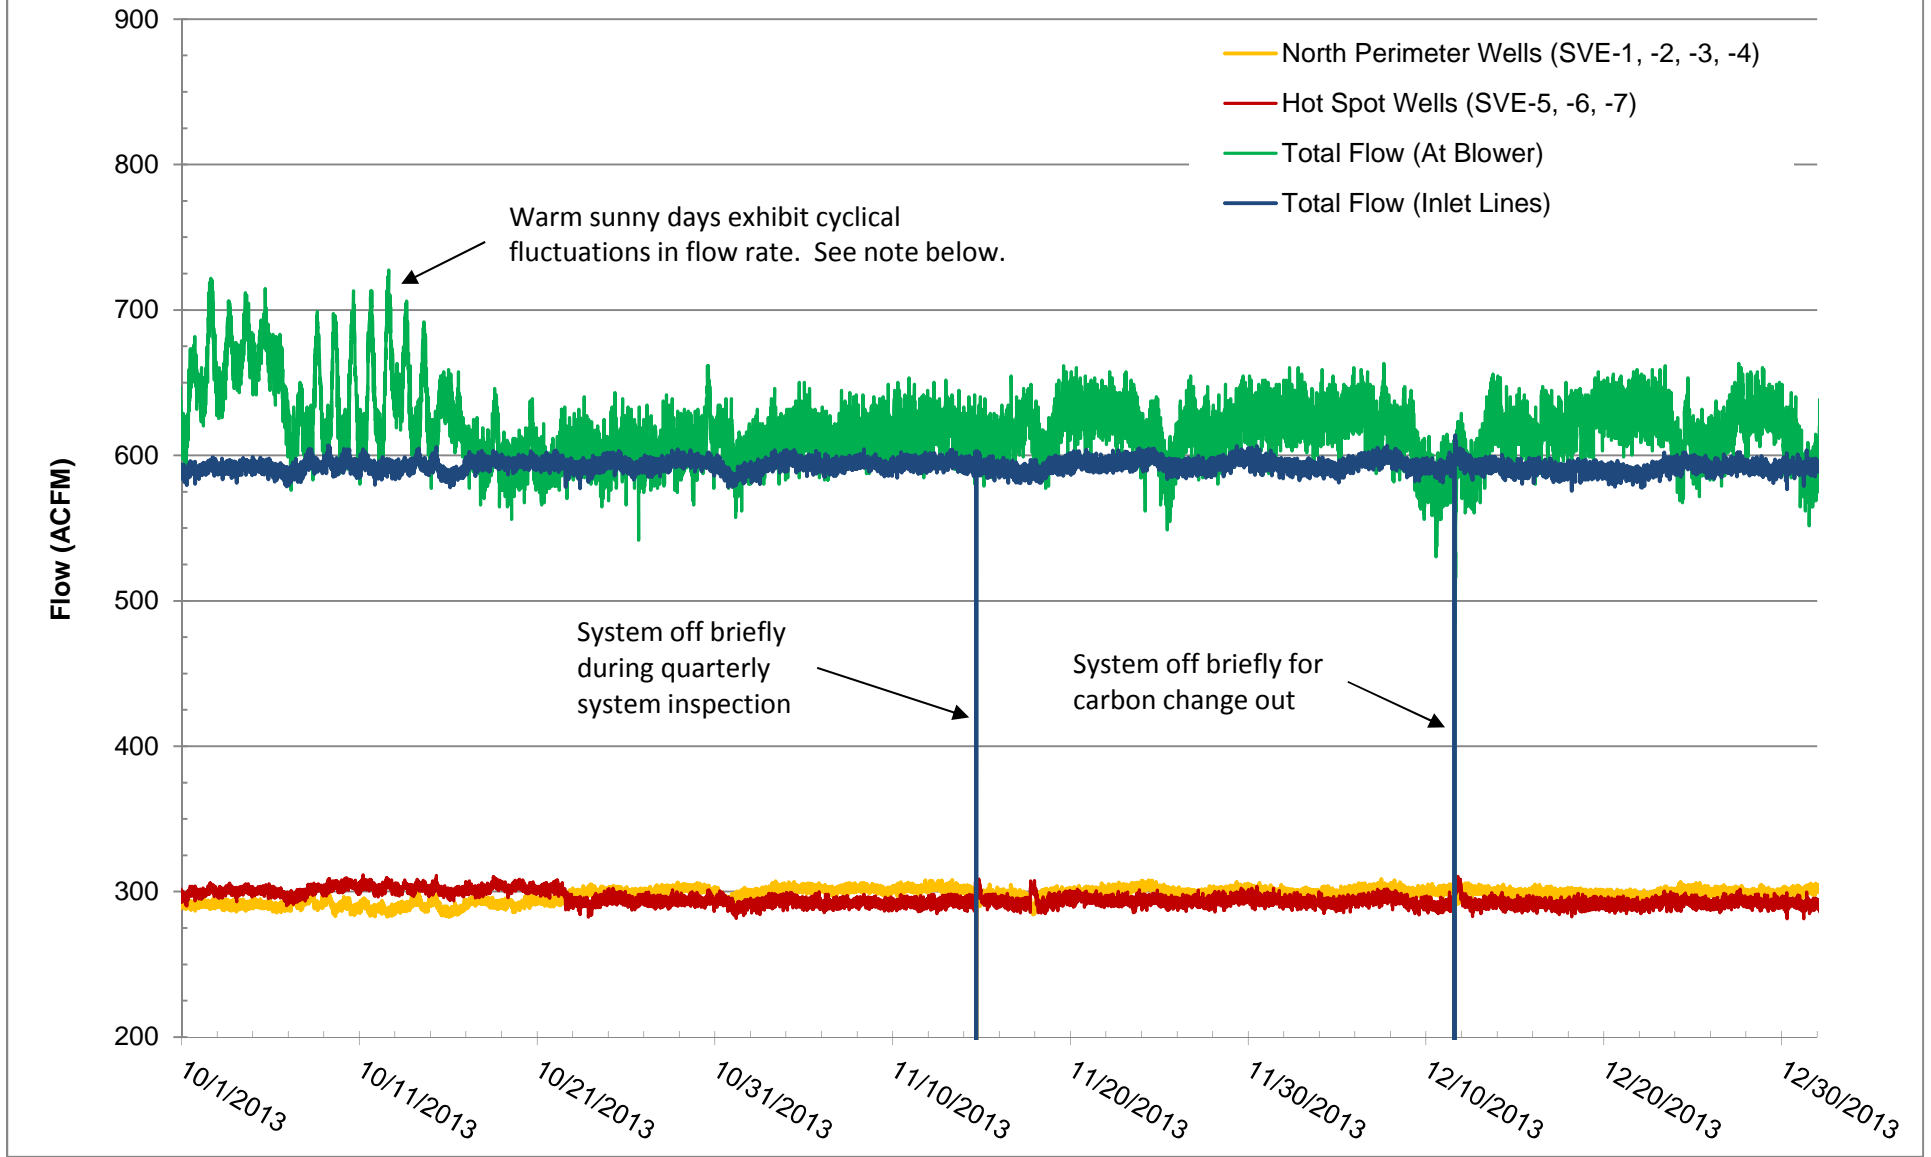
### Chart 4 - SVE System Flow Measurements Fourth Quarter 2013

Note: System flow rate measurements do not account for changes in air density with changes in temperature. Constant subsurface temperatures result in stable inlet flow rates, but flow rates at the blower reflect changes in ambient air temperature.

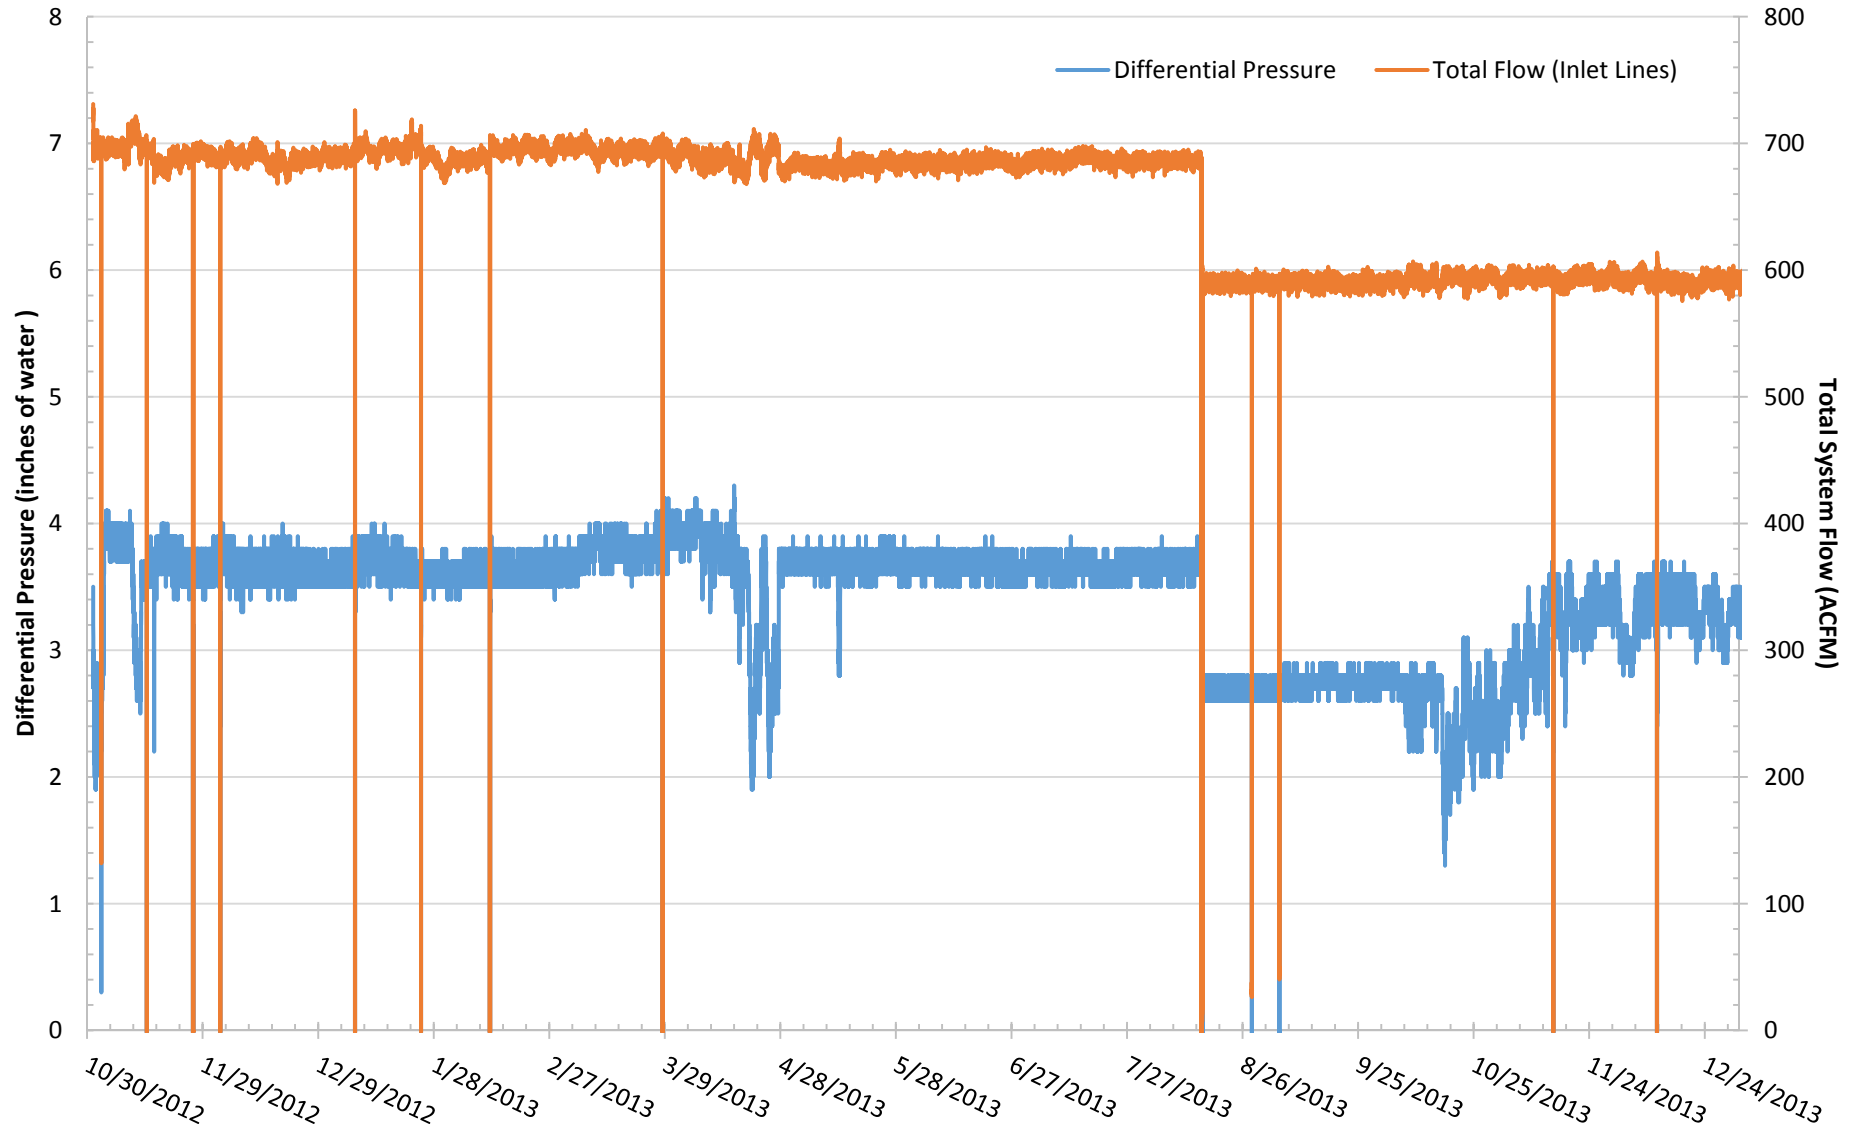
### Chart 5 - Differential Pressure Across Air Filter System Start-Up through December 2013

- As illustrated on Chart 5, the initial differential pressure across the air filter ranged from approximately 3.5 to 3.8 inches of water. An increase in differential pressure of approximately 50 percent (resulting in a total differential pressure of 5.3 to 5.7 inches of water) will trigger replacement of the air filter. Differential pressure remained below 5 inches of water throughout 2013; therefore the air filter was not changed.

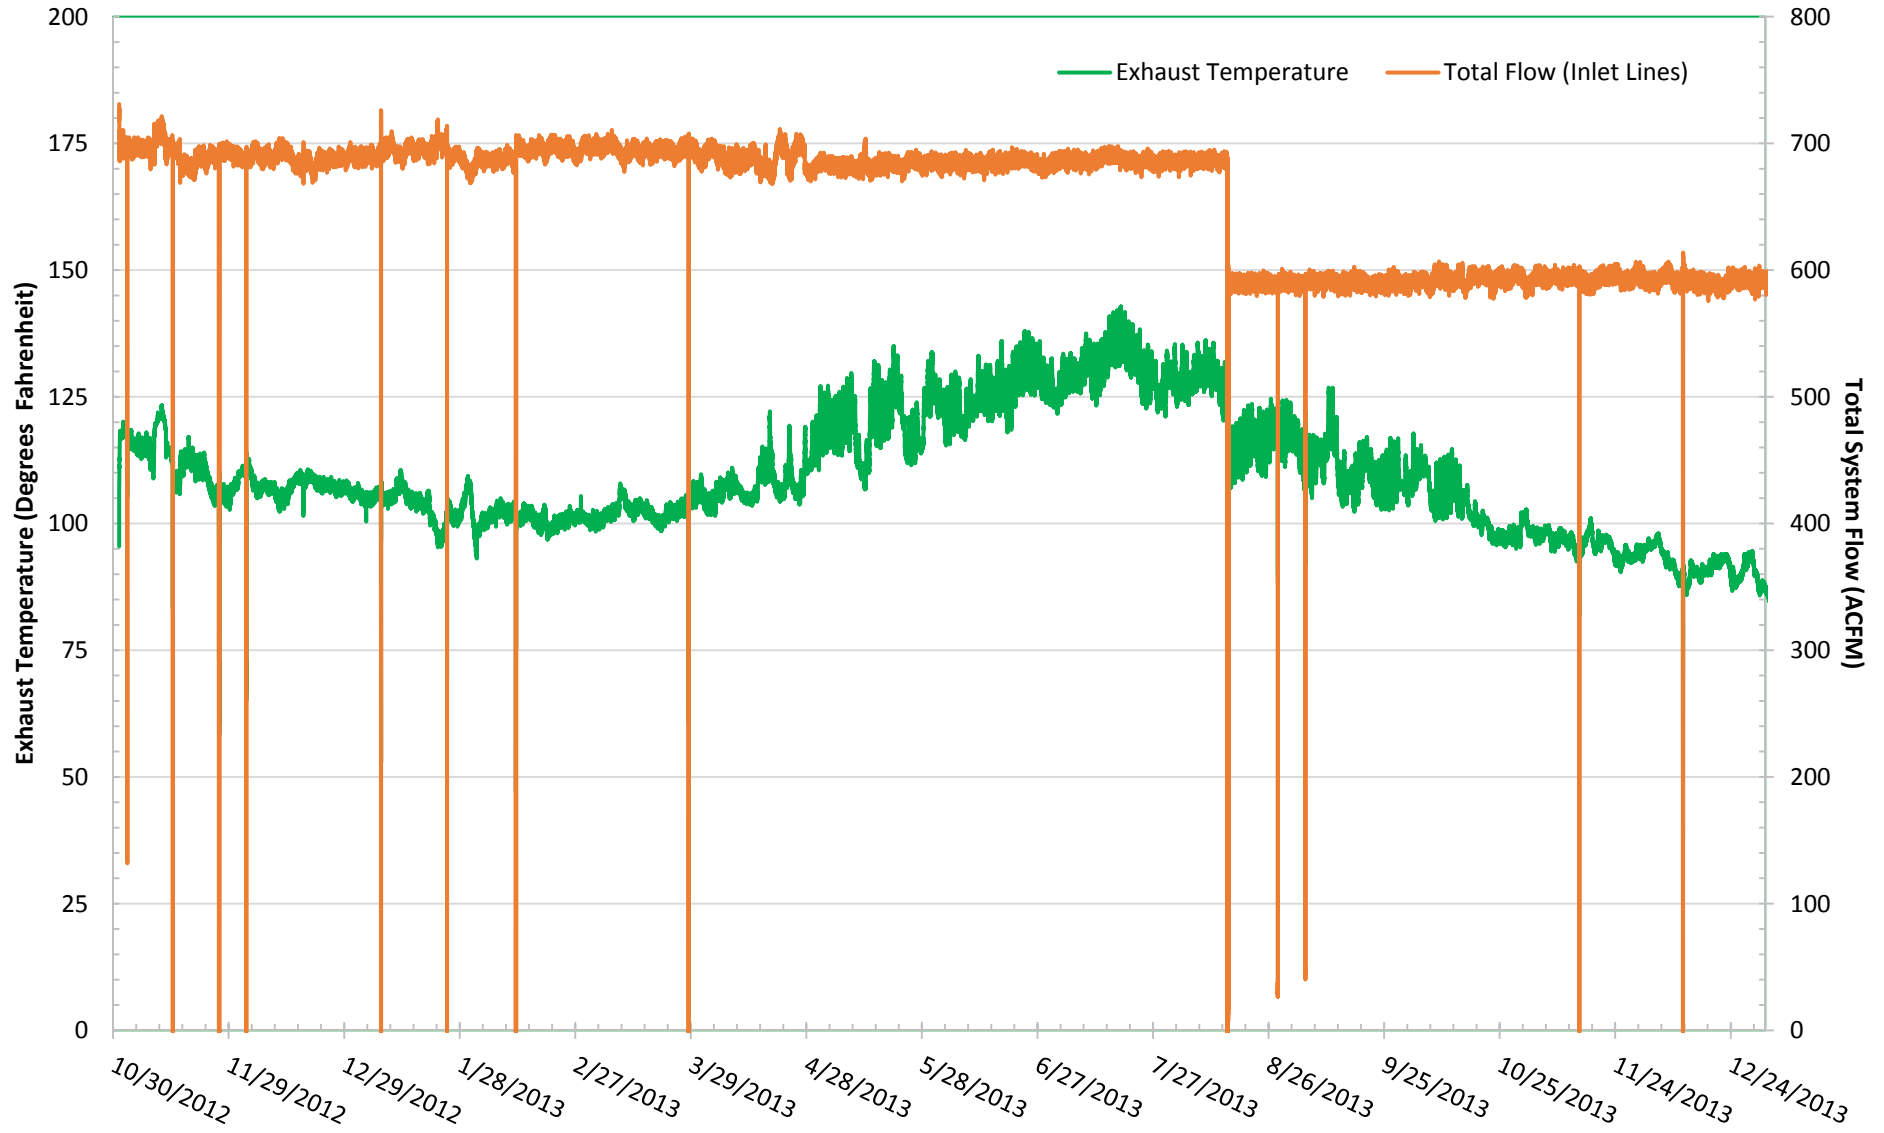
### Chart 6 - Exhaust Temperature System Start-Up through December 2013

- As illustrated on Chart 6, the exhaust temperature varies seasonally with ambient air conditions. Exhaust temperatures ranged from approximately 85 degrees Fahrenheit to 135 degrees Fahrenheit.

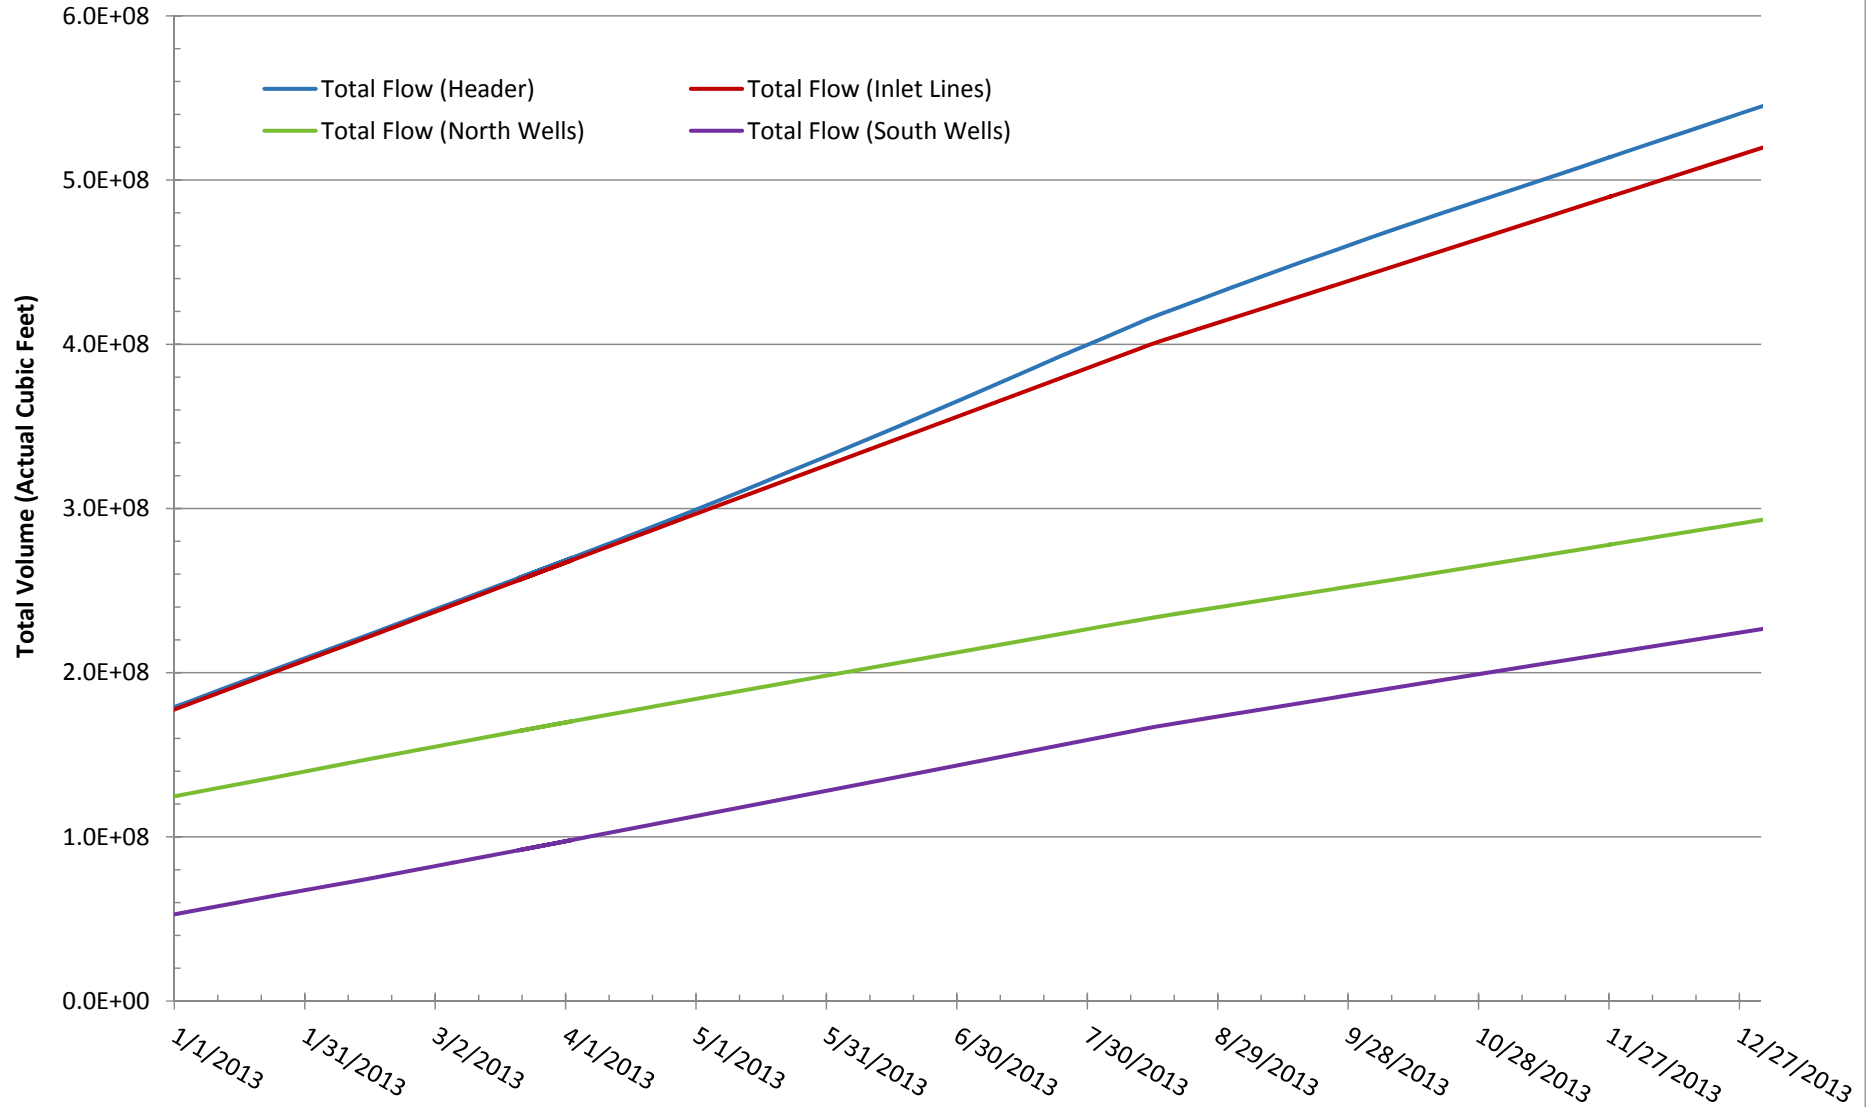
### Chart 7 - Cumulative Volume Removed Through 2013

Note: System flow rate measurements do not account for changes in air density with changes in temperature. The warming effect of the blower results in a slightly higher volume at the blower when compared to the inlet lines.
