Navajo Abandoned Uranium Mine Site Screen Report

Williams and Reynolds AUM Site

Navajo AUM Eastern Region

Weston Solutions, Inc.

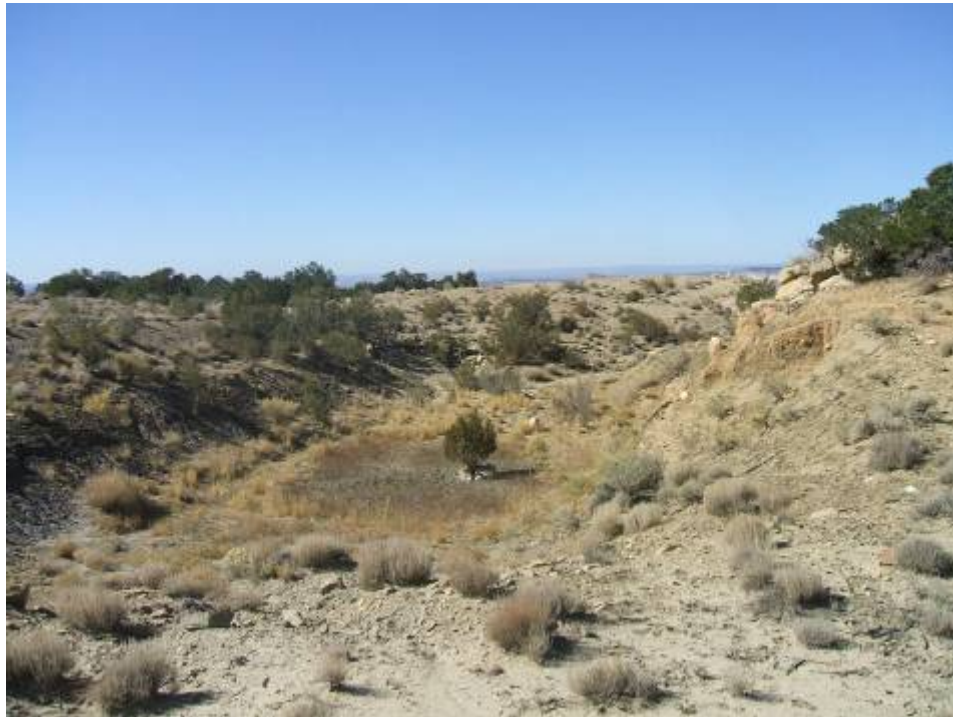
Reclamation status of the mine site is currently unknown. A recessed area was observed in the center of the site. No waste piles, adits or other mine features were observed during the site visit.

Photo 1. Mine site and recessed area, towards the northwest

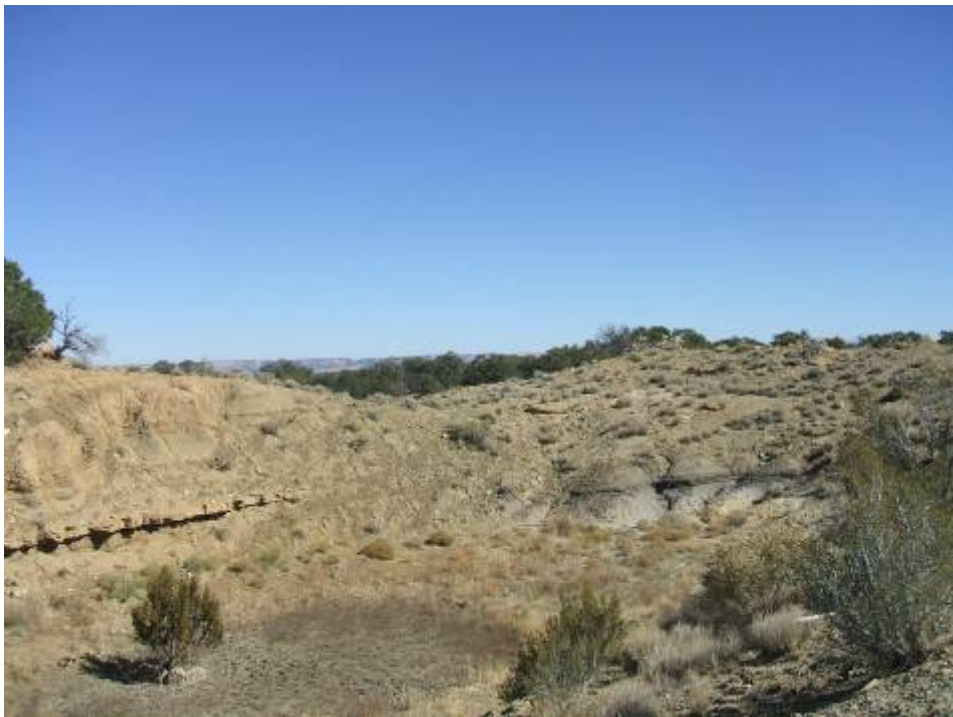
Photo 2. Mine site and recessed area, towards the southeast

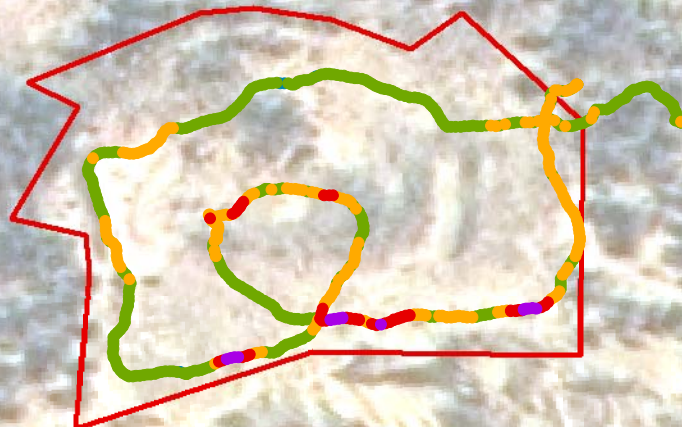
Gamma Radiation Measurements
Williams and Reynolds
Inyabito Chapter
Navajo Nation, New Mexico Figure 2

A total of 582 gamma radiation measurements were collected from mine sites, ranging from 9,438 cpm to 72,420 cpm. The measurements are represented in Figures 1 and 2.

Gamma survey conducted in October 2008
measured as counts per minute
