# Navajo Abandoned Uranium Mine Site Screen Report

## **Section 33 AUM Site**

### **Navajo AUM Eastern Region**

**May 2009**

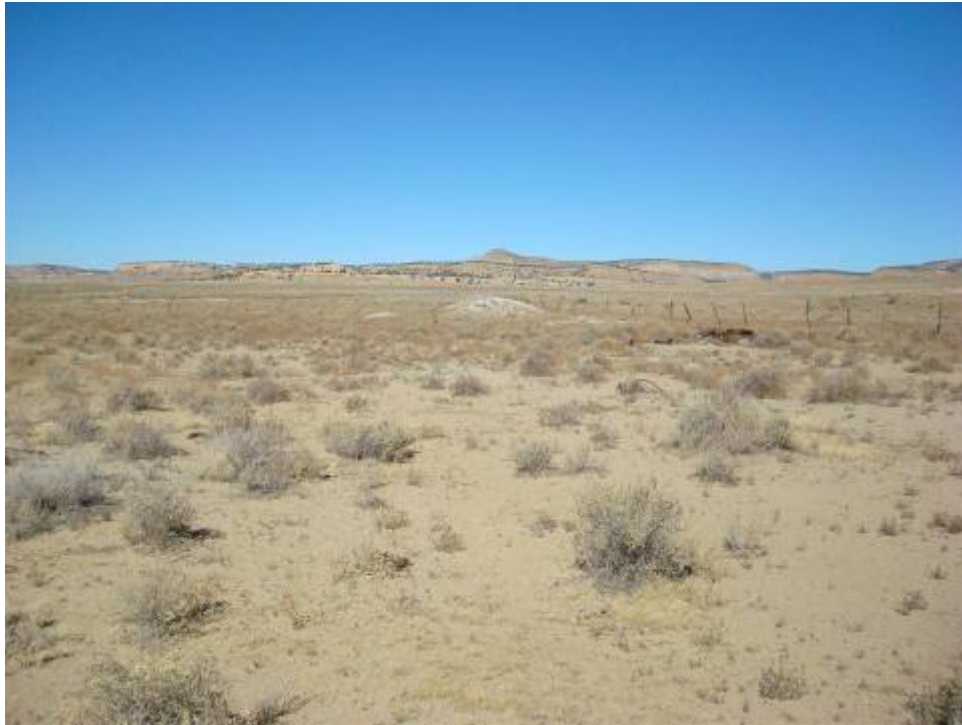
Photo 1. Section 33 Mine site, towards the north

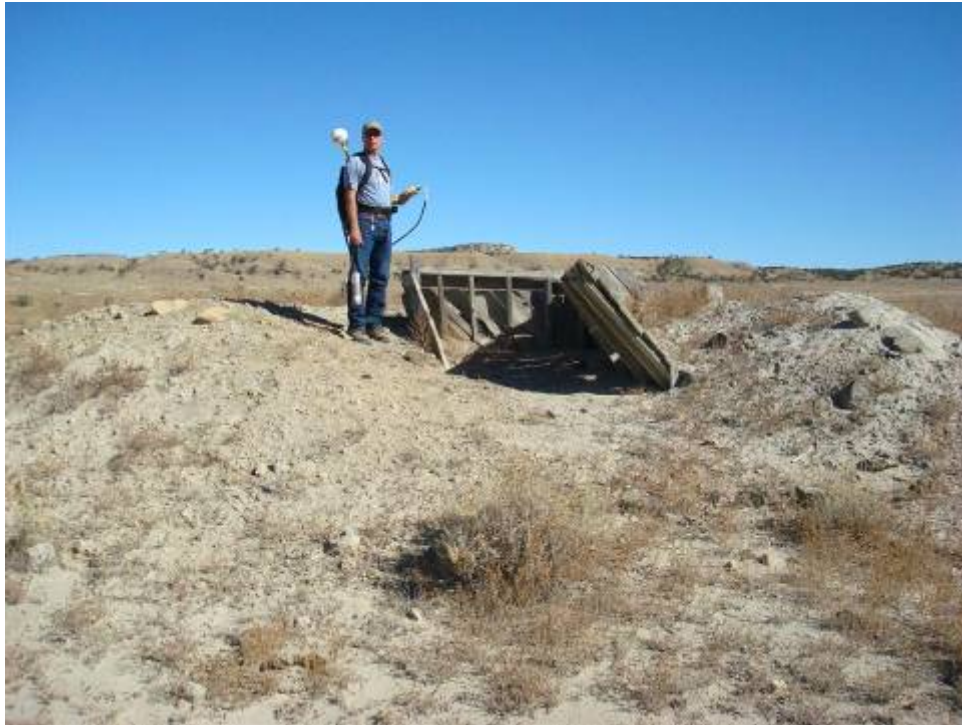
Reclamation status of the mine sites are currently unknown. No visible signs of reclamation were observed. Numerous waste piles were observed at the site and some former unidentified workings. No adits or shafts were observed during the site visit.

Photo 3. Section 33 Mine site, wooden hopper and pulverized waste rock pile located at southeast corner of mine

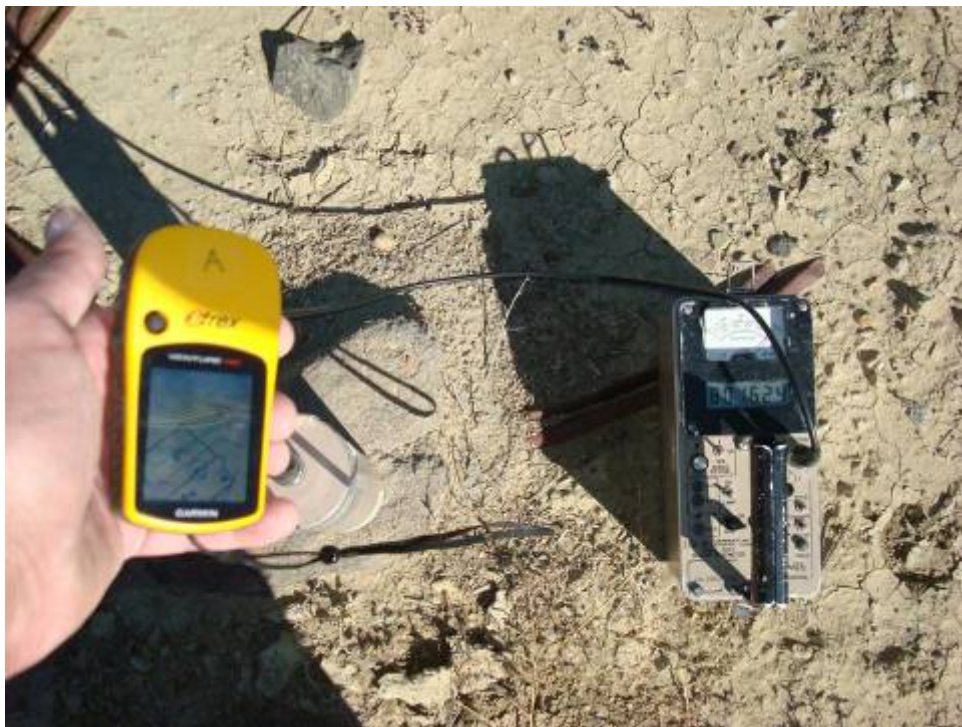
A total of 1,550 gamma radiation measurements were collected from mine sites, ranging from 14,322 cpm to 140,917 cpm. The measurements are represented in Figures 1 and 2. A rock from a waste pile emitted over 800,000 cpm.

Photo 4. Section 33 Mine site, Uranium ore exhibiting over 800,000 cpm

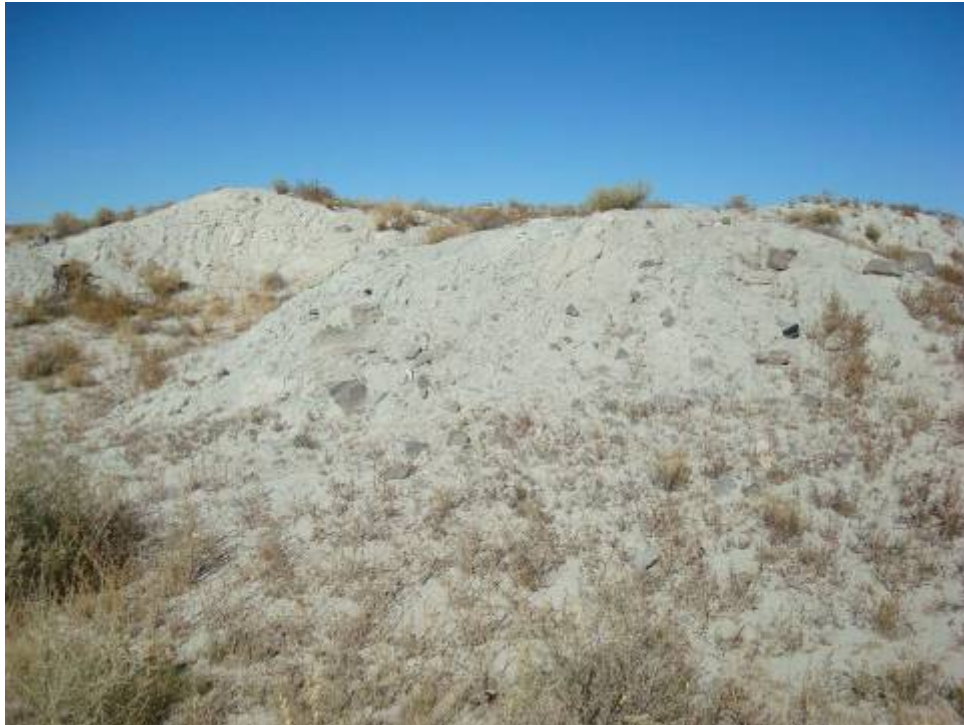
Photo 5. Section 33 Mine site, pulverized waste rock piles.

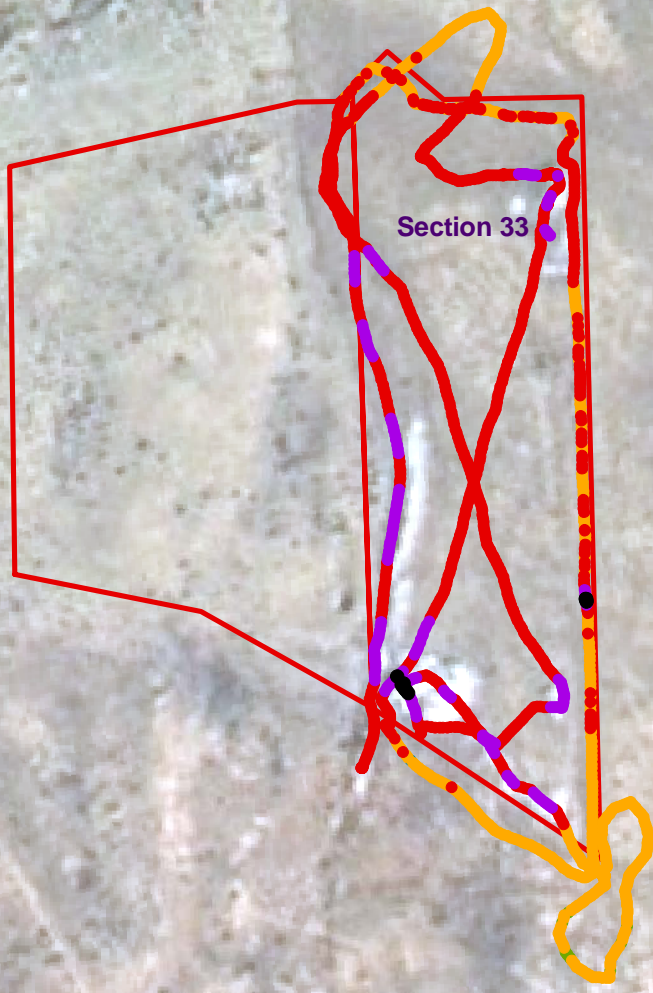
Gamma Radiation Measurements  
Section 33  
Casamero Lake Chapter  
Navajo Nation, New Mexico Figure 2
