Navajo Abandoned Uranium Mine

Site Screen Report

Mine Name: Charles Huskon No. 12

August 2011

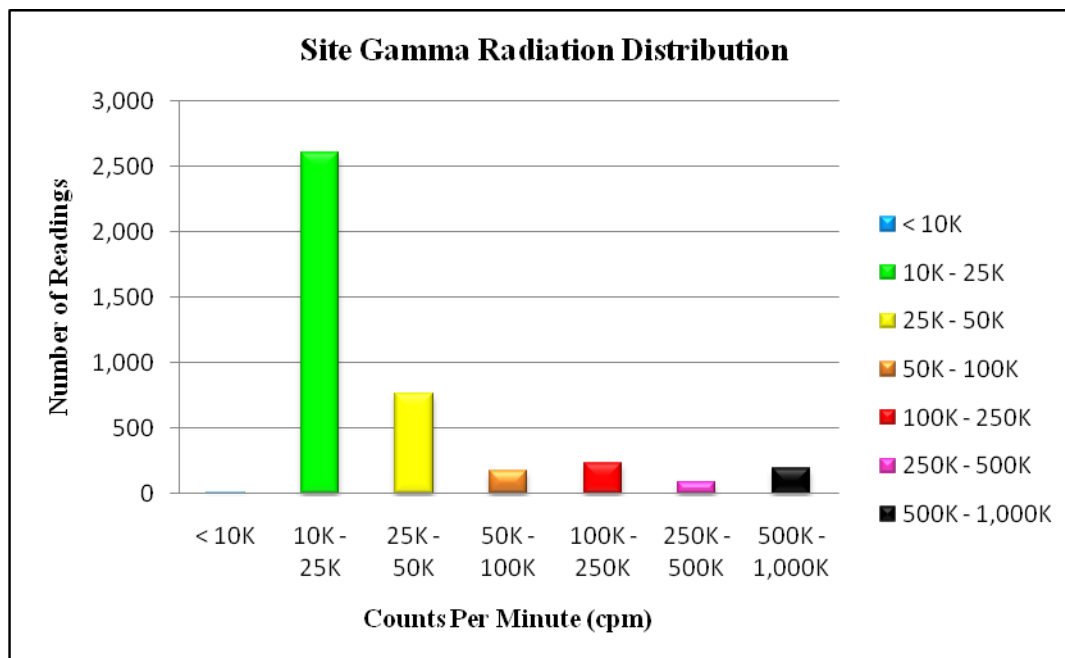
Distribution Chart and Statistics:

Site Gamma Radiation Statistics	
Number of Readings	4,045
Minimum (cpm)	8,927
Maximum (cpm)	999,960
Mean (cpm)	68,893
Median (cpm)	21,109
Standard Deviation	147,074

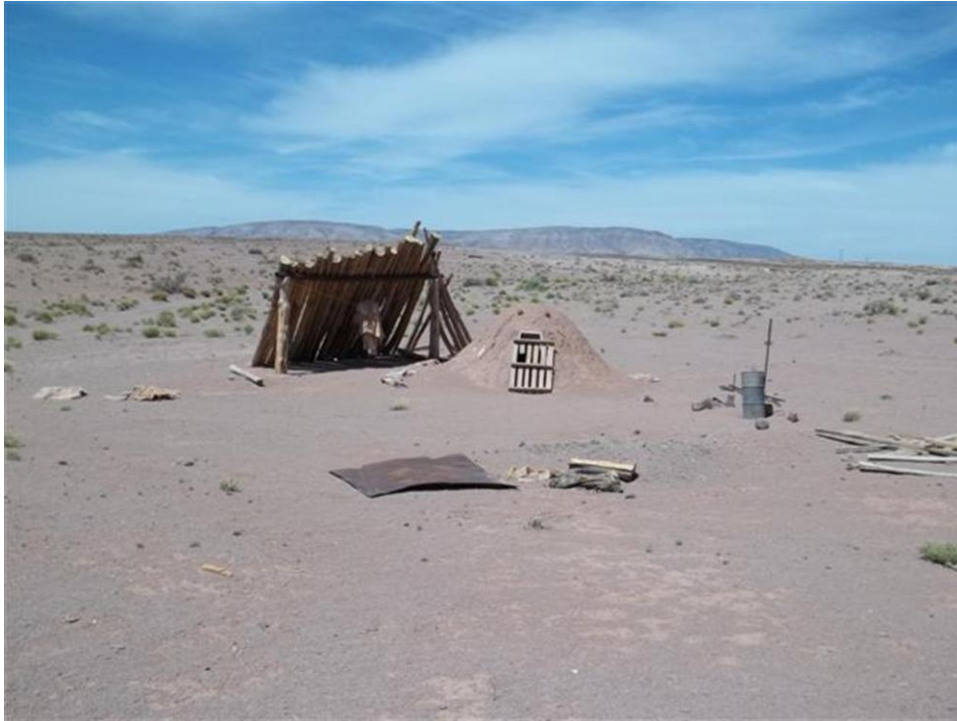
Photo 5: Mine Site #119; Sweathouse immediately east of site

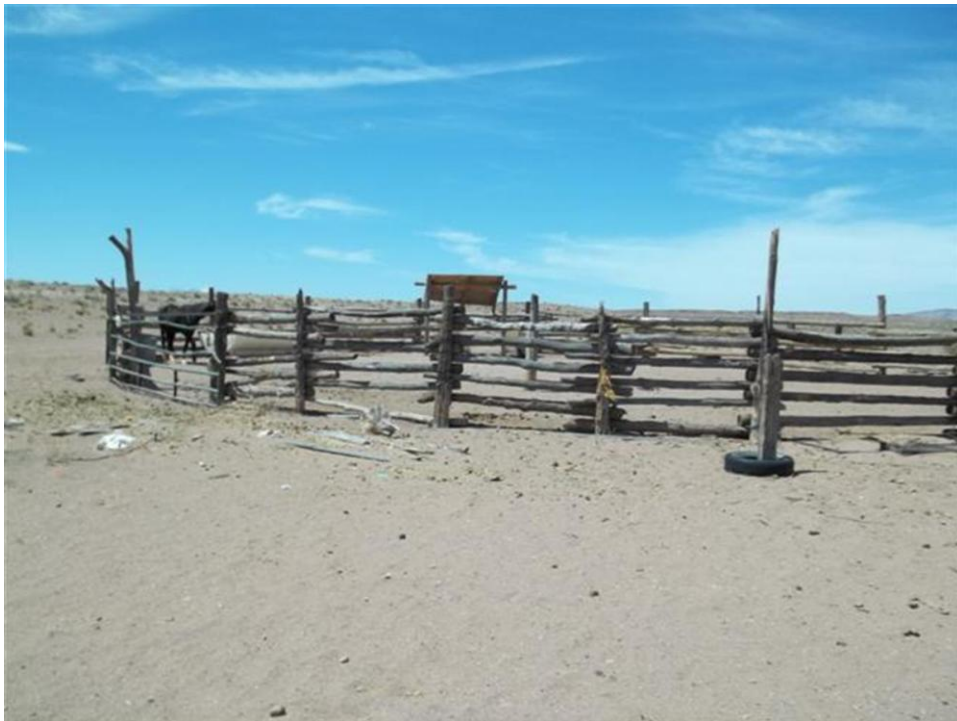
200 feet to 0.25 mile: Mud structure 350 ft E of site; corral 350 ft N of site; 5 housing compounds within 0.25 mi NE of site

Photo 6: Mine Site #119; Corral and horse, immediately north of site

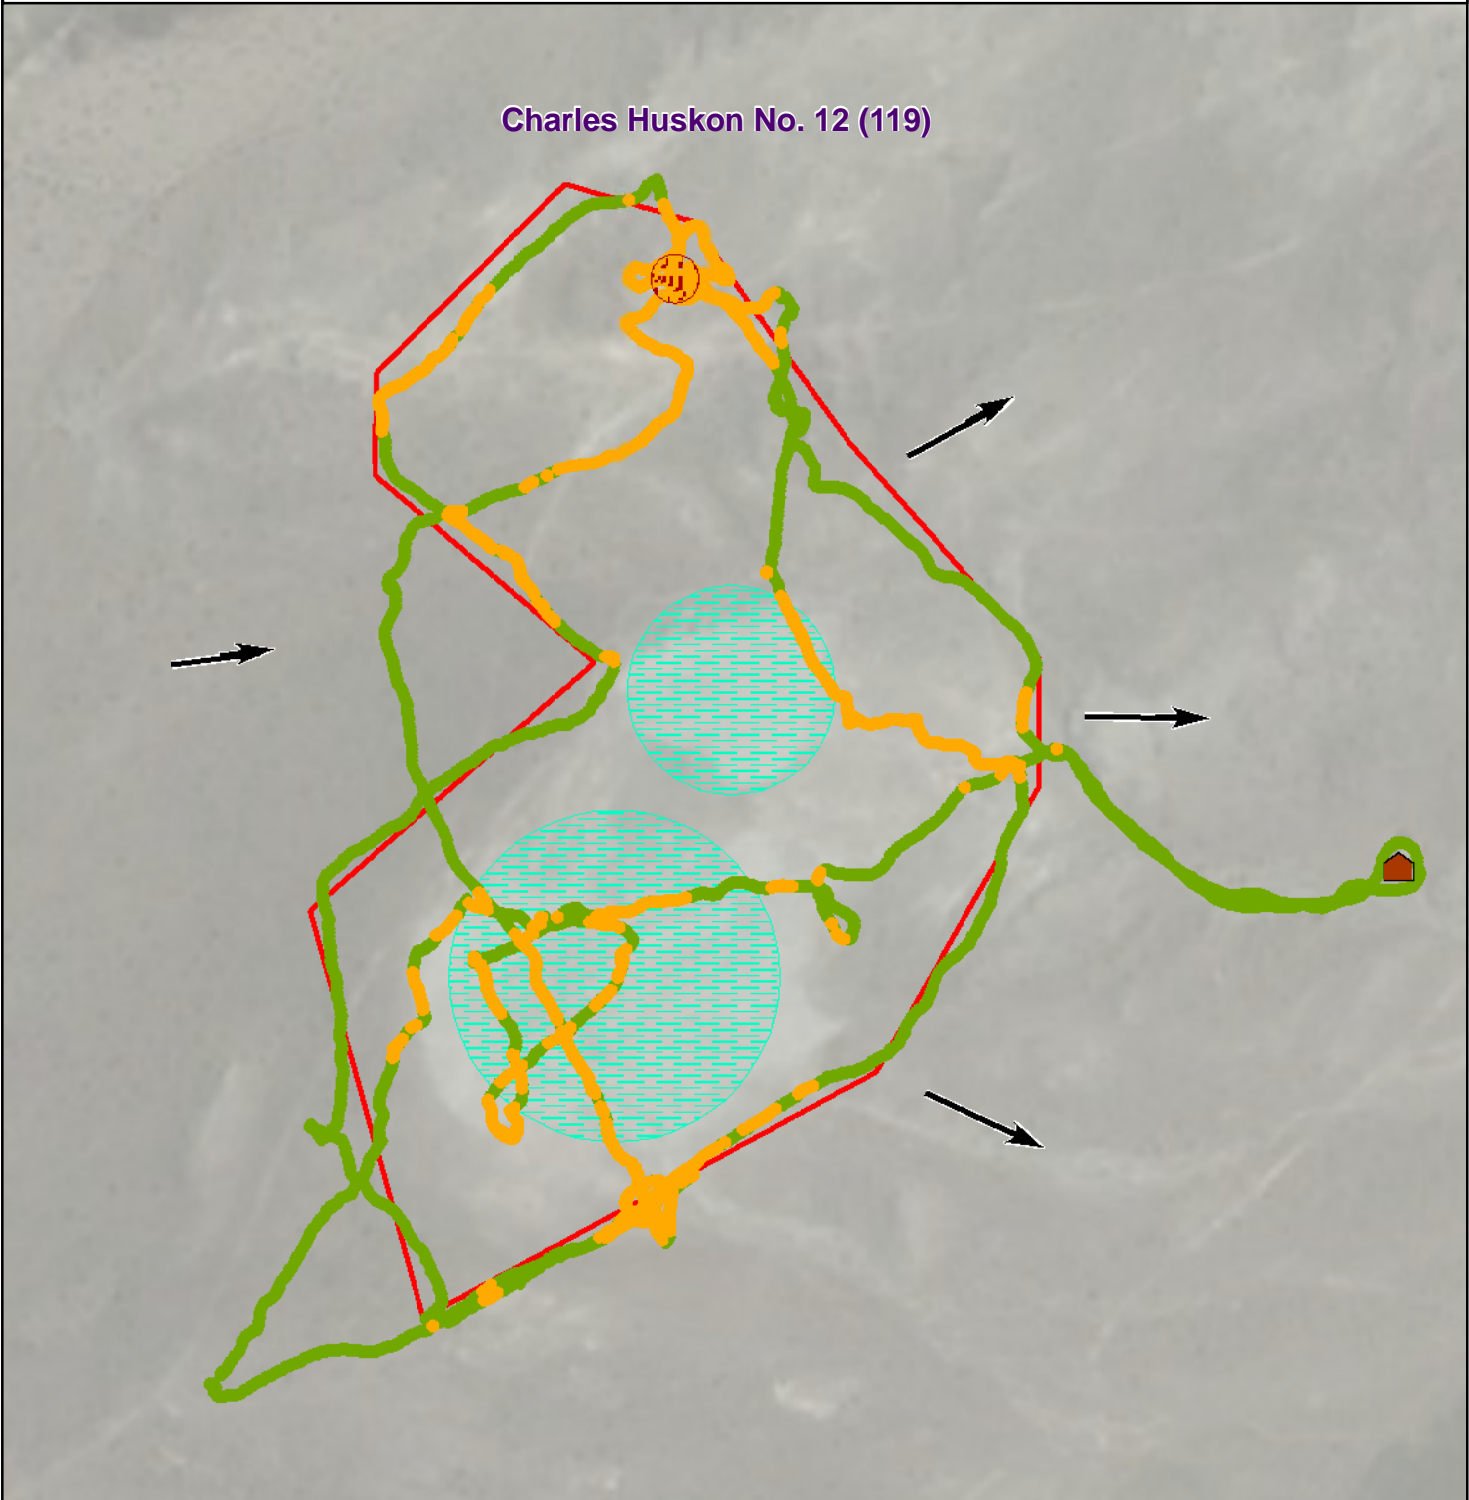
**Figure 1 - Gamma Radiation Measurements, Above Two Times Background
Charles Huskon No. 12 (119)
Coalmine Mesa Chapter, Navajo Nation**

A total of 4,045 gamma radiation measurements were collected from the mine site, ranging from 8,927 cpm to 999,960 cpm. Measurements collected in the vicinity of the waste rock were found at a maximum level of approximately 1,000,000 cpm, and the reclamation area of approximately 200,000 cpm. The measurements are represented in Figures 1 and 2.
