# Navajo Abandoned Uranium Mine

## Site Screen Report

### Jack Huskon No. 3 AUM Site

**January 2011**

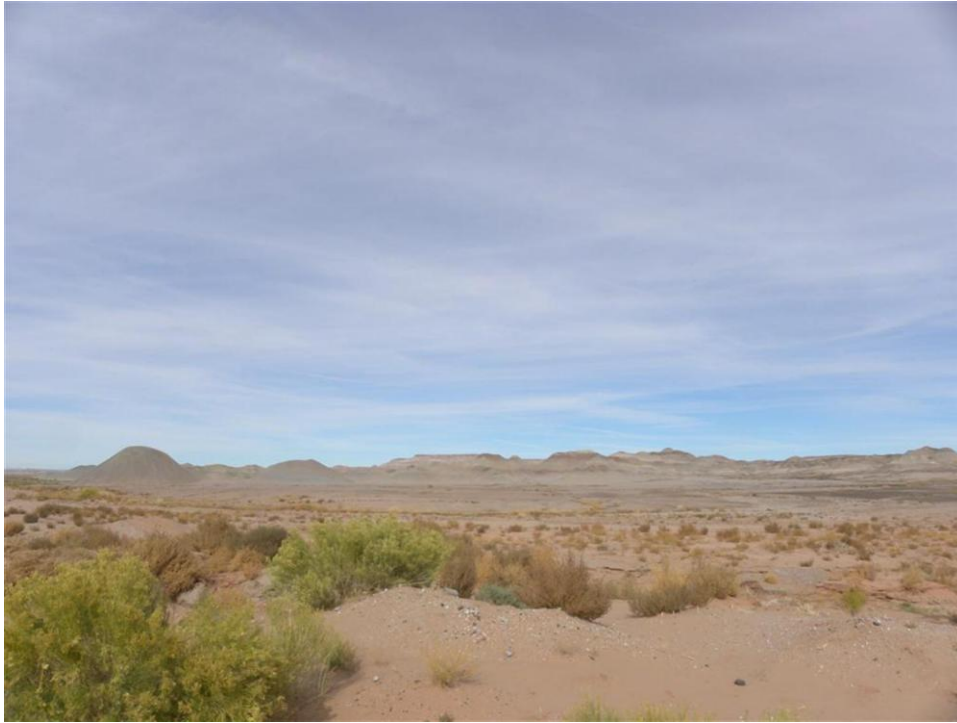
Photo 1. Jack Huskon No. 3 mine site

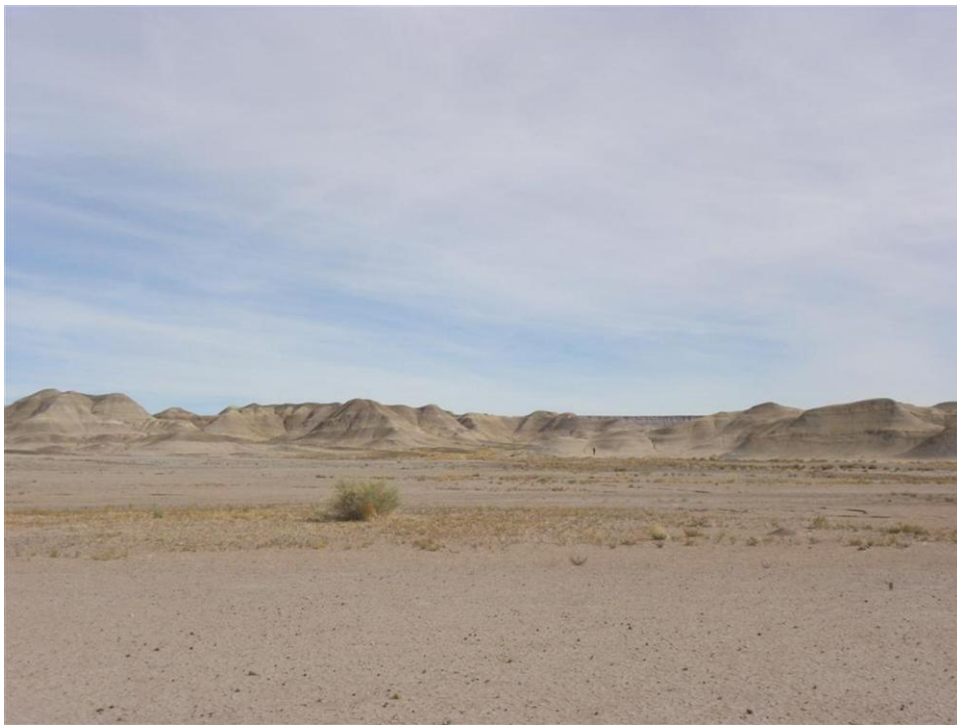
Photo 2. Jack Huskon No. 3 mine site

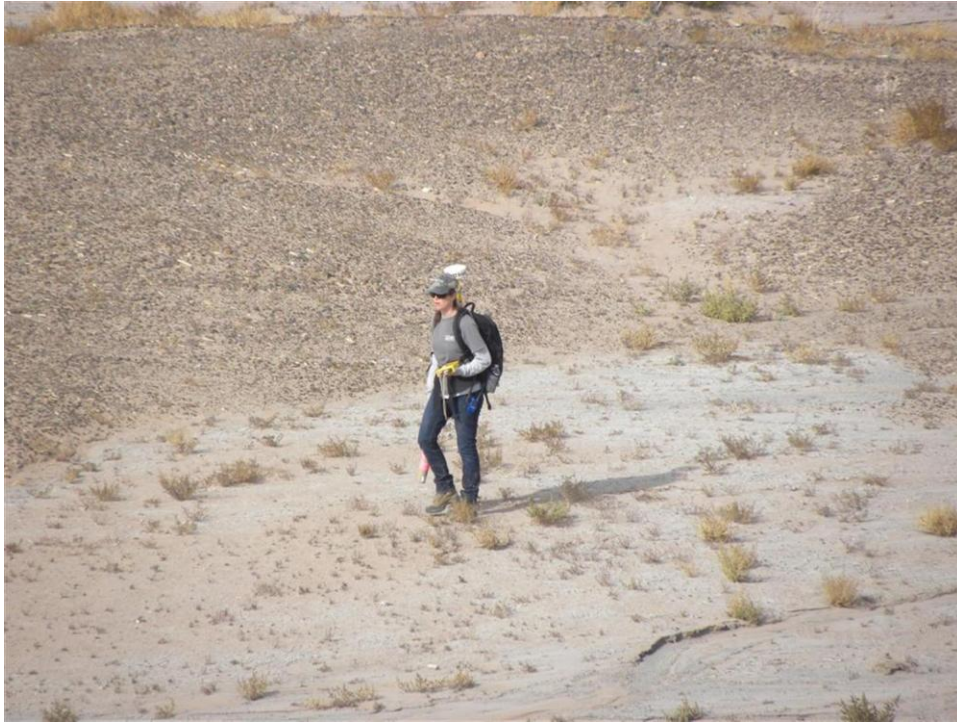
Photo 3. Jack Huskon No. 3 mine site, collecting readings

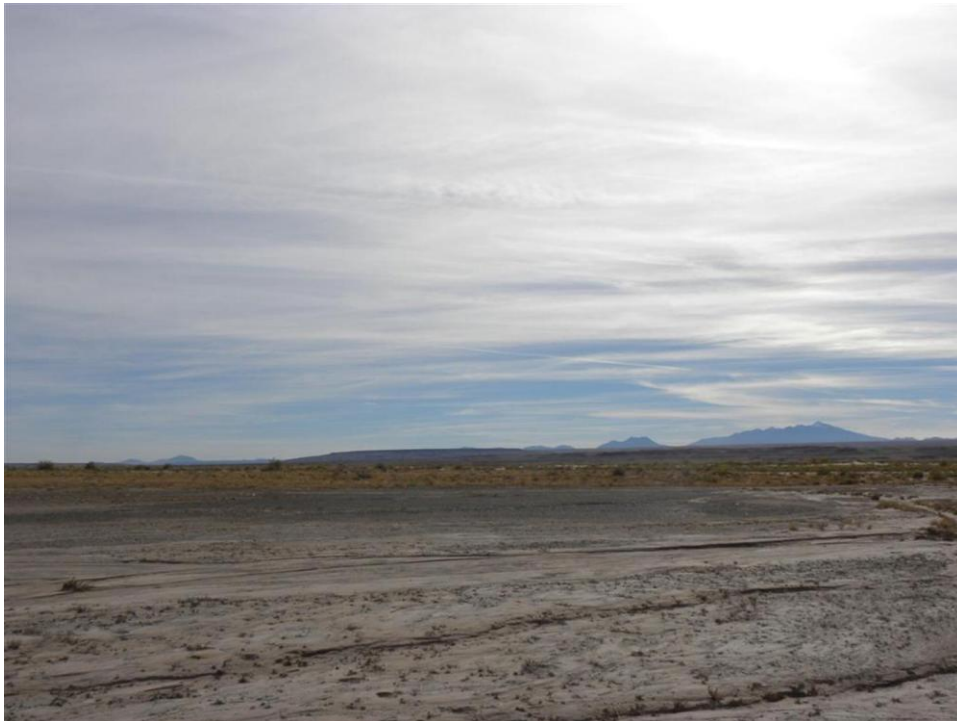
Darkened soil over the area identified as "Open Pit Mine" on topo map, no visual evidence of pit

Photo 4. Jack Huskon No. 3 mine site, darkened soil, possible former pit area

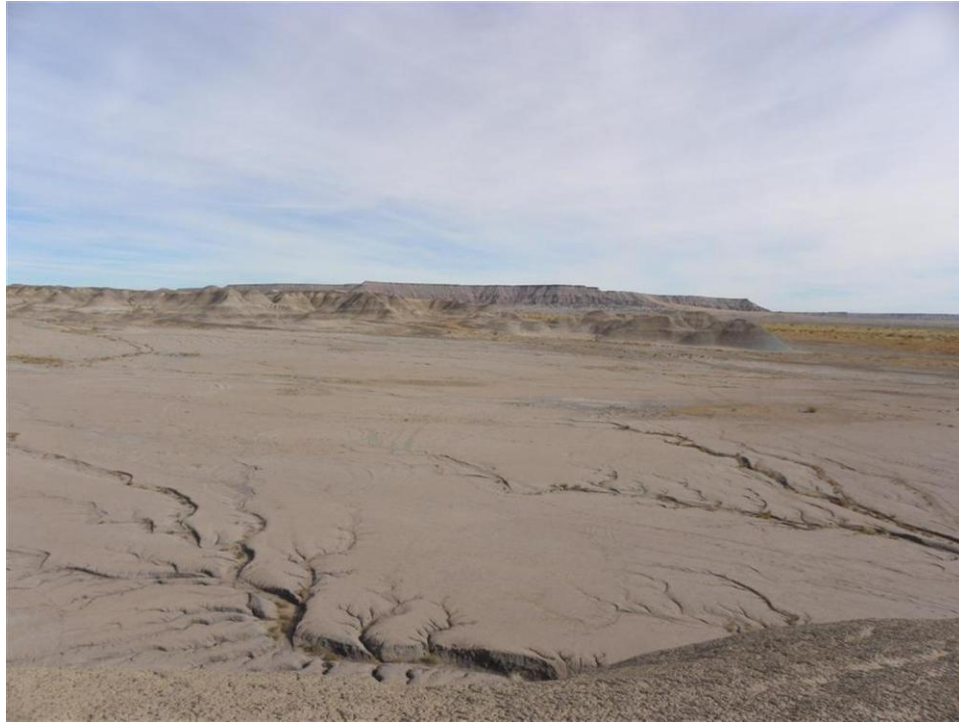
Photo 5. Jack Huskon No. 3 mine site, onsite drainage paths

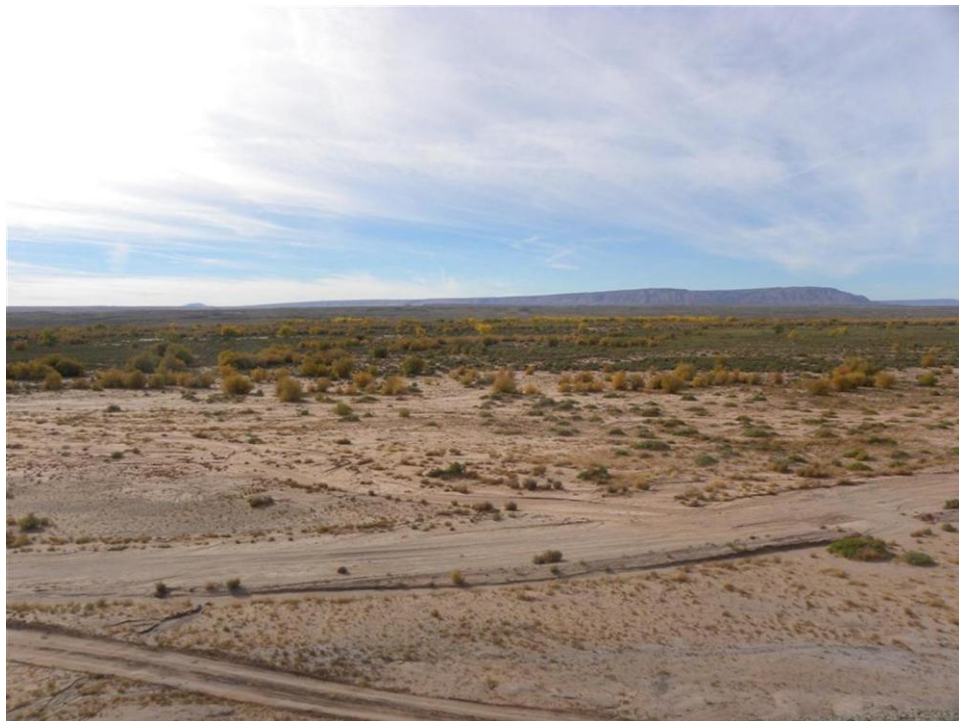
Photo 6. Jack Huskon No. 3 mine site, western road area and river basin

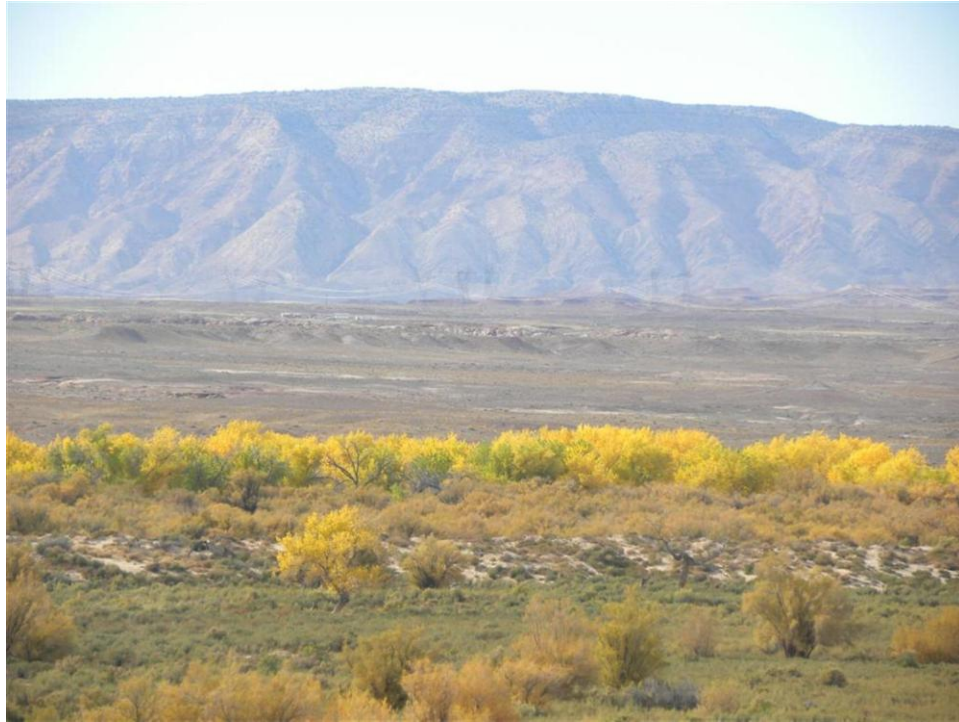
**0.25 miles to 4 miles:** Windmill Well approximately 1.5 mi NW of the site; Little Colorado River Basin approximately 1 mi W of the site

Photo 7. Jack Huskon No. 3 mine site, Little Colorado River basin to the west
