# Navajo Abandoned Uranium Mine

## Site Screen Report

**Mine Name: Max Johnson No. 10**

**August 2011**

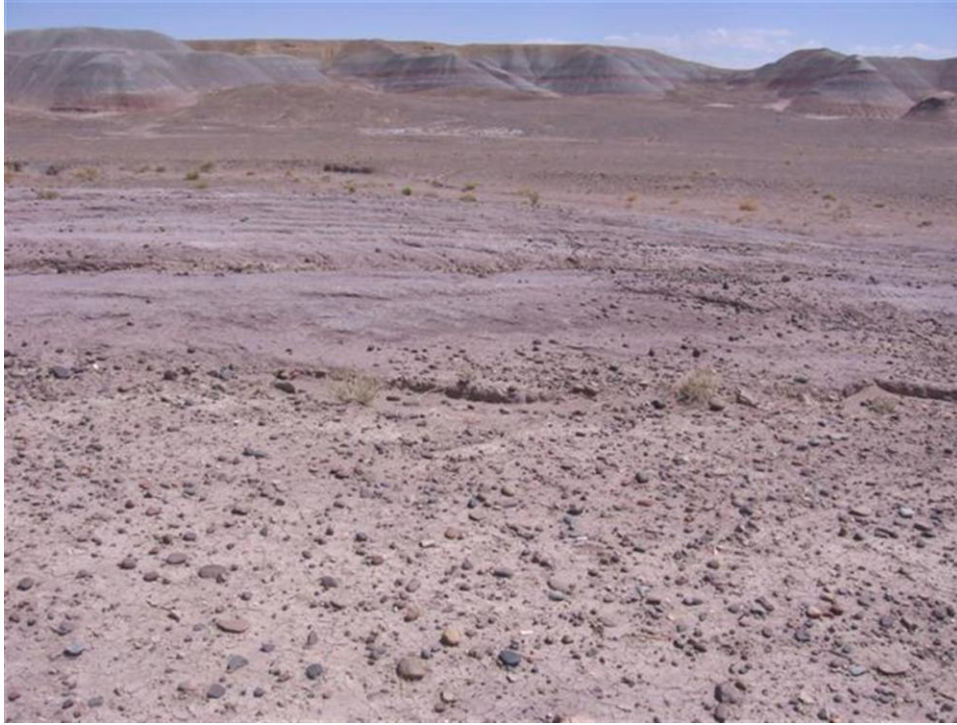
**Photo 1:** Mine Site #128

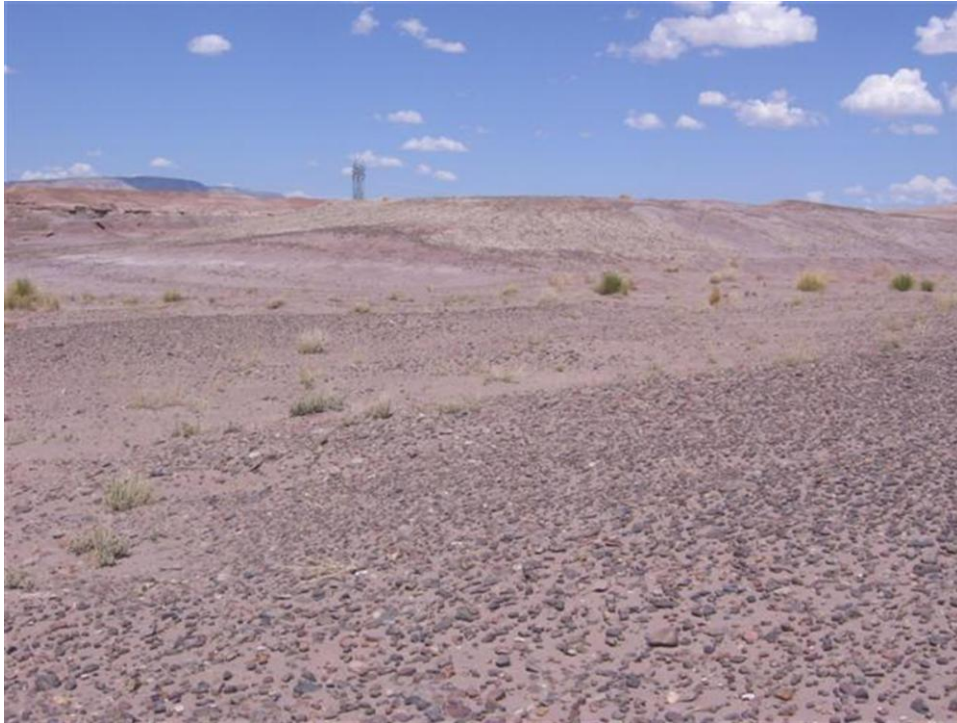
Reclamation cap in western portion of site, 250'x350'x10' oval, fine red-gray soil, no erosion control; some metal debris

**Photo 2:** Mine Site #128; Reclamation area
