Navajo Abandoned Uranium Mine

Site Screen Report

Mine Name: Alyce Tolino No. 1 & 3
Mine ID: 131

Weston Solutions, Inc.

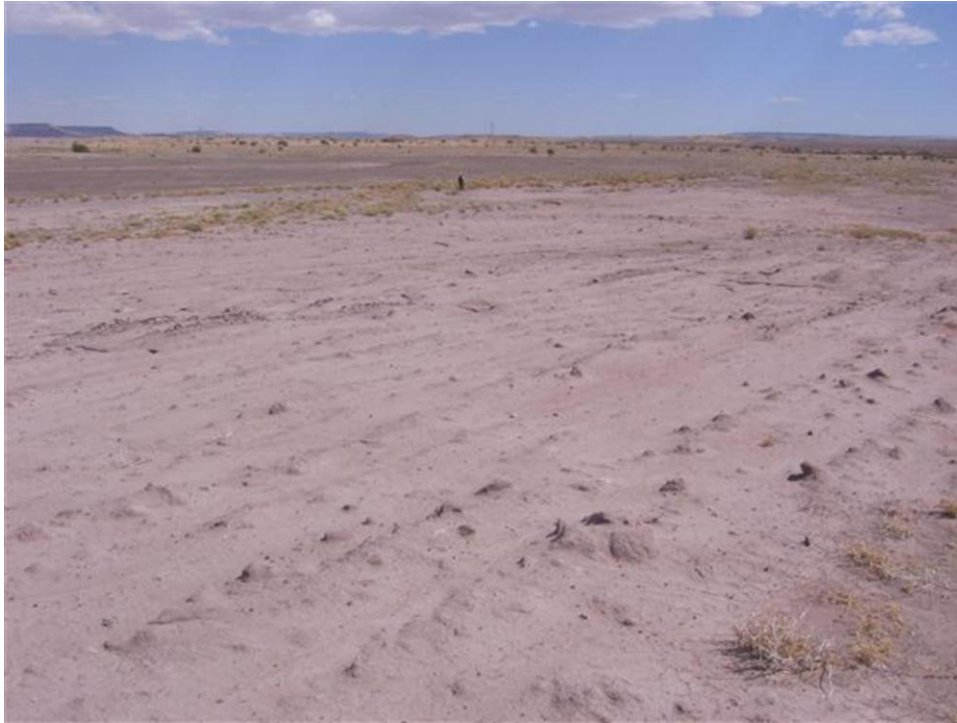
Photo 2: Mine Site #131; Reclamation area

Reclamation cap, fine red-gray clay mound, 500'x650'x6',
