Navajo Abandoned Uranium Mine

Site Screen Report

Mine Name: Yazzie No. 101
Mine ID: 132

Weston Solutions, Inc.

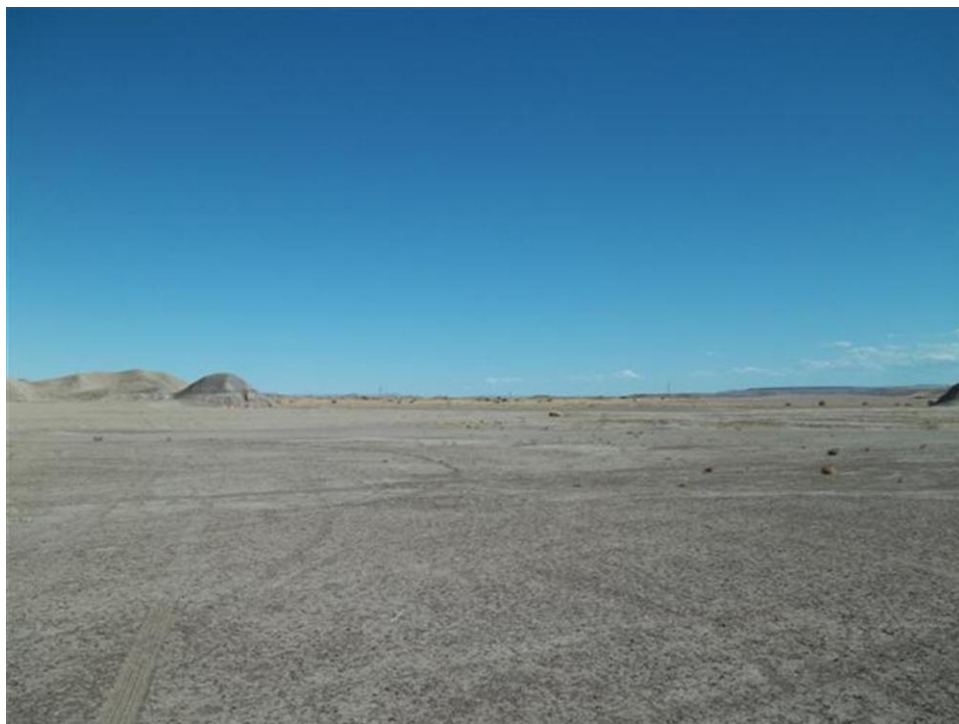
Photo 2: Mine Site #132; Former pond area

Mound near former pond area
