Navajo Abandoned Uranium Mine

Site Screen Report

Mine Name: Yazzie No. 312

Mine ID: 134

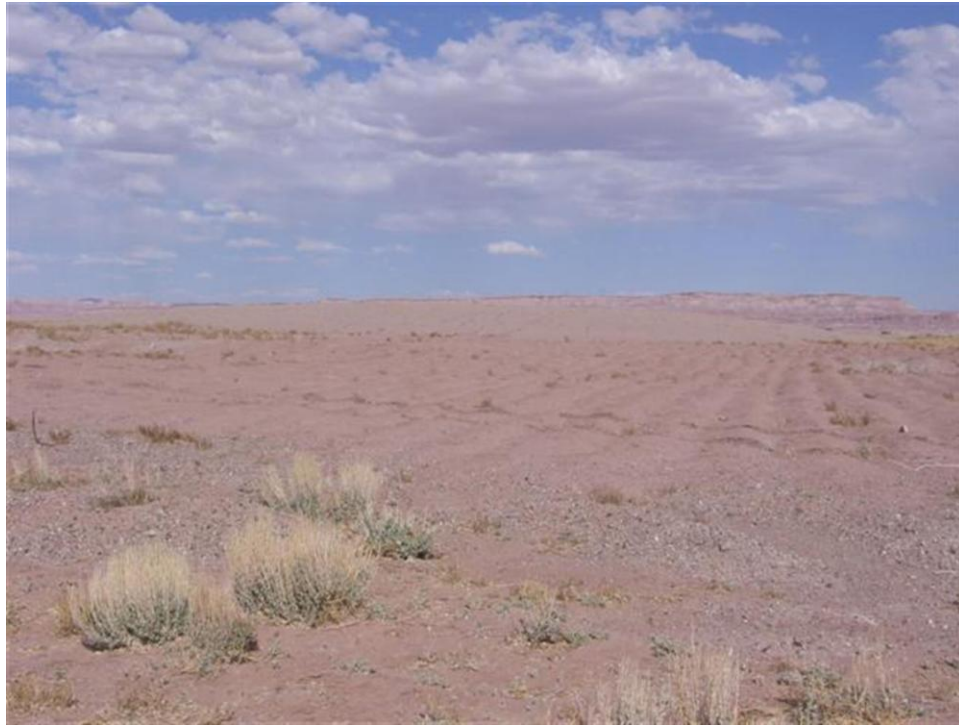
Photo 1: Mine Site #134; Reclamation area

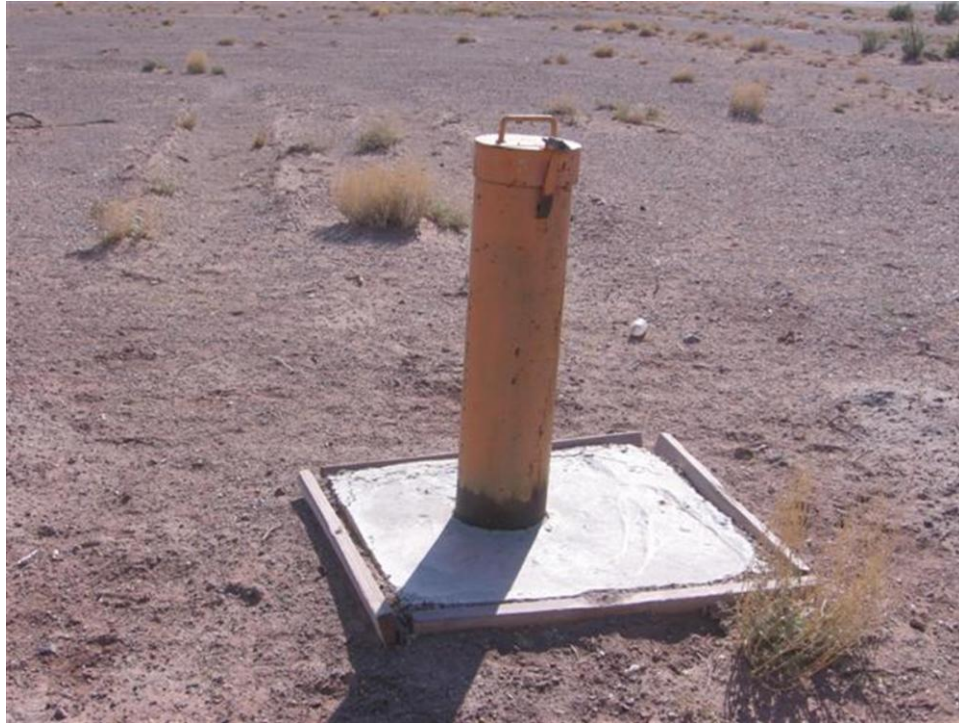
Photo 2: Mine Site #134; Monitoring well
