Navajo Abandoned Uranium Mine

Site Screen Report

Jackpot No. 1 AUM Site

January 2011

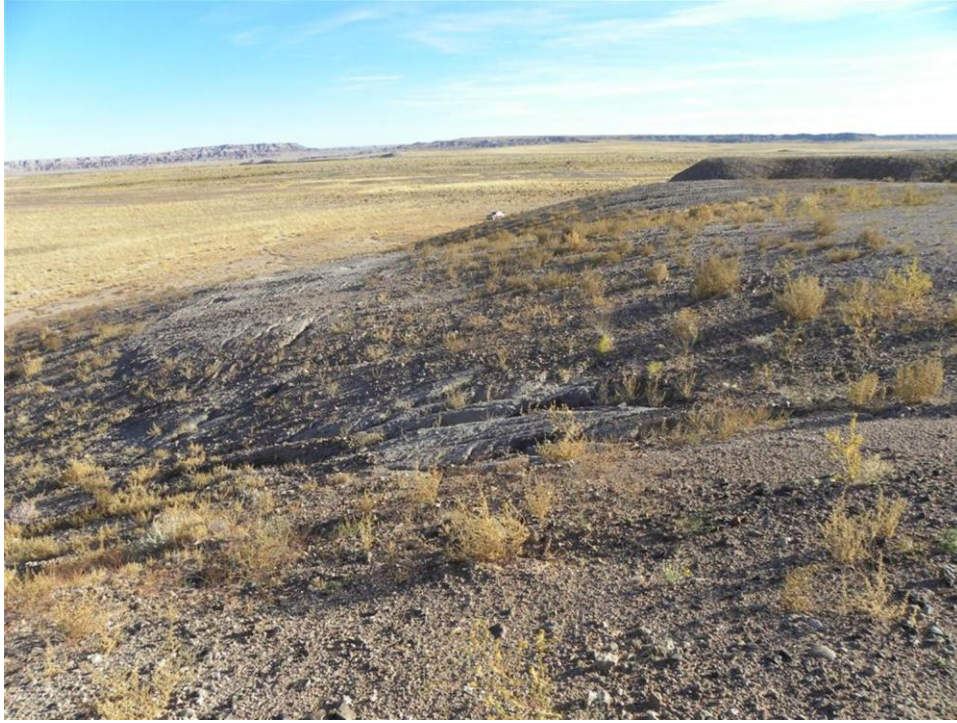
Large reclamation cap with drainage beneath, grey fine/granular material, some hot spots and minor erosion

Photo 1. Jackpot No. 1 mine site

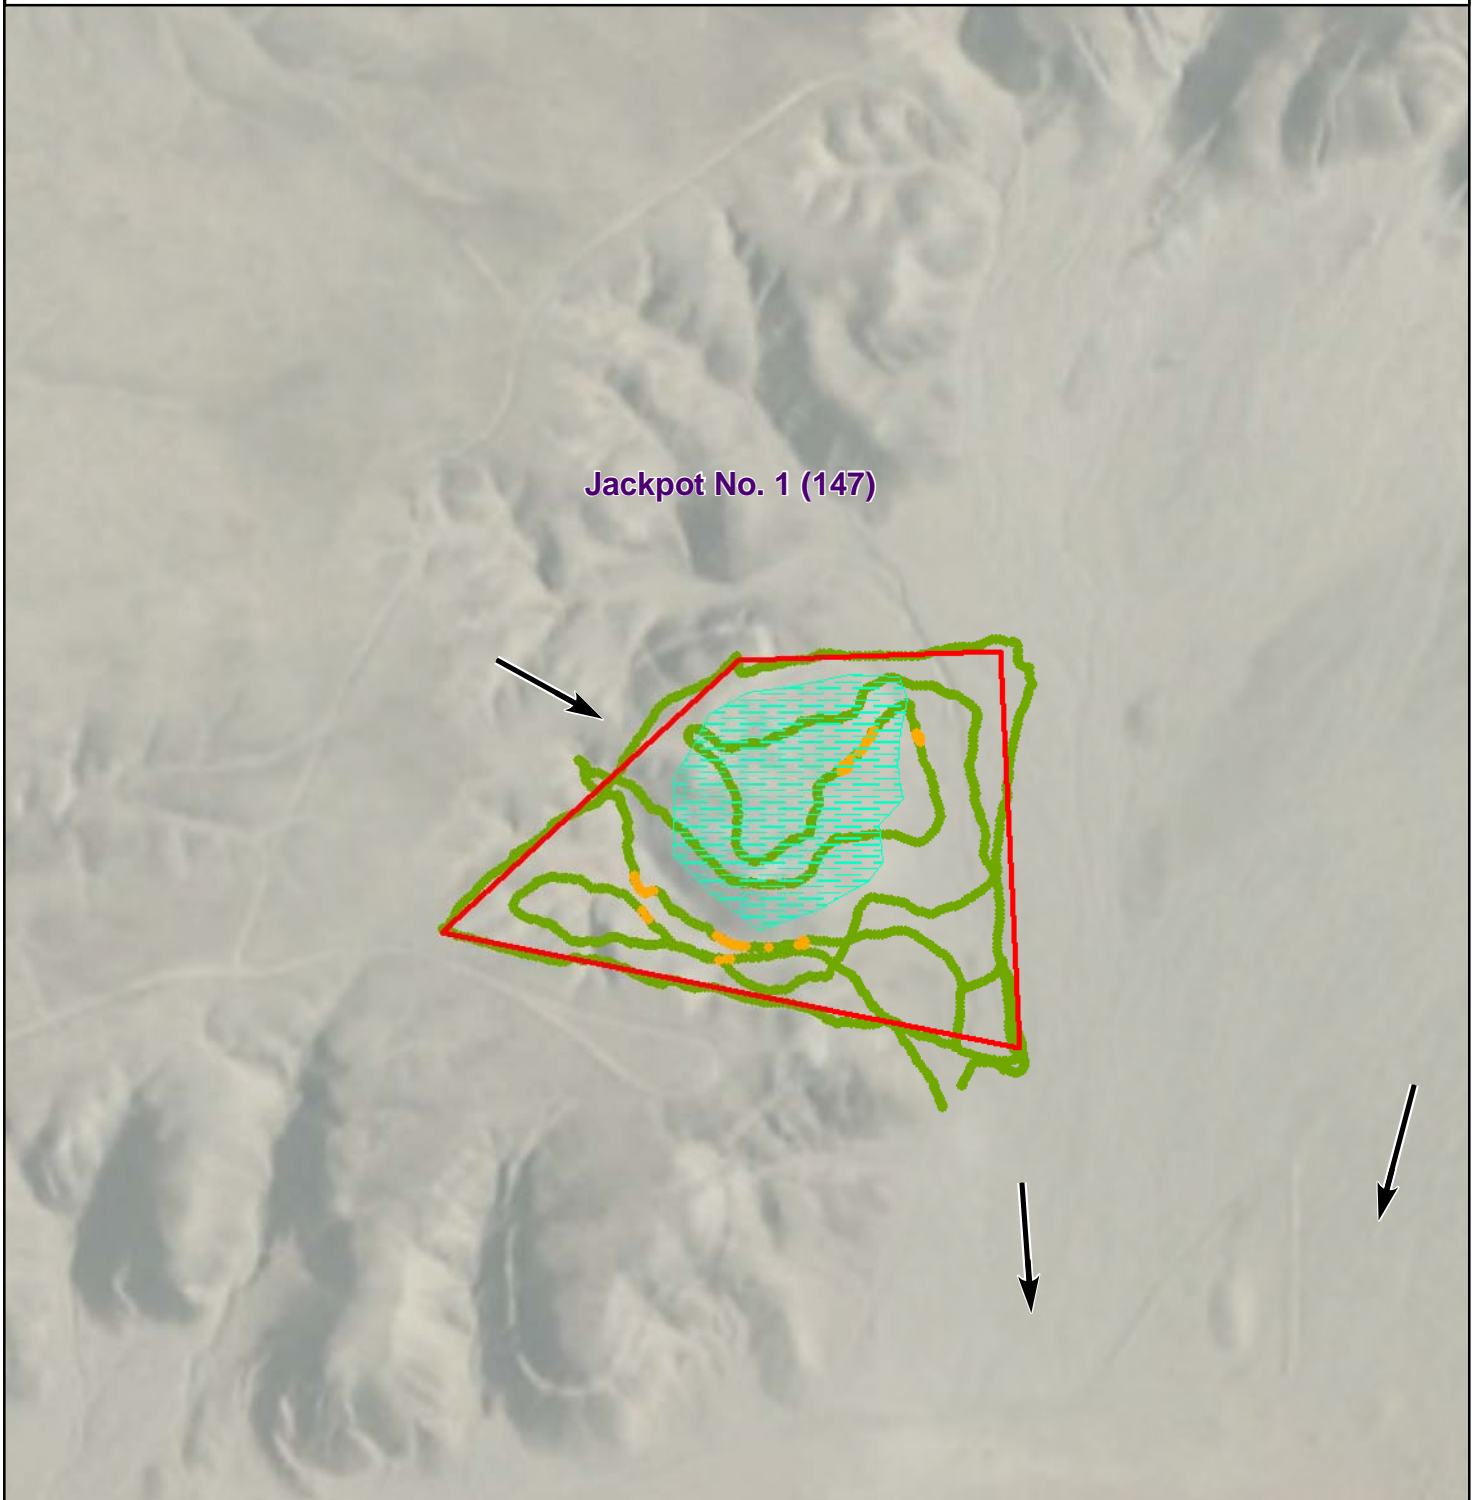
**Figure 1 - Gamma Radiation Measurements, Above Two Times Background
Jackpot No. 1 (147)
Coalmine Mesa Chapter, Navajo Nation**

A total of 2,000 gamma radiation measurements were collected from the mine site, ranging from 7,003 cpm to 905,754 cpm. The measurements collected at the reclamation cap were found mostly at background levels, with a few isolated hot spots with maximum levels of 900,000 cpm. The measurements are represented in Figures 1 and 2.

Gamma survey conducted 11/2010
Measured as counts per minute (cpm)

Average background 11,281 cpm
