Navajo Abandoned Uranium Mine

Site Screen Report

Ramco No. 22 AUM Site

January 2011

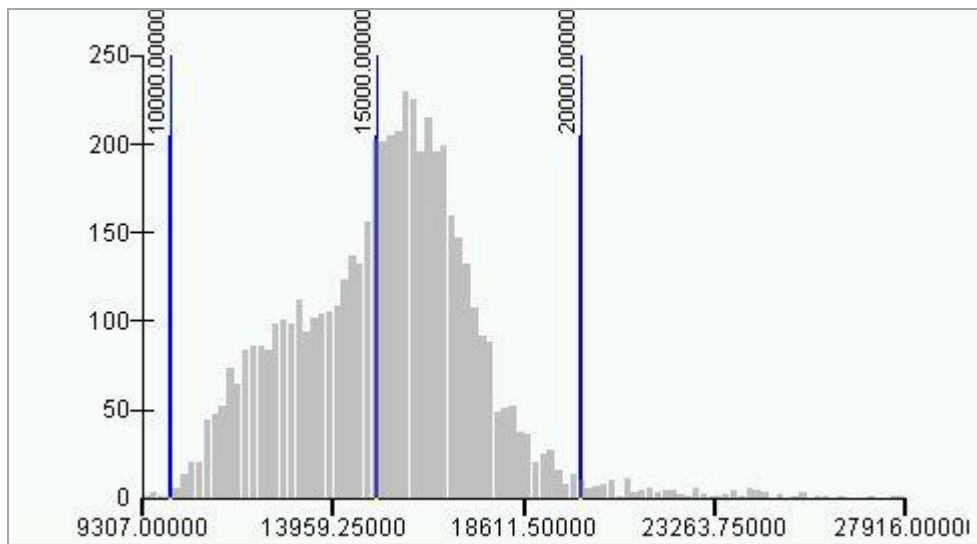
The following chart and statistics were generated by ESRI ArcGIS 9.3.1, and show the general distribution of the site gamma radiation measurements. The horizontal X axis represents the gamma radiation reading levels in cpm (lowest levels to the left). The vertical Y axis represents the frequency of each gamma radiation level.

Count:	5406
Minimum:	9307.00000
Maximum:	27916.00000
Sum:	82351579.00000
Mean:	15233.36644
Median:	15397.50000
Standard Deviation:	2248.79744

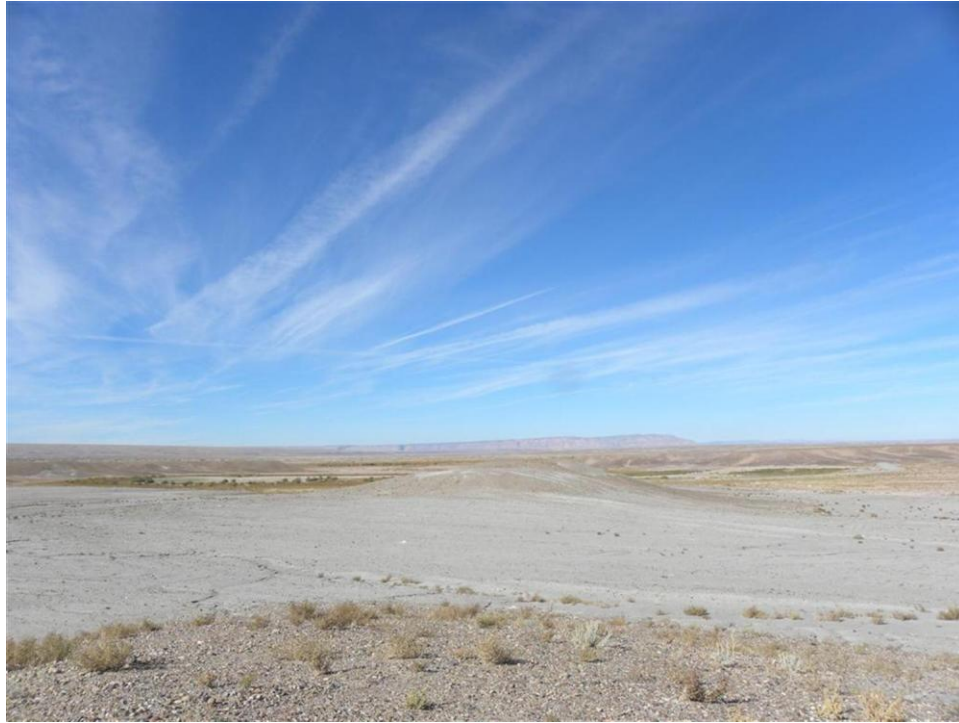
Photo 1. Ramco No. 22 mine site

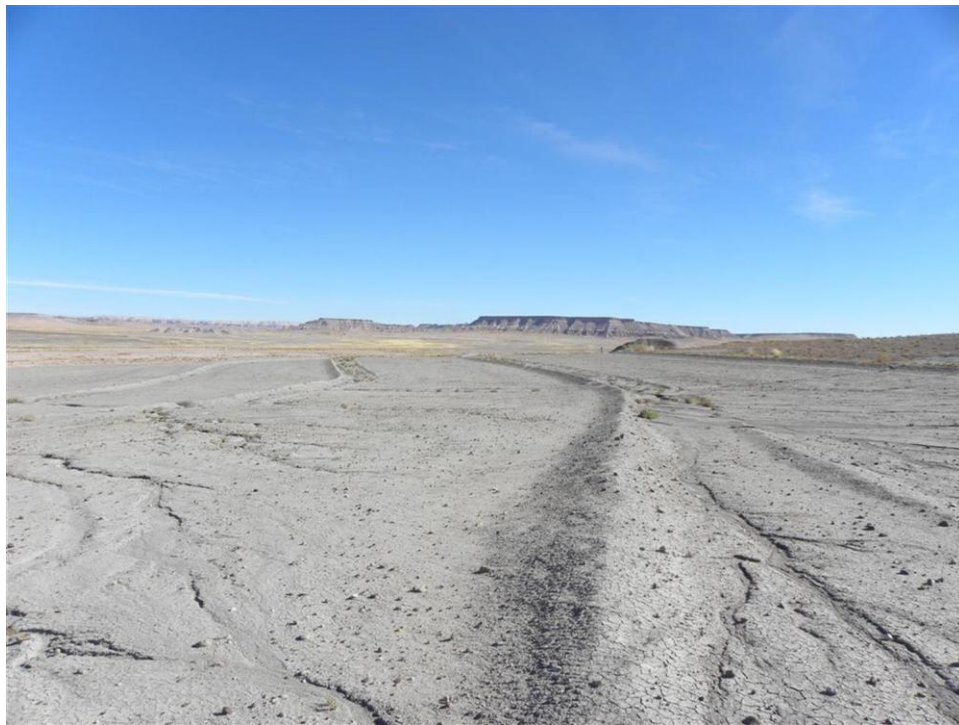
Photo 2. Ramco No. 22 mine site, berm area

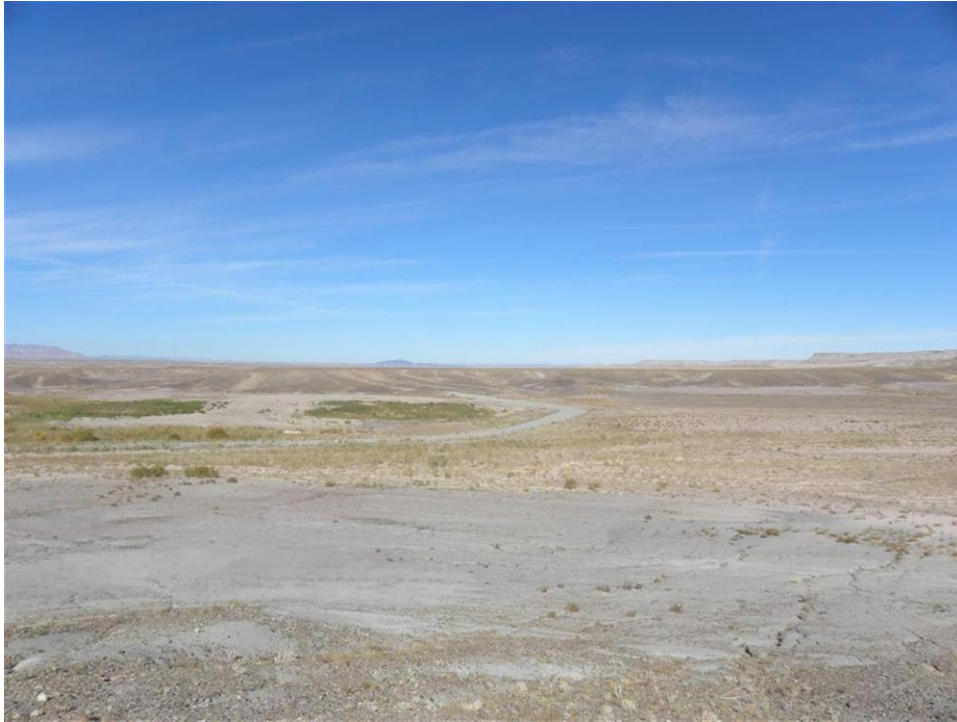
Photo 3. Ramco No. 22 mine site

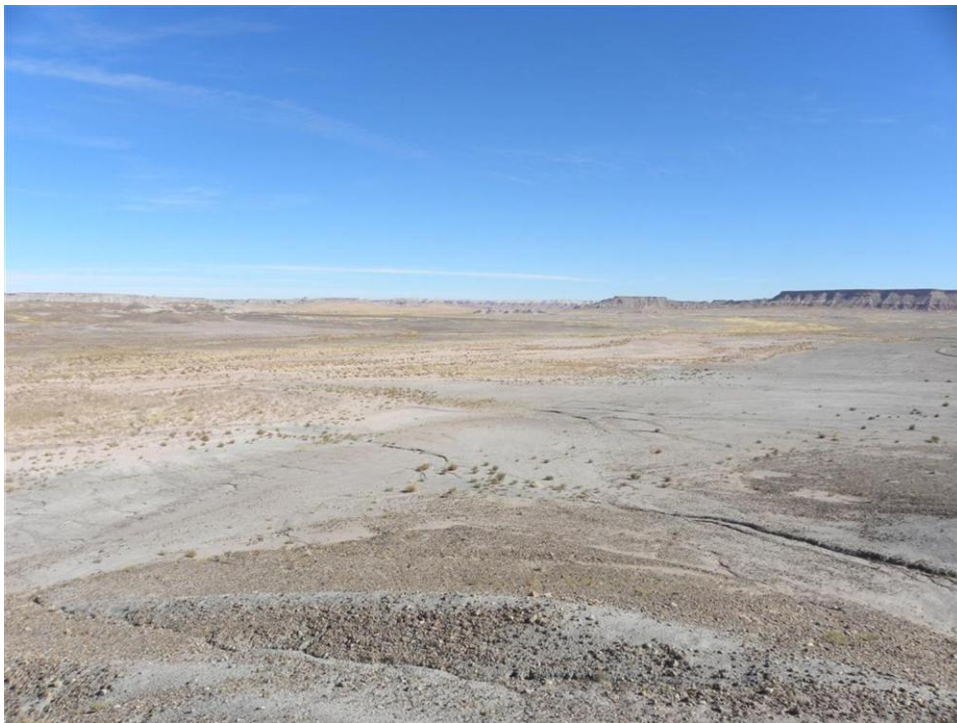
Photo 4. Ramco No. 22 mine site, berm area

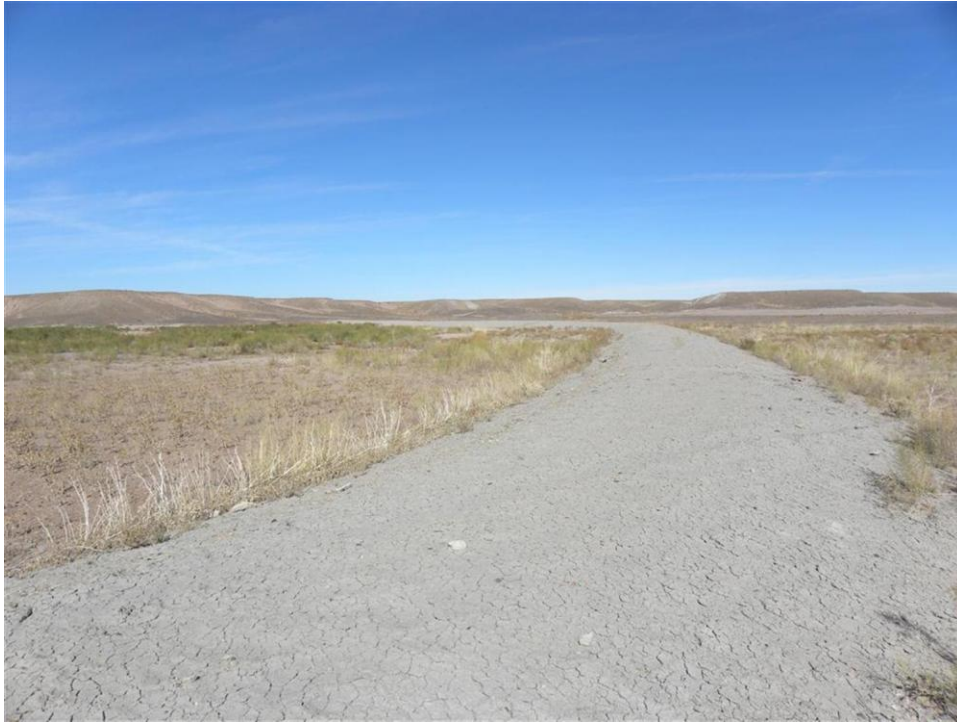
Section of berm surrounding former pond area from adjacent site (#153); erosion control berms in SW section

Photo 5. Ramco No. 22 mine site, berm along border with site #153

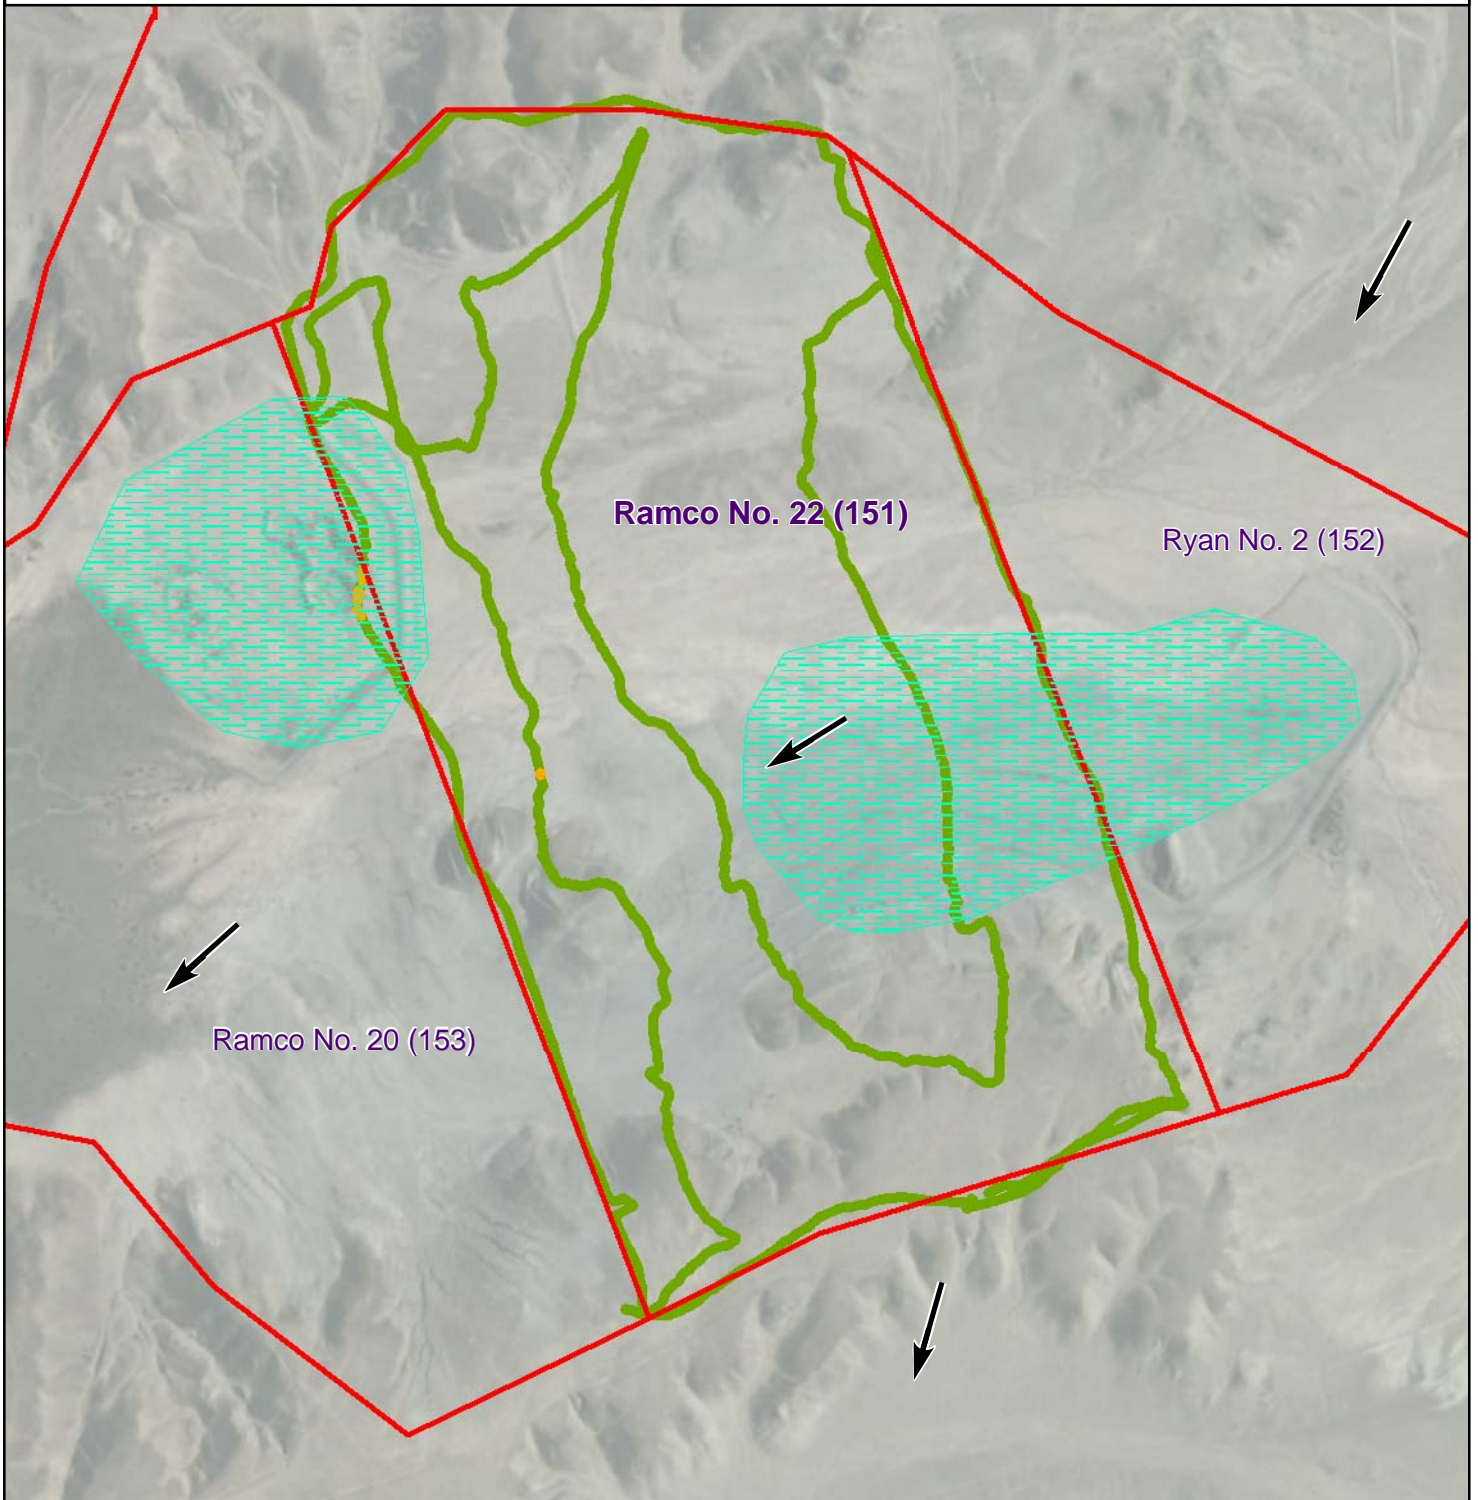
**Figure 1 - Gamma Radiation Measurements, Above Two Times Background
 Ramco No. 22 (151)
 Coalmine Mesa Chapter, Navajo Nation**

A total of 5,406 gamma radiation measurements were collected from the mine site, ranging from 9,307 cpm to 27,916 cpm. The measurements collected at the berm were found at a background levels. The measurements are represented in Figures 1 and 2.

Gamma survey conducted 11/2010
 Measured as counts per minute (cpm)

Average background 11,885 cpm

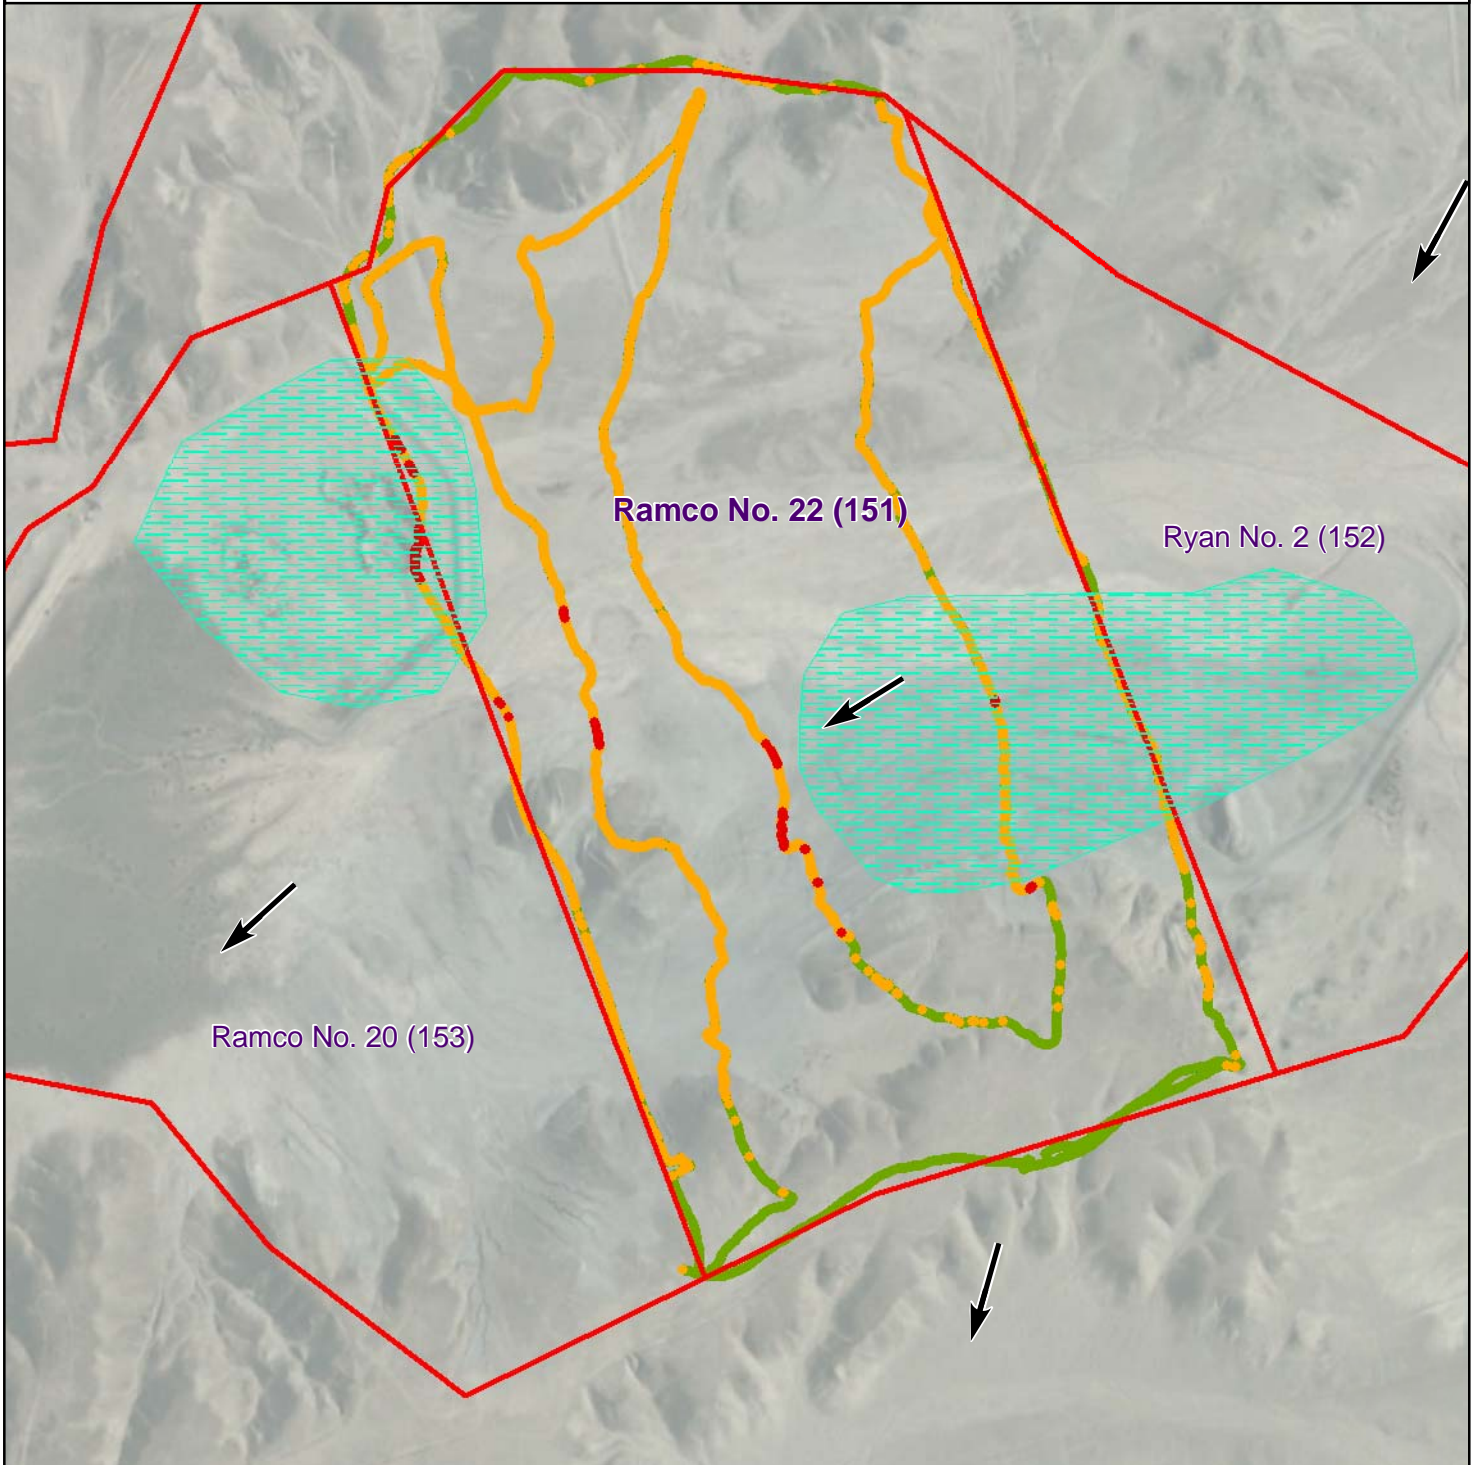
**Figure 2 - Gamma Radiation Measurements
 Ramco No. 22 (151)
 Coalmine Mesa Chapter, Navajo Nation**

**Gamma survey conducted 11/2010
 Measured as counts per minute (cpm)**

Average background 11,885 cpm
