Navajo Abandoned Uranium Mine

Site Screen Report

Julia Semallie AUM Site

January 2011

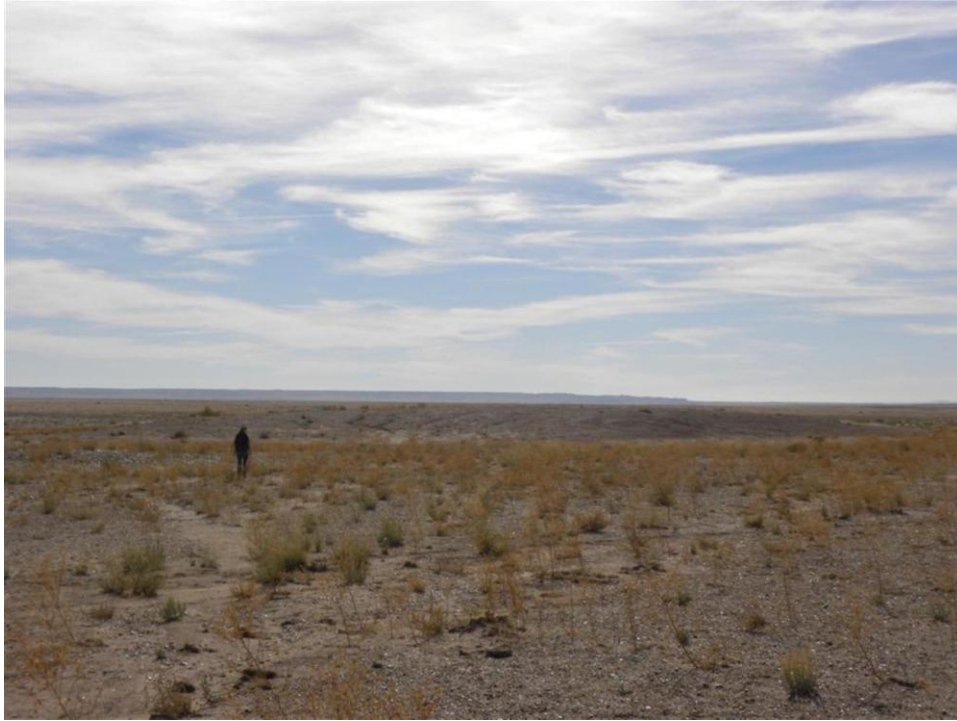
Photo 1. Julia Semallie mine site

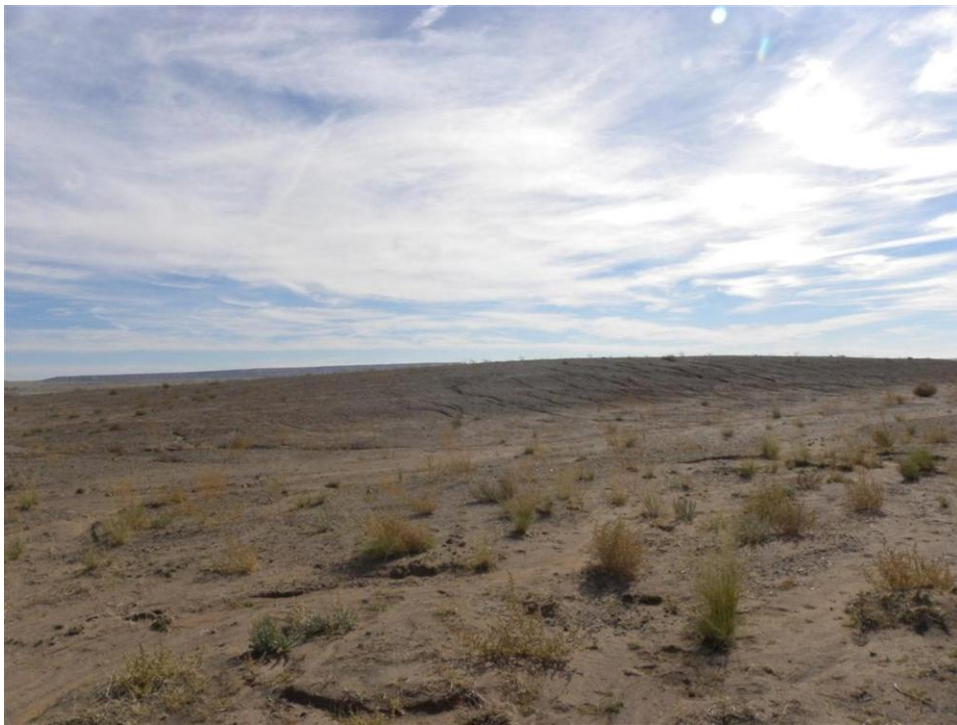
2 reclamation caps, shared with site #542: western cap 1000' x 300'; eastern cap 400' x 100', both made of grey material

Photo 2. Julia Semallie mine site, reclamation cap
