Navajo Abandoned Uranium Mine

Site Screen Report

Ramco No. 24 AUM Site

January 2011

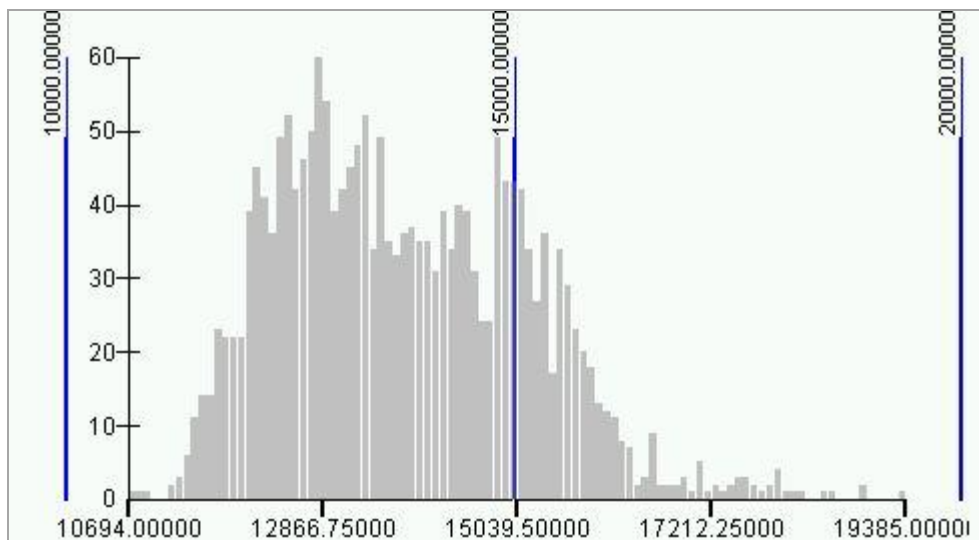
The following chart and statistics were generated by ESRI ArcGIS 9.3.1, and show the general distribution of the site gamma radiation measurements. The horizontal X axis represents the gamma radiation reading levels in cpm (lowest levels to the left). The vertical Y axis represents the frequency of each gamma radiation level.

Count:	1968
Minimum:	10694.00000
Maximum:	19385.00000
Sum:	27120773.00000
Mean:	13780.88059
Median:	13589.50000
Standard Deviation:	1370.24590

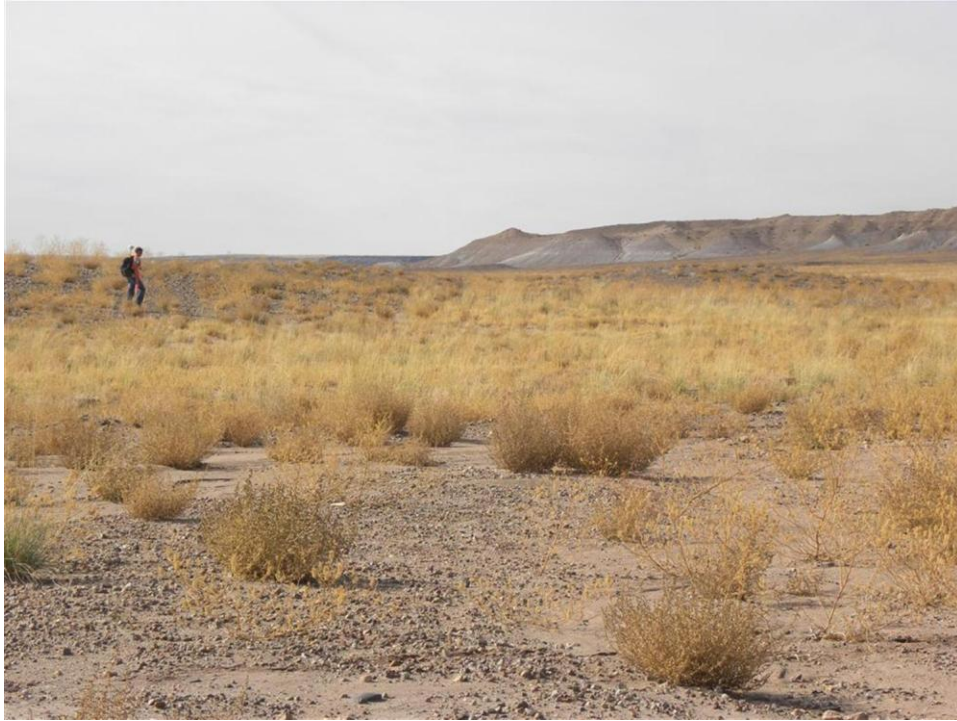
Photo 1. Ramco No. 24 mine site

Possible cap area in center of site, grey soil

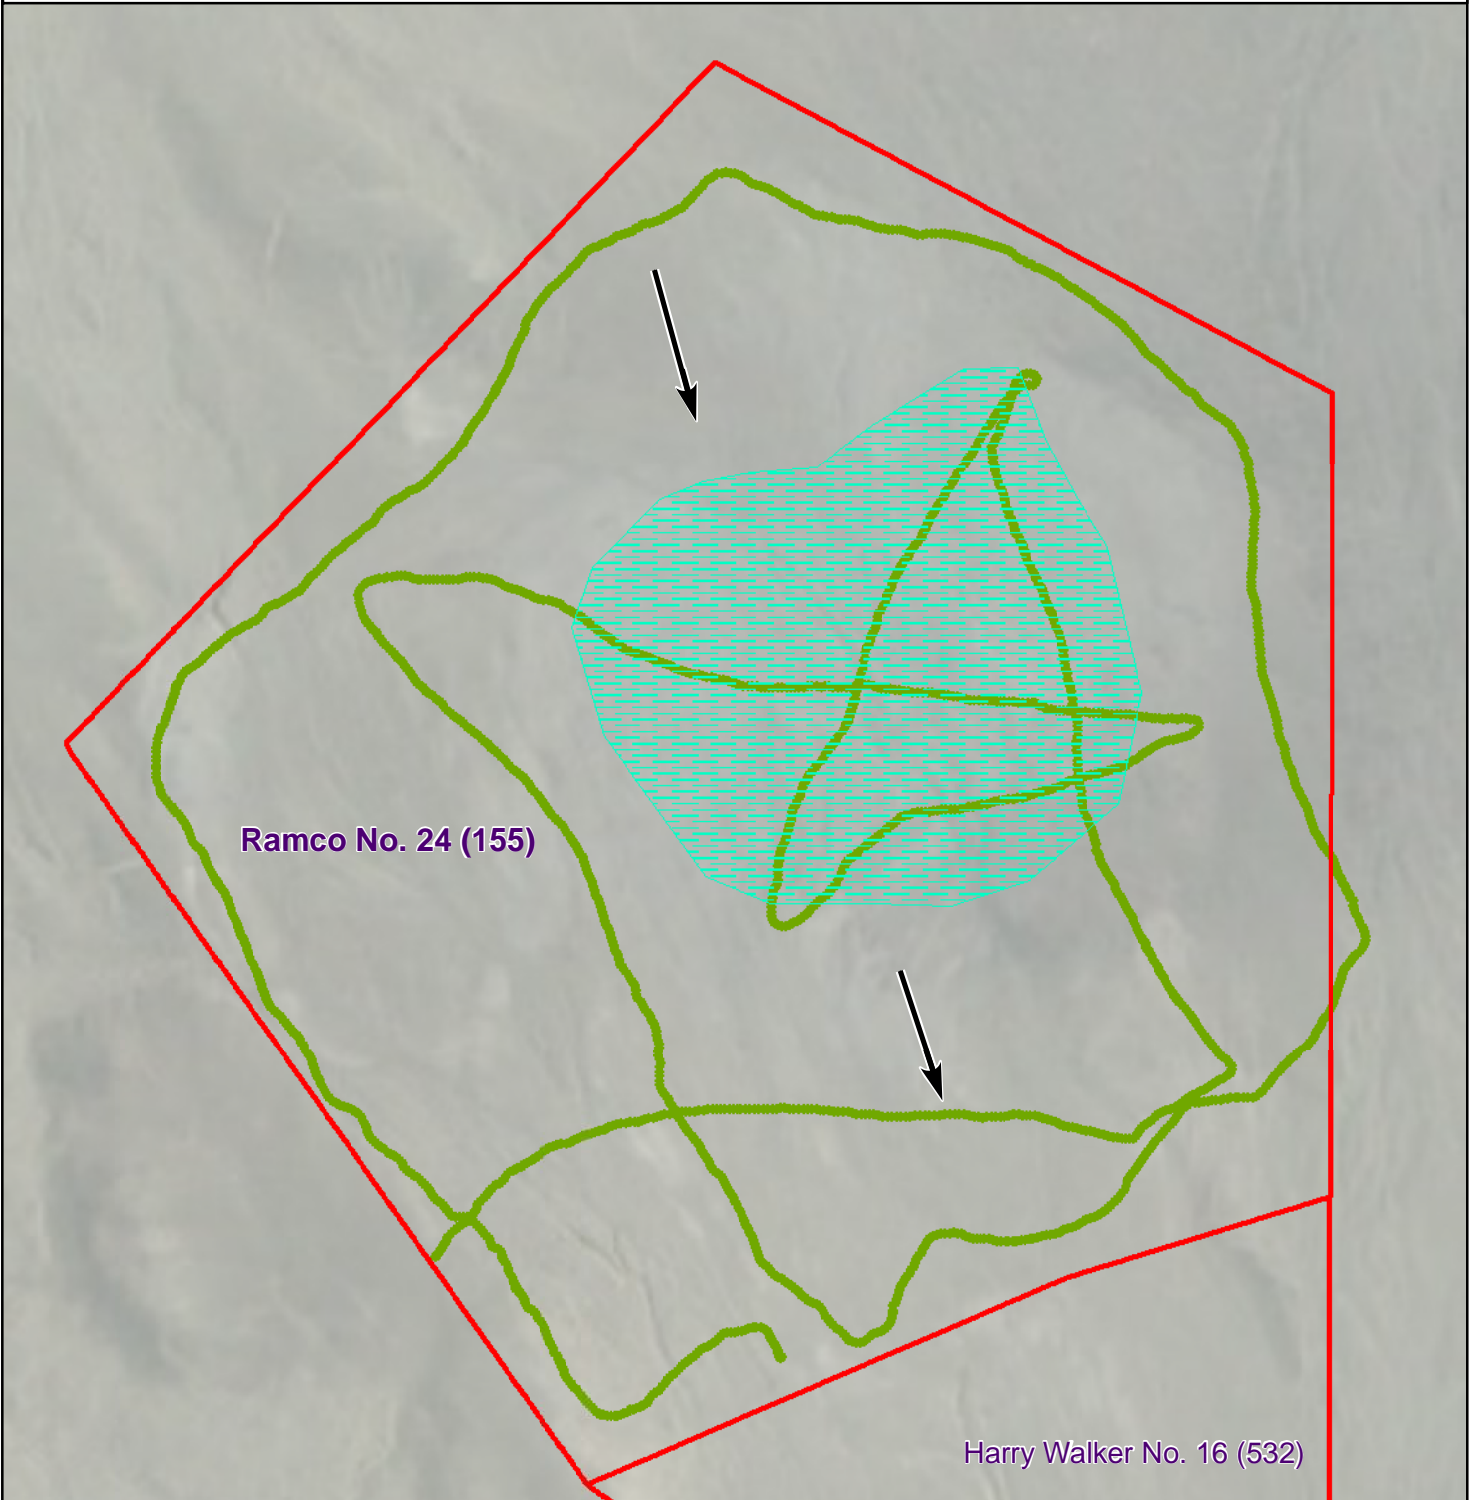
**Figure 1 - Gamma Radiation Measurements, Above Two Times Background
 Ramco No. 24 (155)
 Coalmine Mesa Chapter, Navajo Nation**

A total of 1,968 gamma radiation measurements were collected from the mine site, ranging from 10,694 cpm to 19,385 cpm. The measurements are represented in Figures 1 and 2.

Gamma survey conducted 11/2010
 Measured as counts per minute (cpm)

Average background 12,341 cpm

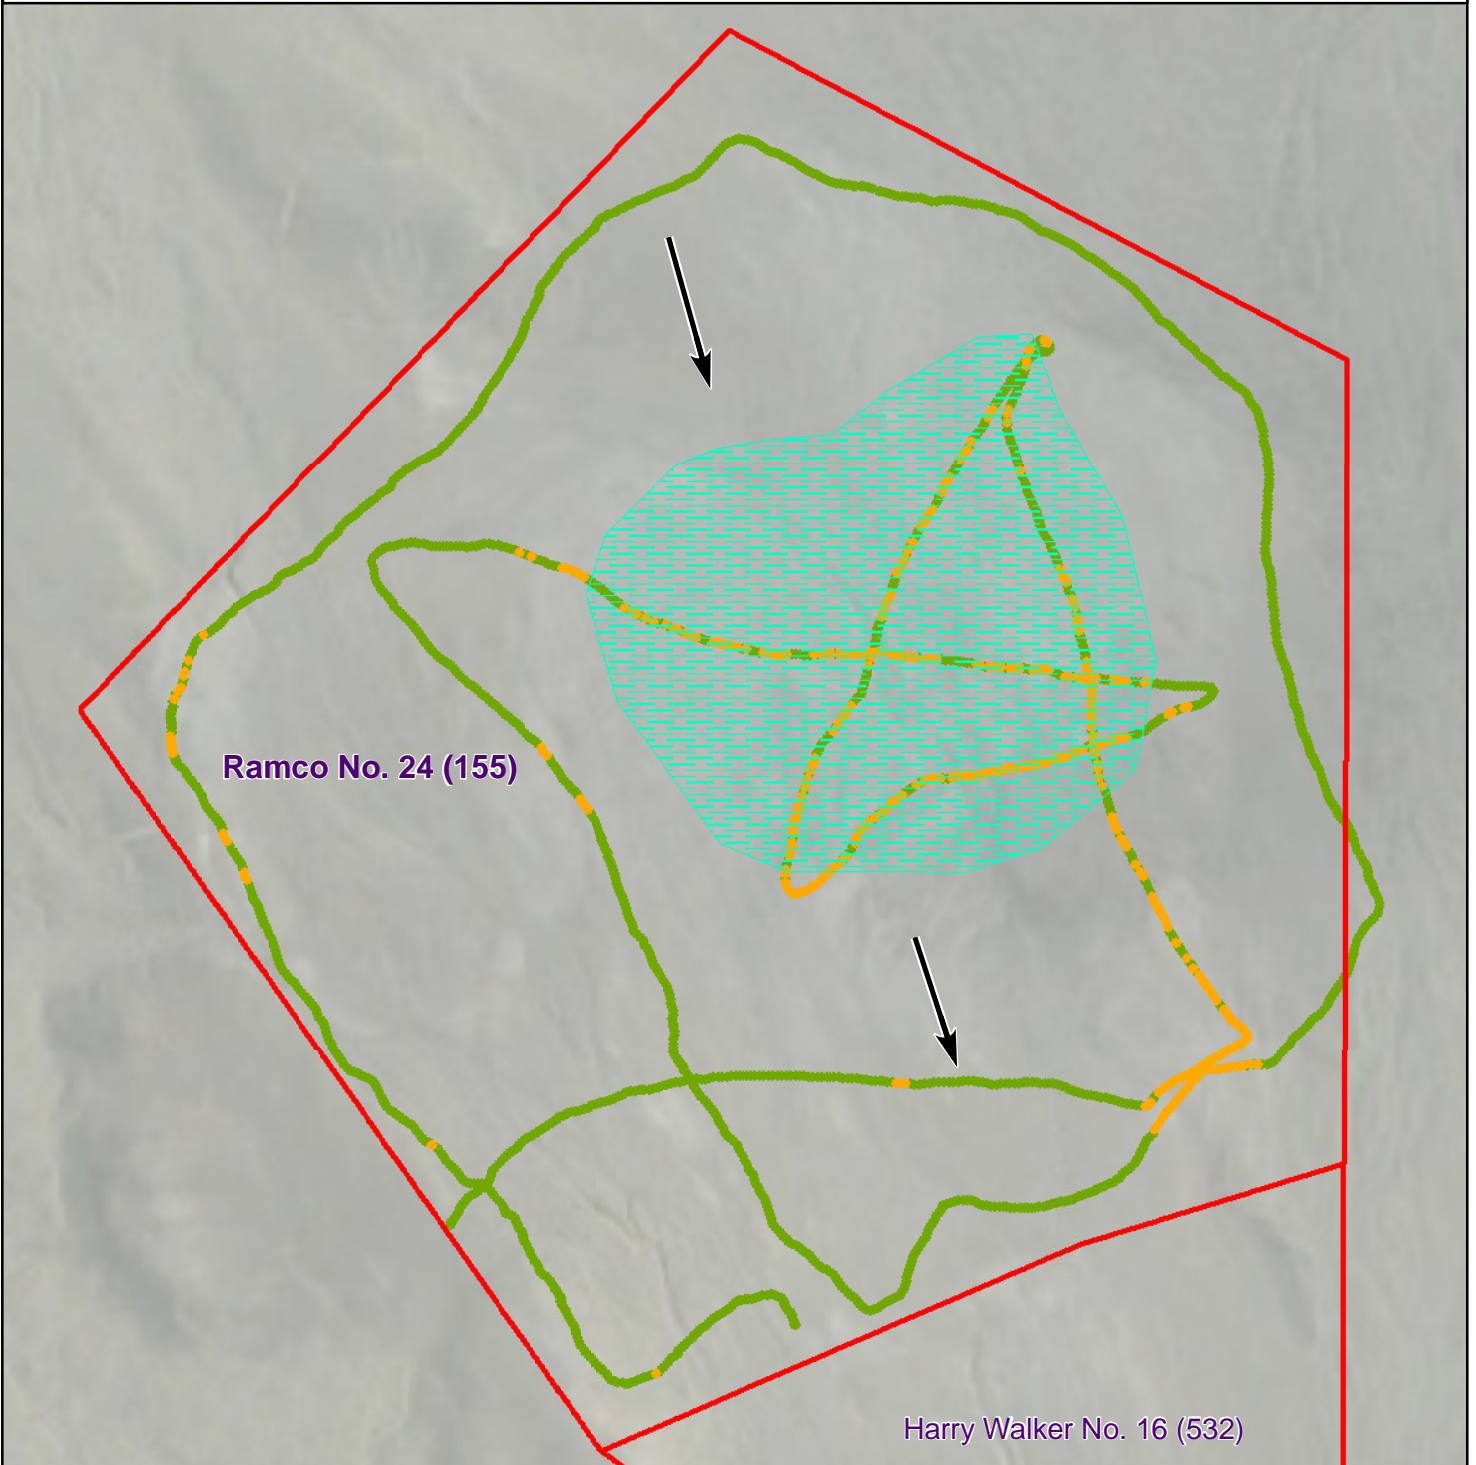
**Figure 2 - Gamma Radiation Measurements
 Ramco No. 24 (155)
 Coalmine Mesa Chapter, Navajo Nation**

**Gamma survey conducted 11/2010
 Measured as counts per minute (cpm)**

Average background 12,341 cpm
