Navajo Abandoned Uranium Mine

Site Screen Report

Mine Name: Harve Black No. 2
Mine ID: 181

Navajo AUM North Central Region

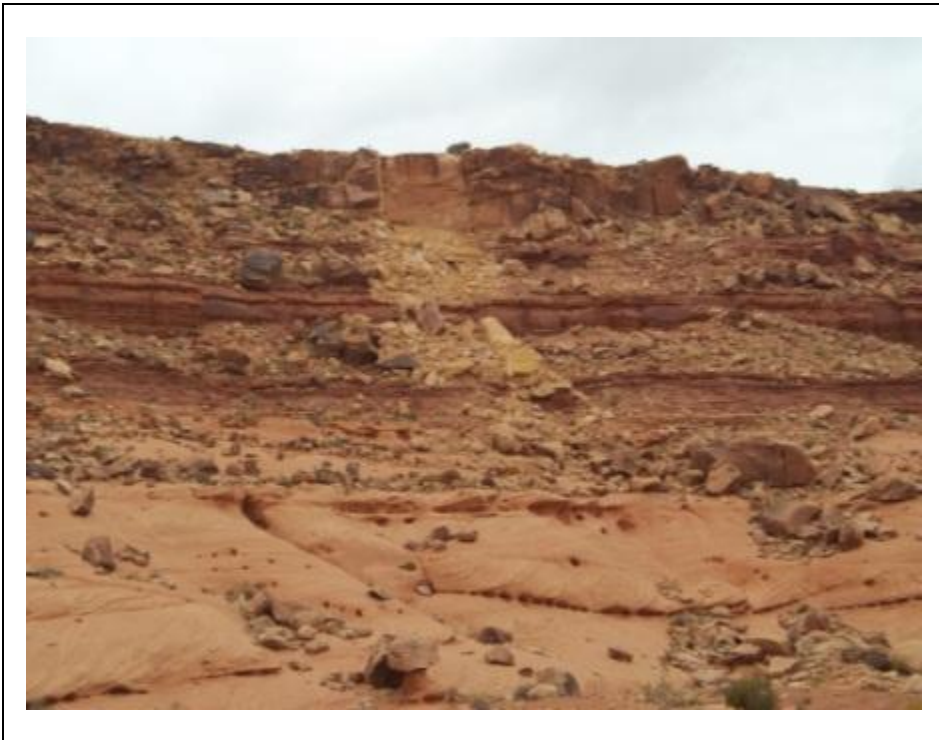
Photo 1	Mine Site #181
----------------	----------------

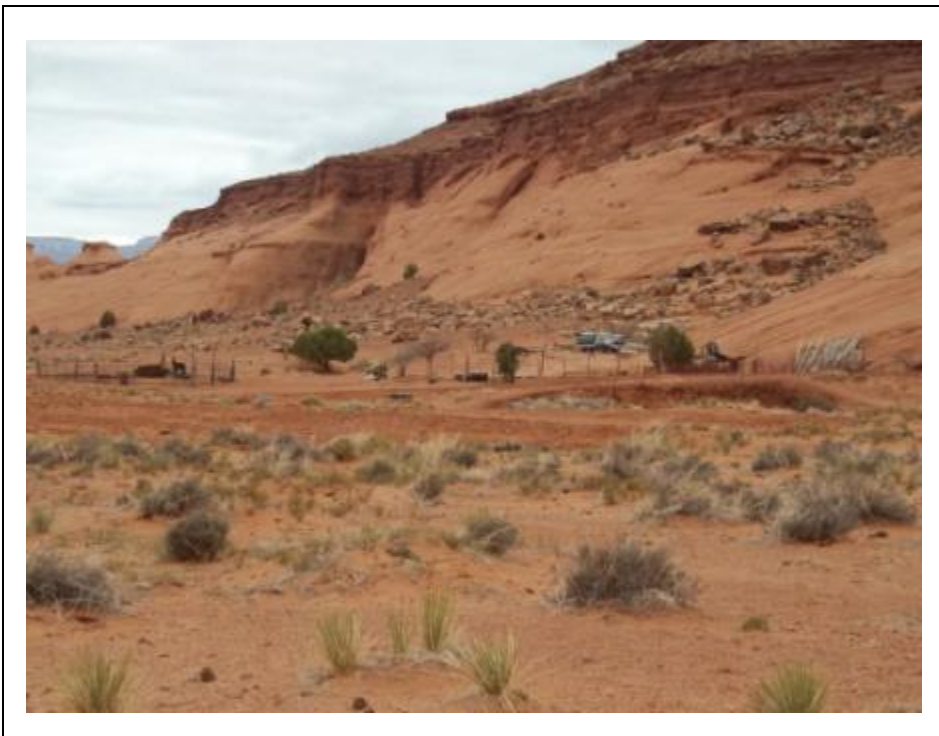
200 feet to 0.25 mile: 300 ft S - Horse pen

Photo 2	Mine Site #181 – Horse pen
----------------	----------------------------

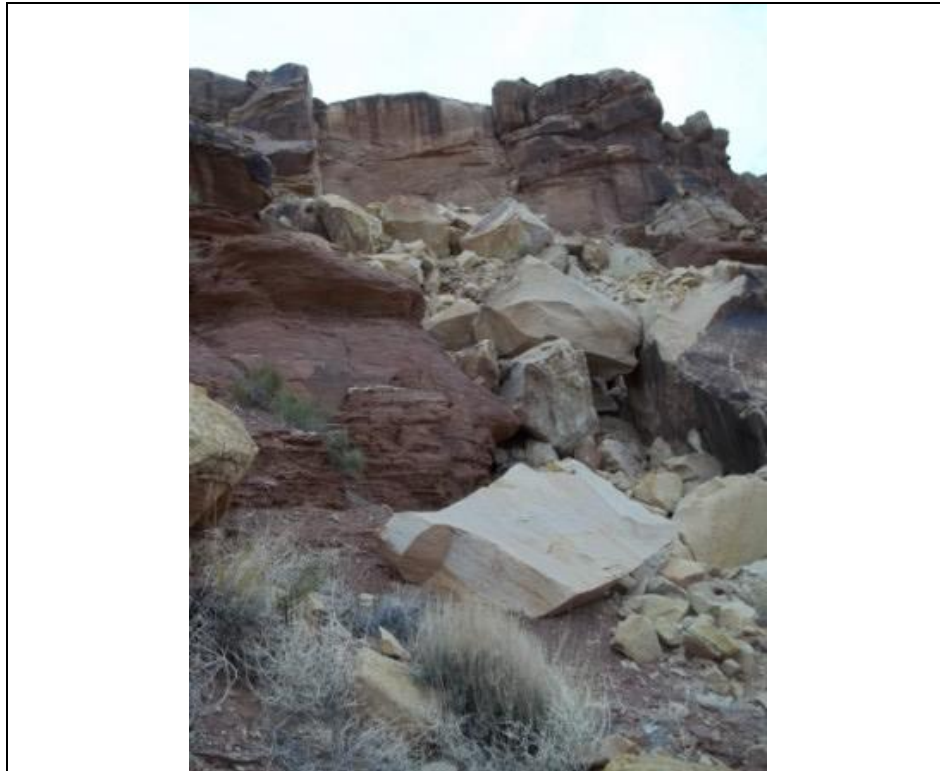
Photo 3

Possible waste/ tailings pile, large yellow boulders w/ black staining

Mine Site #181 - Tailings

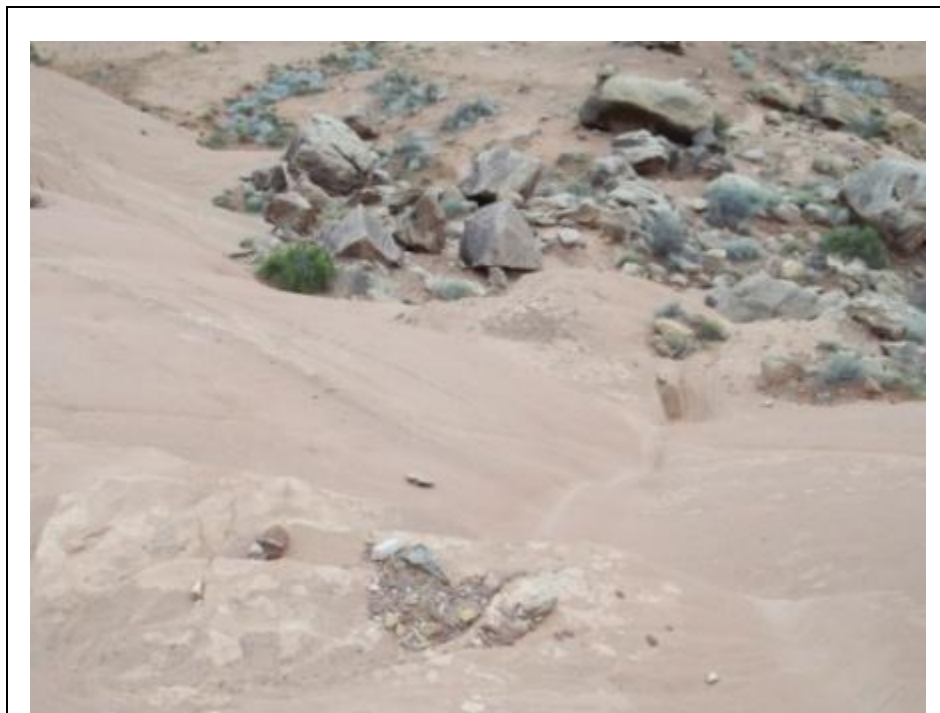
Photo 4

Mine Site #181 - Tailings

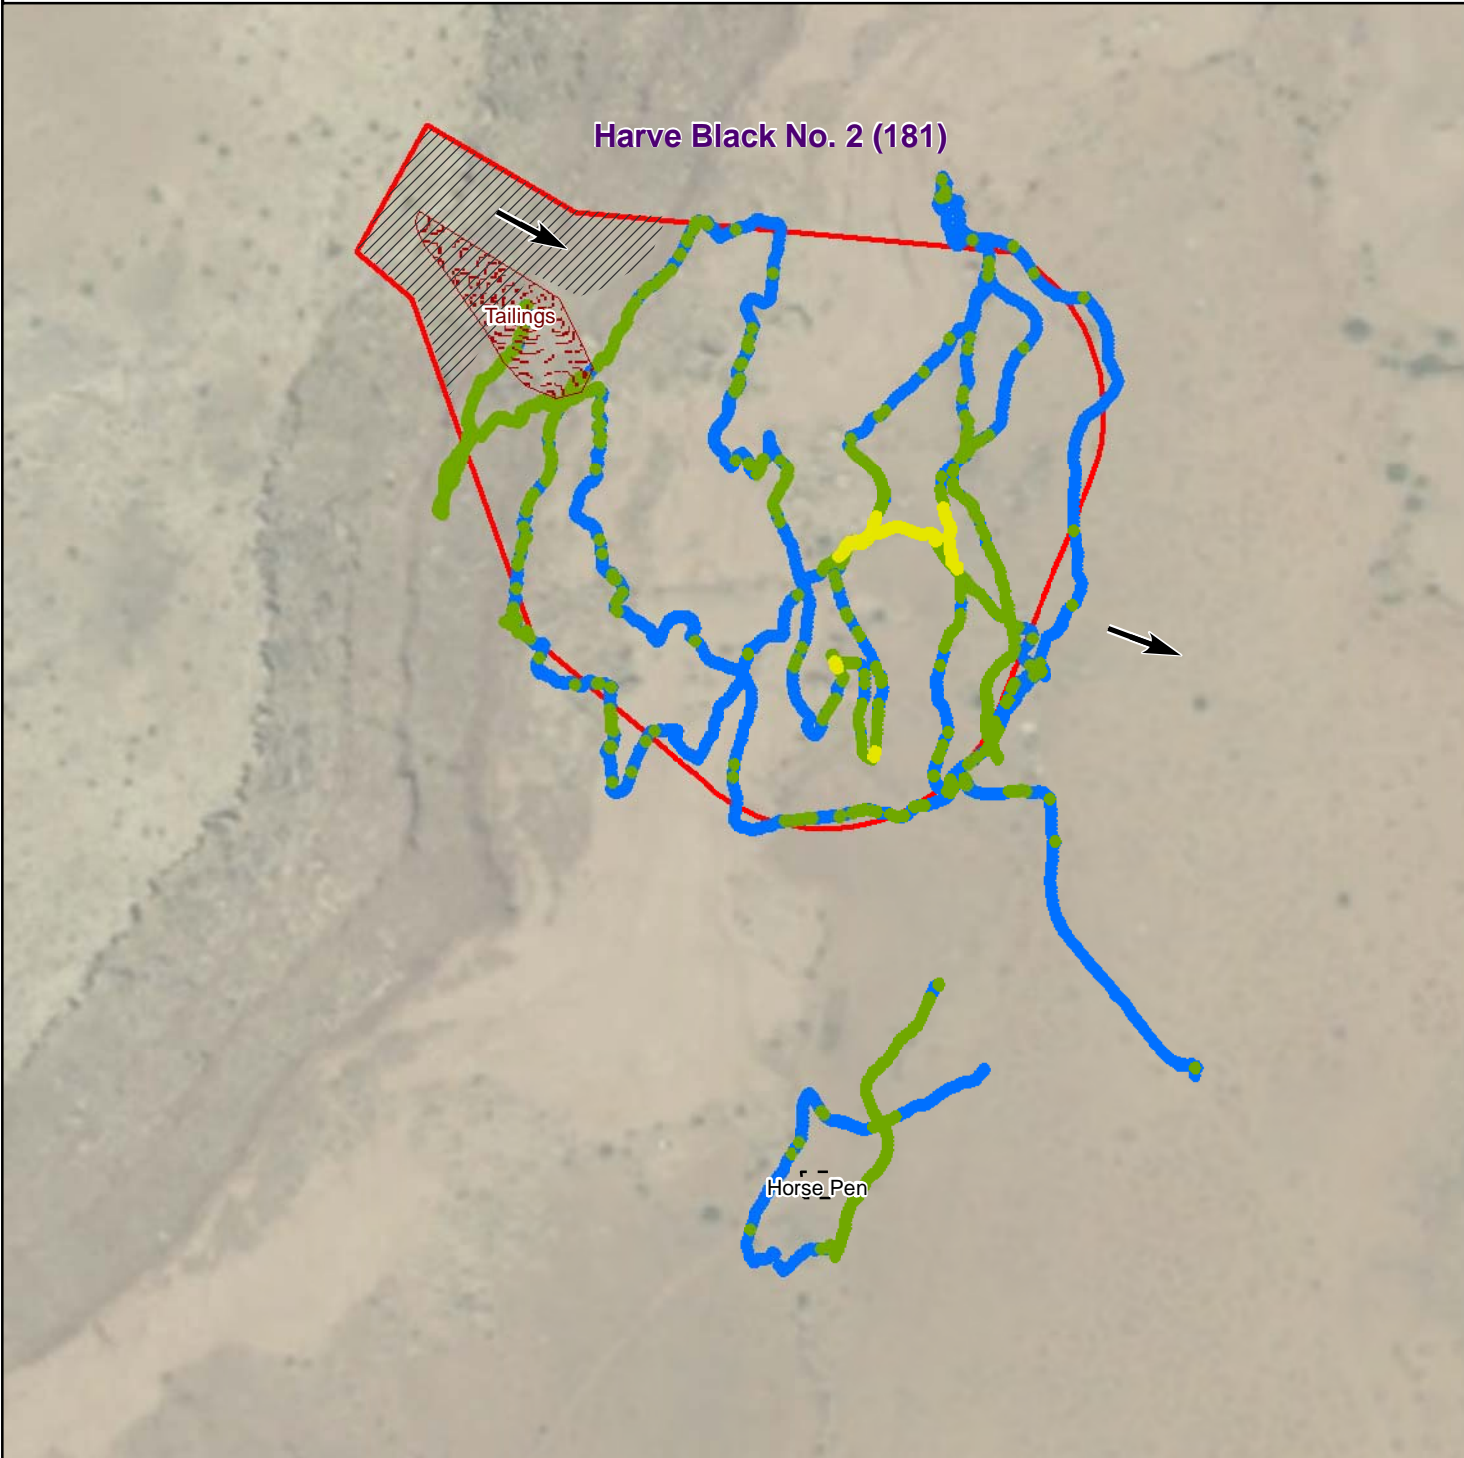
A total of 3,342 gamma radiation measurements were collected from the mine site, ranging from 5,740 cpm to 40,538 cpm. Maximum levels of approximately 25,000 cpm were found in the vicinity of the waste rock. The measurements are represented in Figures 1 and 2.

**Figure 2 - Gamma Radiation Measurements
Harve Black No. 2 (181)
Oljato Chapter, Navajo Nation**

Average background 7,439 cpm
