Navajo Abandoned Uranium Mine

Site Screen Report

Johnny McCoy 1 AUM Site

August 2010

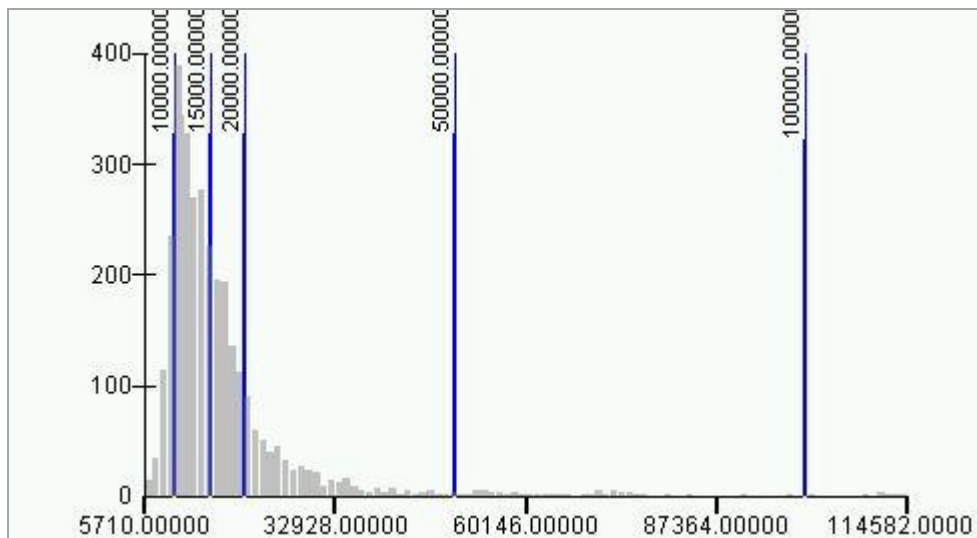
The following chart and statistics were generated by ESRI ArcGIS 9.3.1, and show the general distribution of the site gamma radiation measurements. The horizontal X axis represents the gamma radiation reading levels in cpm (lowest levels to the left). The vertical Y axis represents the frequency of each gamma radiation level.

Count:	3142
Minimum:	5710.00000
Maximum:	114582.00000
Sum:	52978053.00000
Mean:	16861.25175
Median:	14043.00000
Standard Deviation:	10862.48186

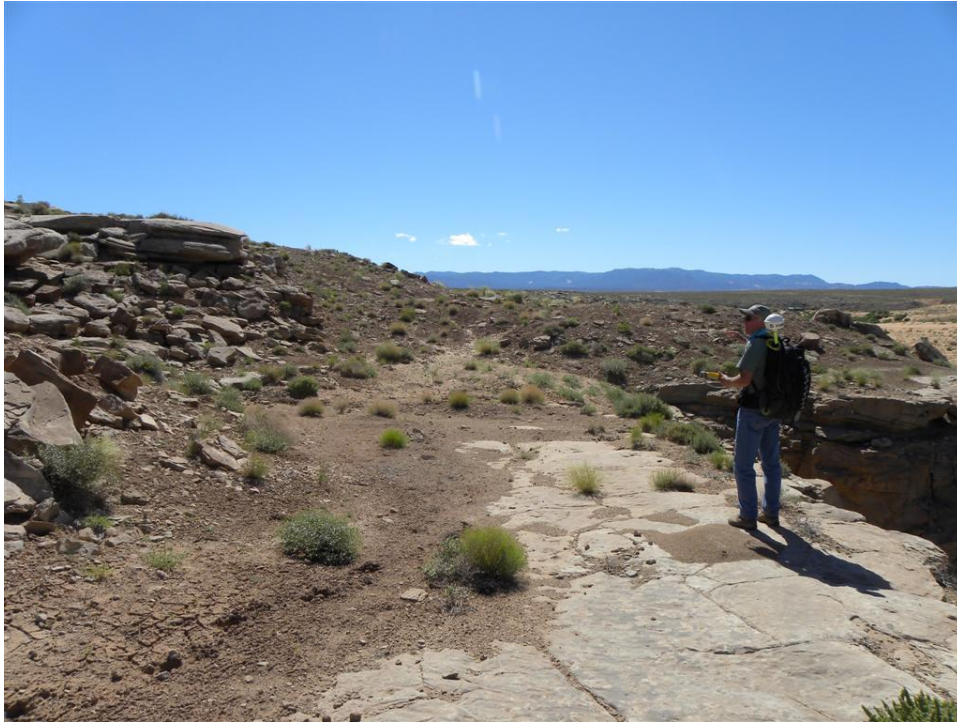
Former trench area in S area of site (covered), 30'x30'

Photo 3. Johnny McCoy 1 site, former trench area

Site reclaimed by AML in 1997, covered trench and shaft, and removed waste

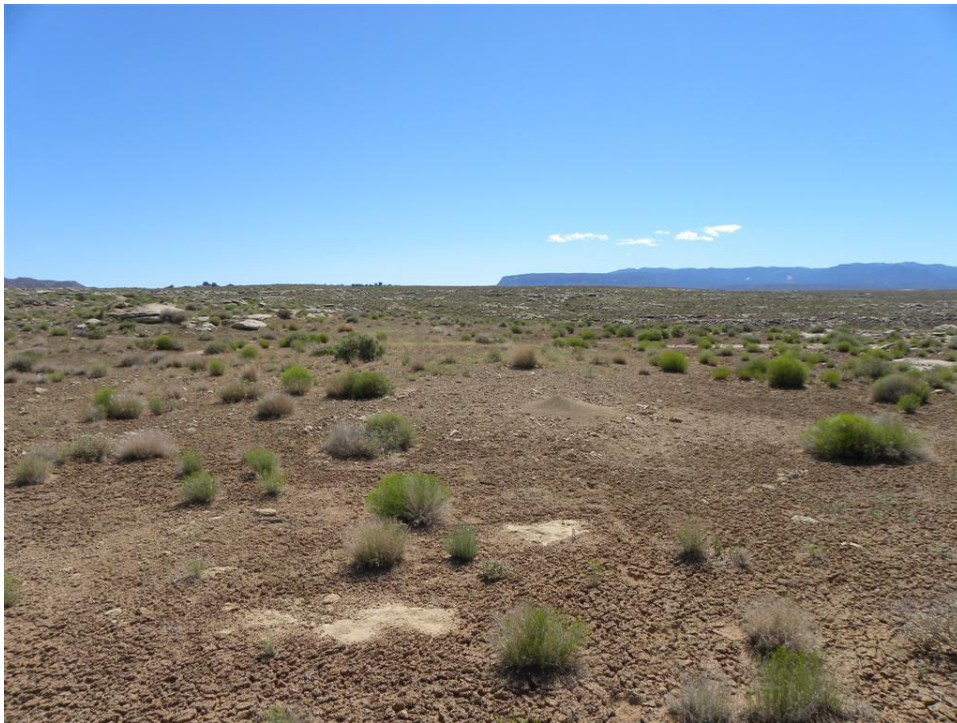
Former shaft area (covered), 25'x25', shaft was estimated to be 10' deep by AML

Photo 4. Johnny McCoy 1 site, former shaft area

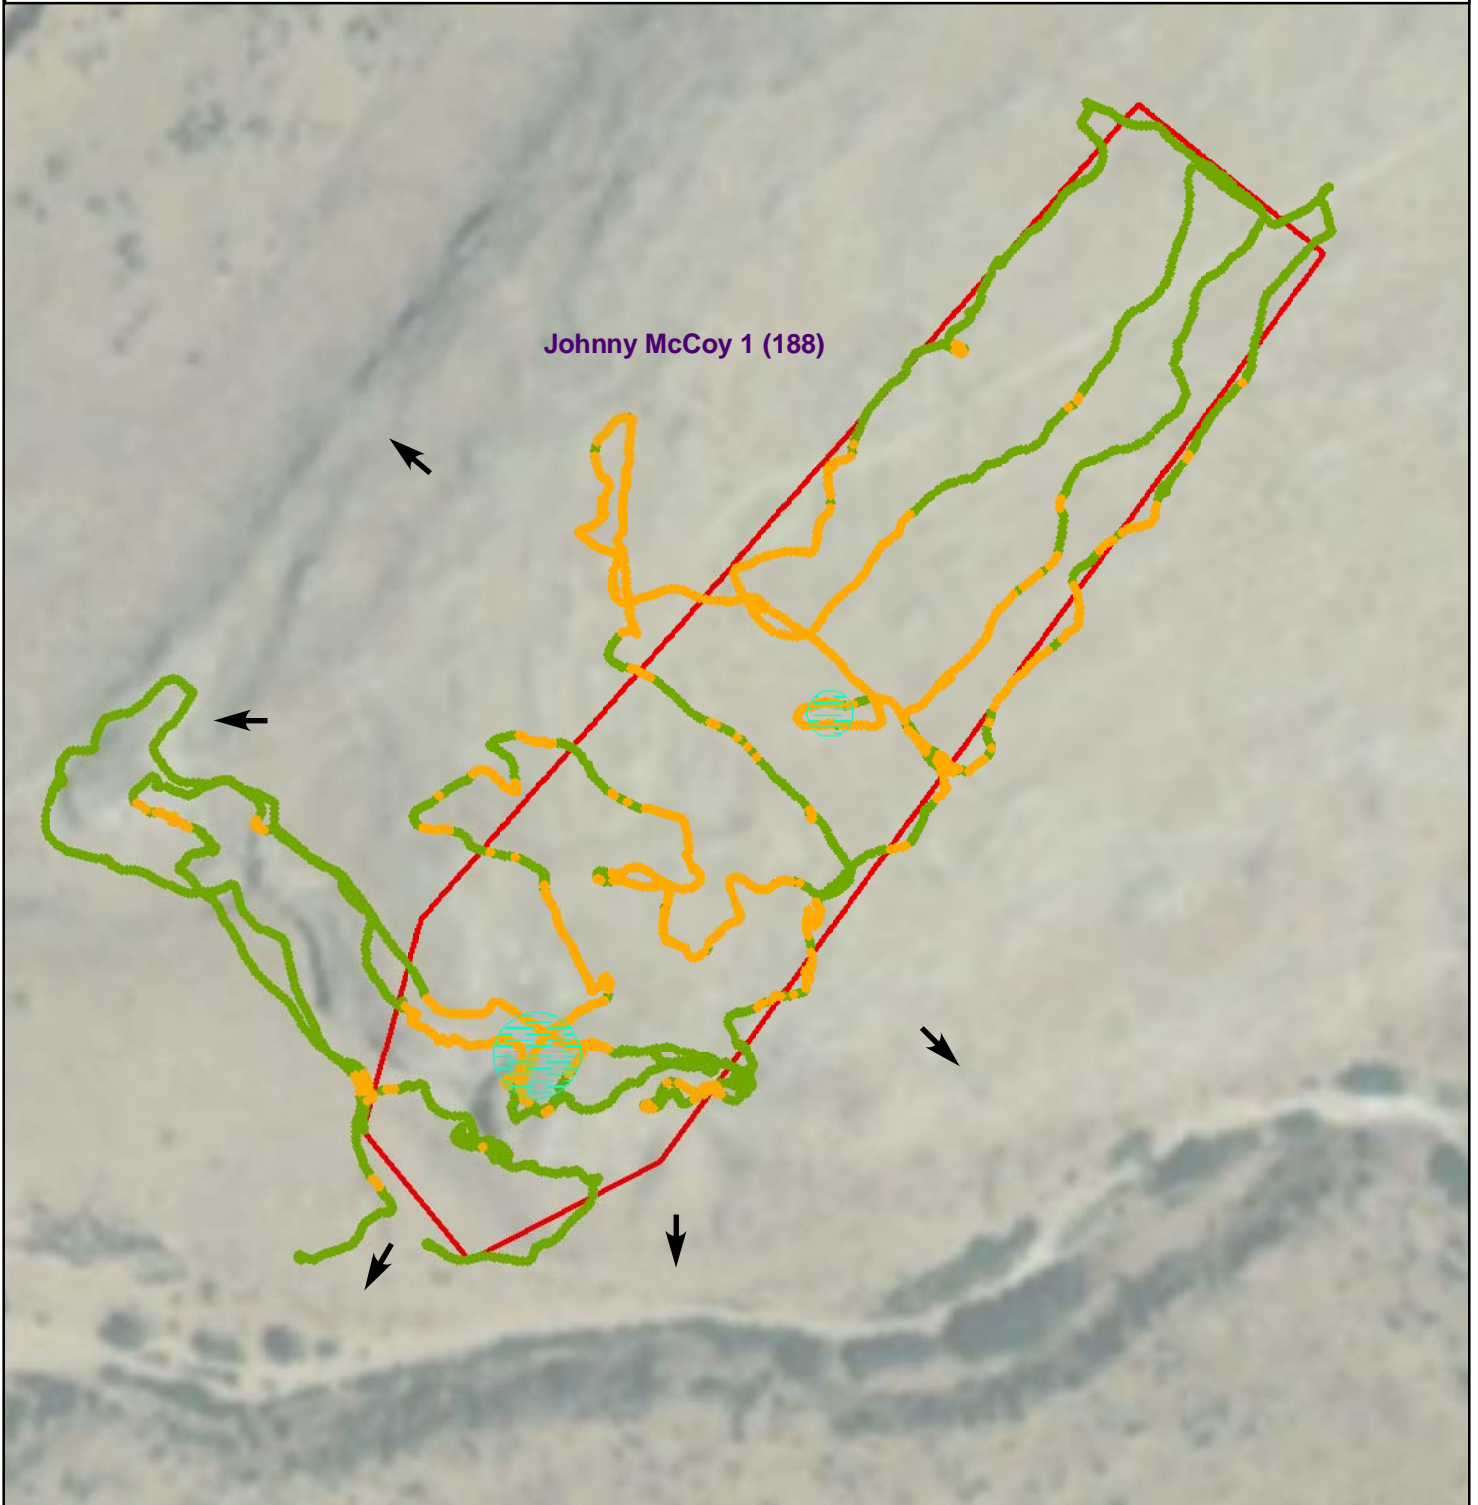
A total of 3,142 gamma radiation measurements were collected from the mine site, ranging from 5,710 cpm to 114,582 cpm. Measurements collected in the vicinity of the trench area were found at levels up to approximately 50,000 cpm. The measurements are represented in Figures 1 and 2.

**Figure 1 - Gamma Radiation Measurements, Above Two Times Background
Johnny McCoy 1 (188)
Sweetwater Chapter, Navajo Nation**

Gamma survey conducted 06/2010
Measured as counts per minute (cpm)

Average background = 7,749 cpm

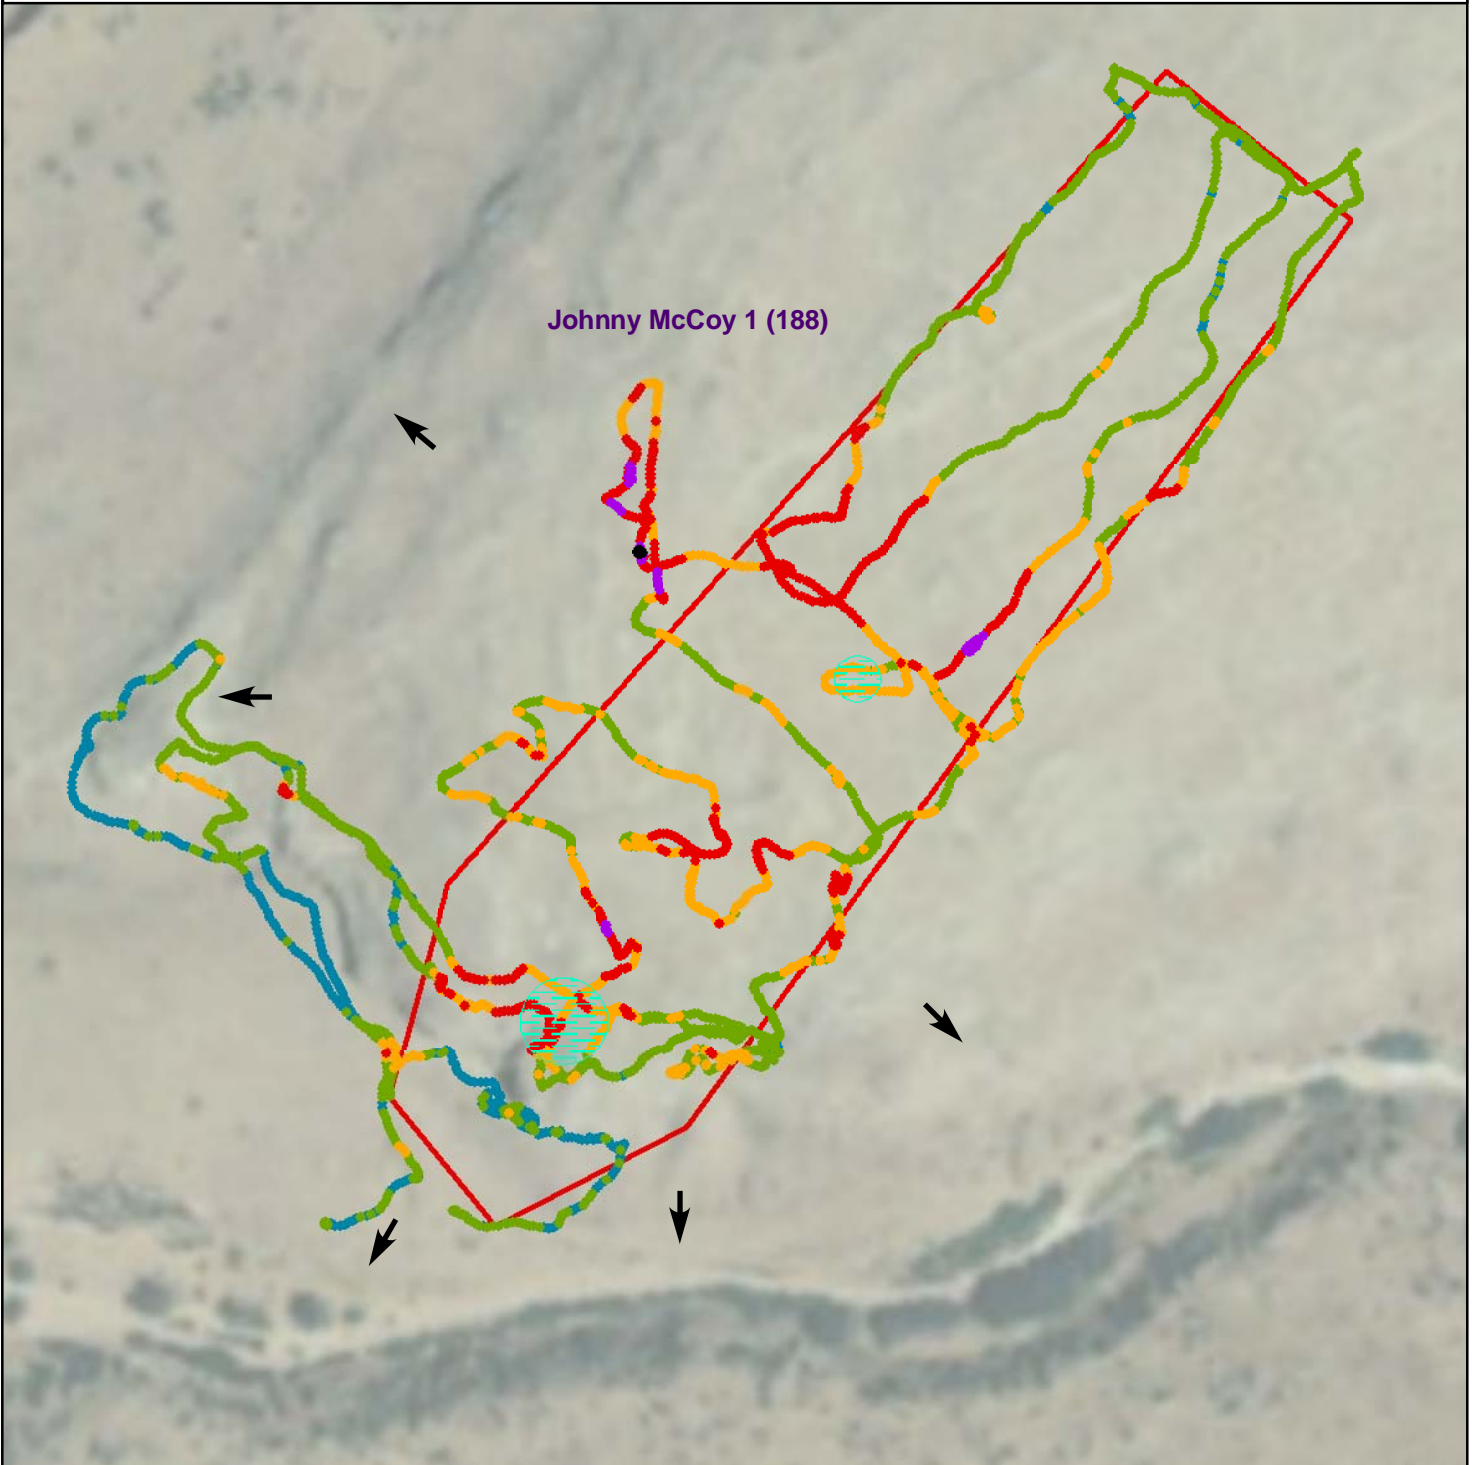
**Figure 2 - Gamma Radiation Measurements
Johnny McCoy 1 (188)
Sweetwater Chapter, Navajo Nation**

Gamma survey conducted 06/2010
Measured as counts per minute (cpm)

Average background 7,749 cpm
