Navajo Abandoned Uranium Mine

Site Screen Report

NA-0509A AUM Site

August 2010

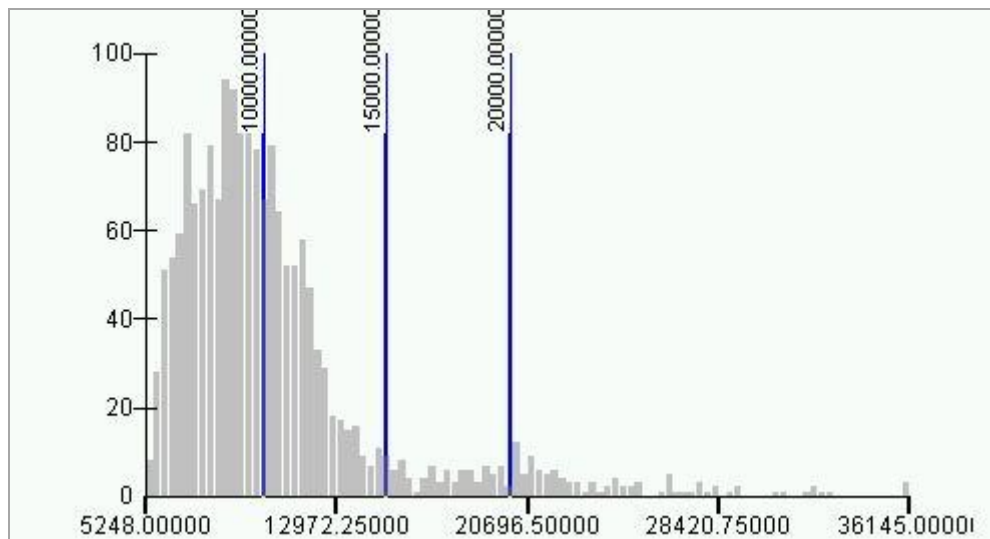
The following chart and statistics were generated by ESRI ArcGIS 9.3.1, and show the general distribution of the site gamma radiation measurements. The horizontal X axis represents the gamma radiation reading levels in cpm (lowest levels to the left). The vertical Y axis represents the frequency of each gamma radiation level.

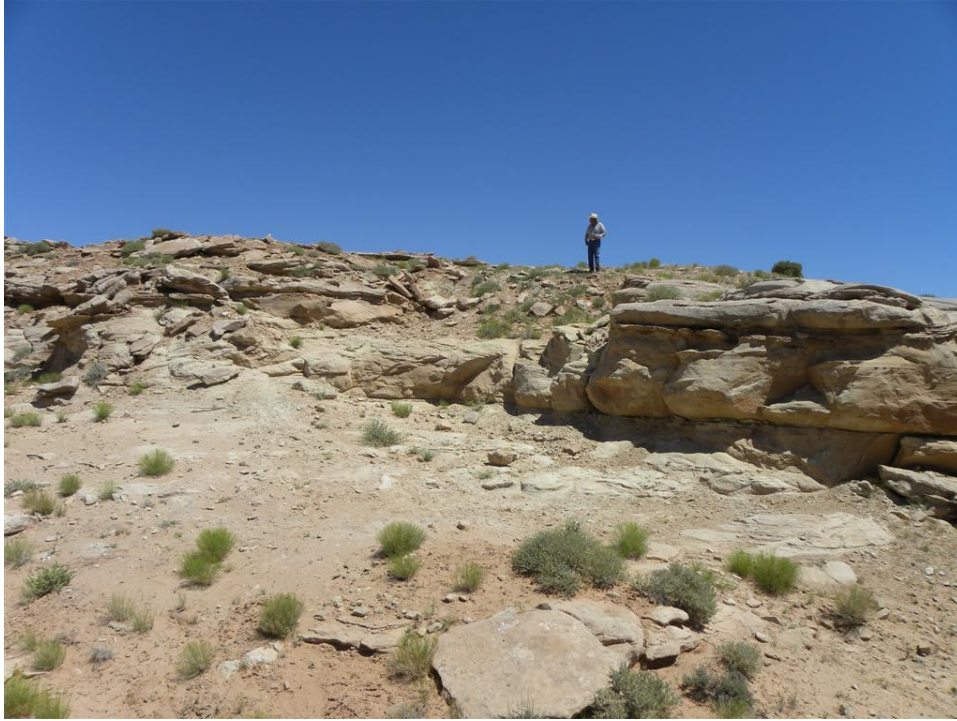
According to Navajo AML (Carl Holiday), a former waste pile was covered, immediately E of site boundary, 30' x 30' area

Photo 1. NA-0509A site, former waste pile area

Covered waste pile, immediately E of site boundary, 30' x 30'

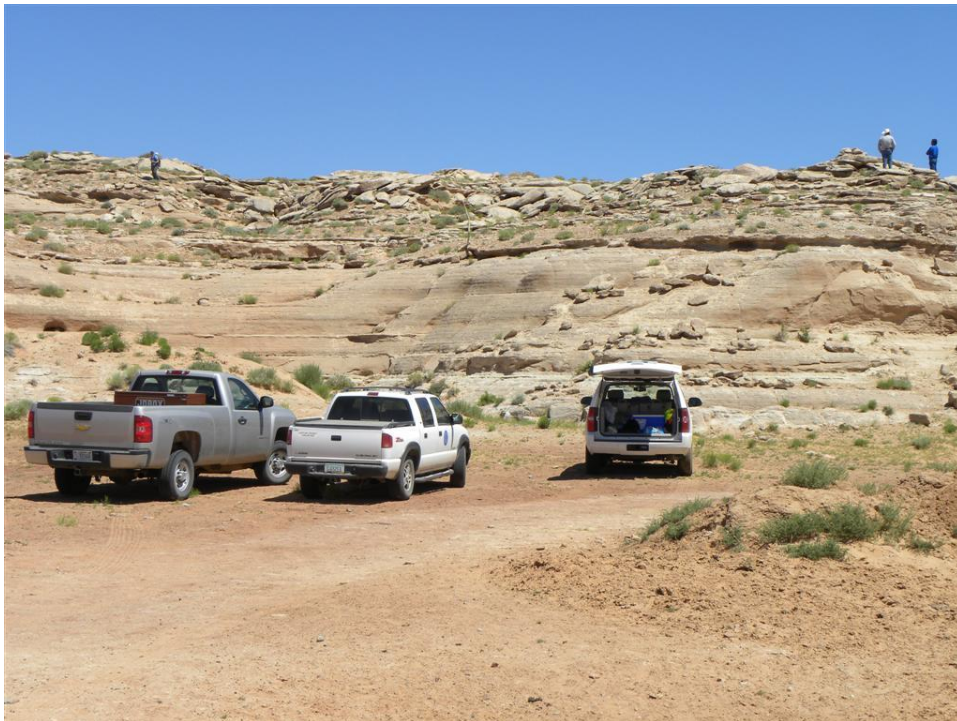
0 to 0.25 miles: Windmill well immediately S of site boundary

Photo 2. NA-0509A site, taken from base of windmill well

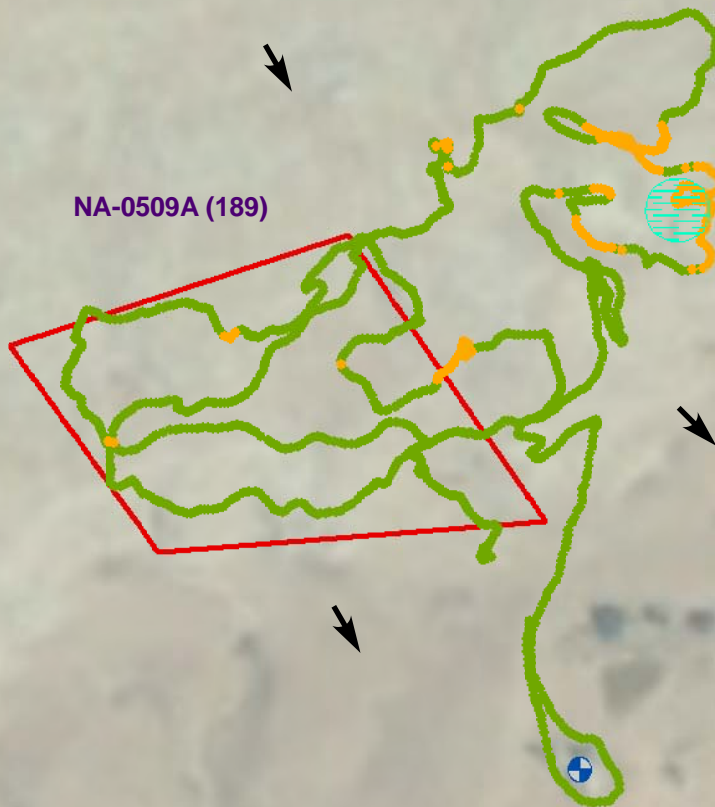
**Figure 1 - Gamma Radiation Measurements, Above Two Times Background
NA-0509A (189)
Red Mesa Chapter, Navajo Nation**

A total of 1,772 gamma radiation measurements were collected from the mine site, ranging from 5,248 cpm to 36,145 cpm. Measurements collected in the vicinity of the covered former waste pile area were found at levels up to approximately 30,000 cpm. The measurements are represented in Figures 1 and 2.

Gamma survey conducted 06/2010
Measured as counts per minute (cpm)

Average background = 6,955 cpm

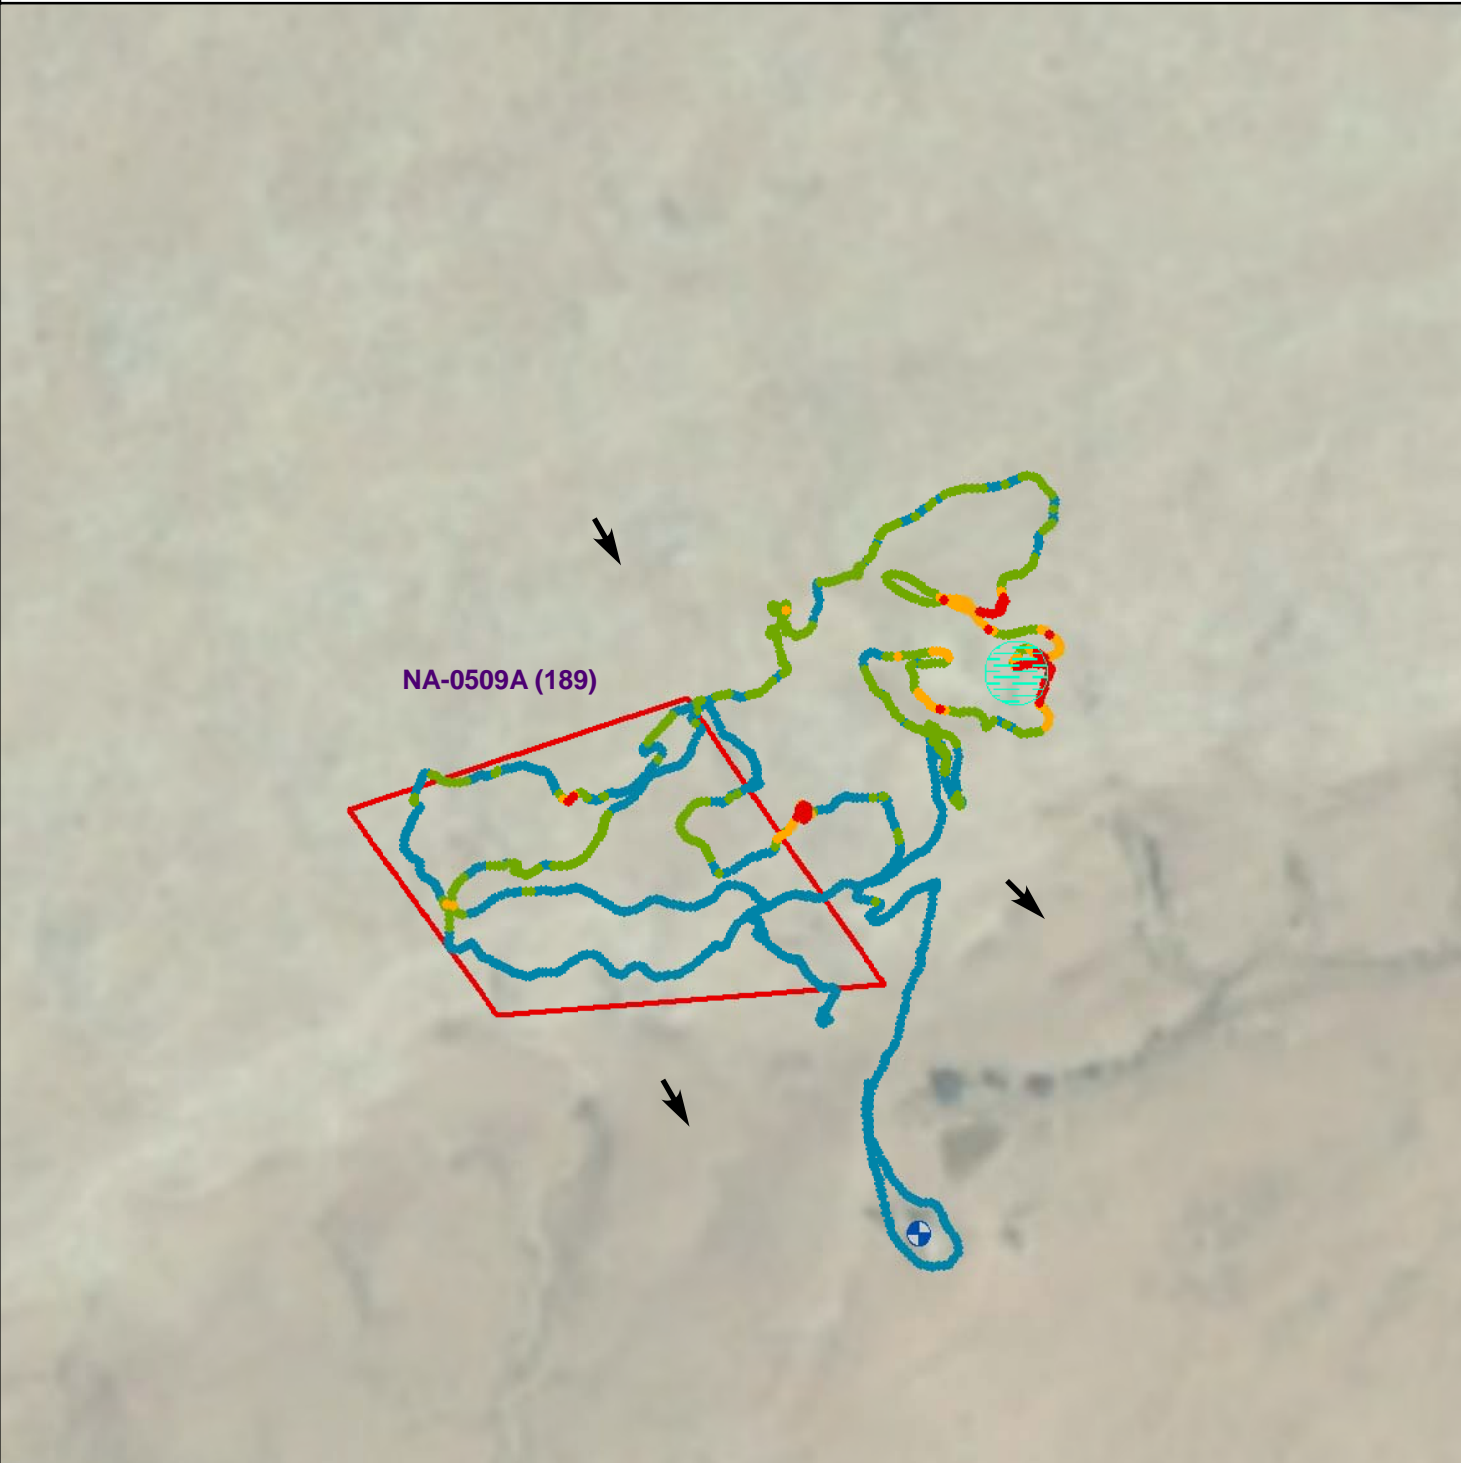
**Figure 2 - Gamma Radiation Measurements
NA-0509A (189)
Red Mesa Chapter, Navajo Nation**

**Gamma survey conducted 06/2010
Measured as counts per minute (cpm)**

Average background 7,749 cpm
