# Navajo Abandoned Uranium Mine

## Site Screen Report

### **Brodie 1 AUM Site**

**August 2010**

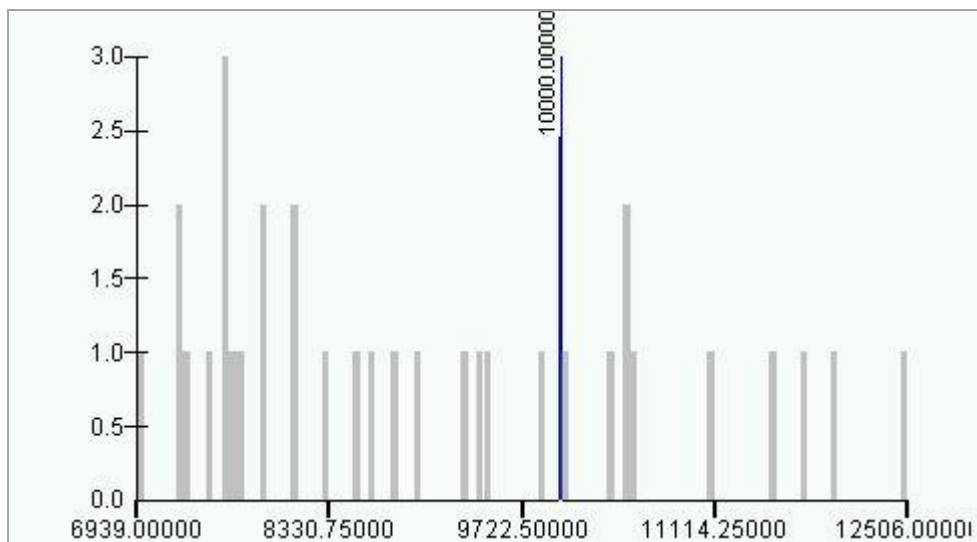
The following chart and statistics were generated by ESRI ArcGIS 9.3.1, and show the general distribution of the site gamma radiation measurements. The horizontal X axis represents the gamma radiation reading levels in cpm (lowest levels to the left). The vertical Y axis represents the frequency of each gamma radiation level.

Count:	33
Minimum:	6939.00000
Maximum:	12506.00000
Sum:	298127.00000
Mean:	9034.15152
Median:	8646.00000
Standard Deviation:	1565.06457

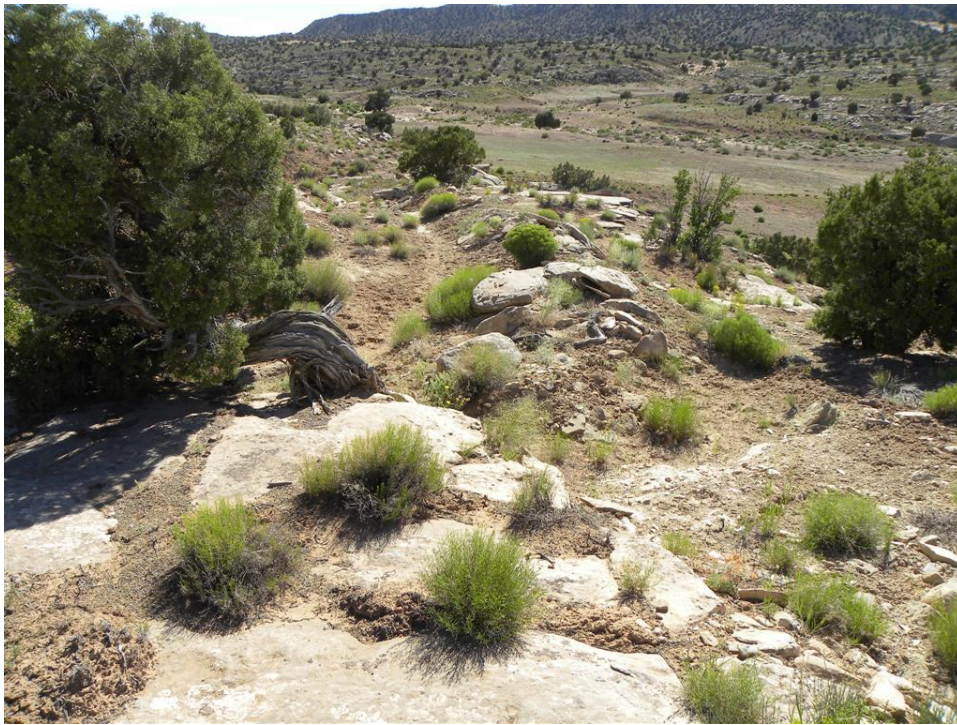
Photo 2. Brodie 1 site, berm area

Small rock-berm area W end of site

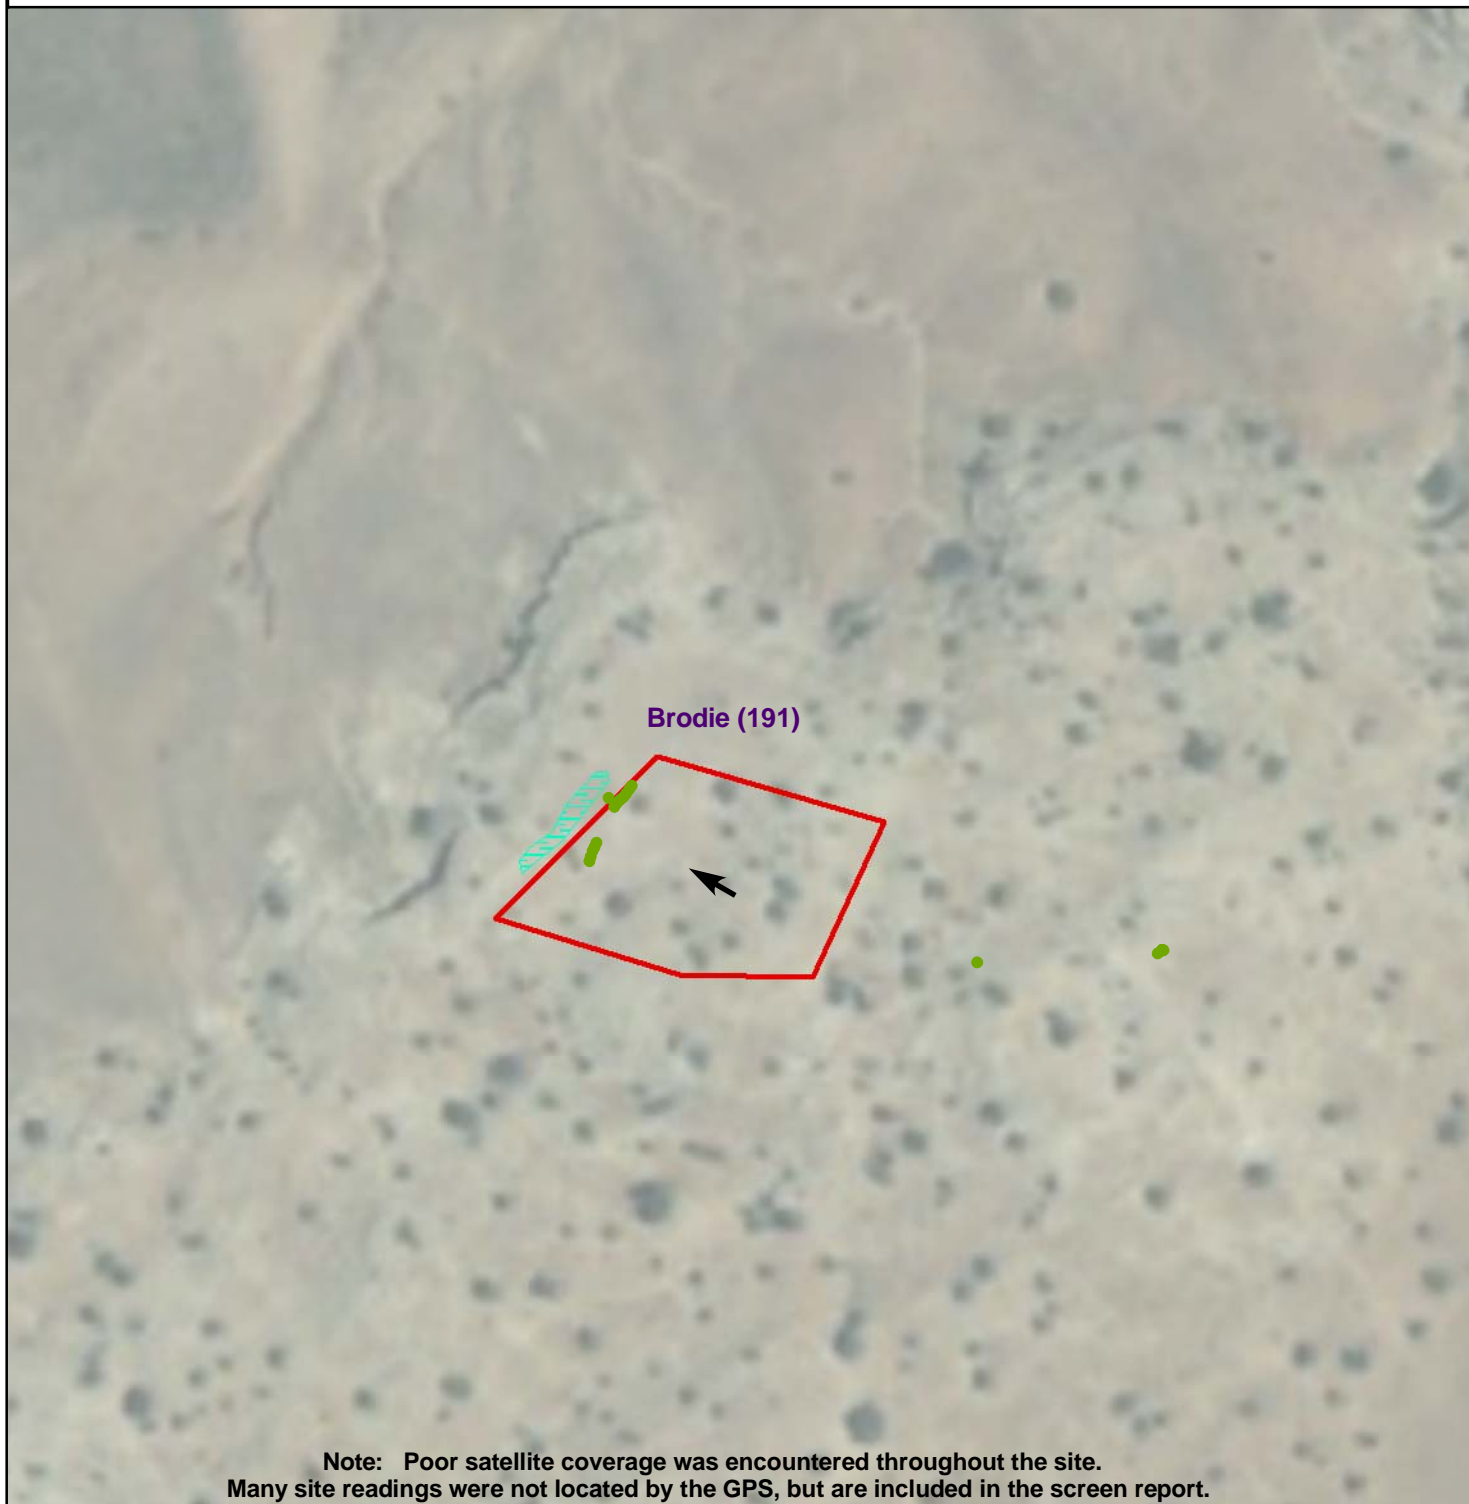
**Figure 1 - Gamma Radiation Measurements, Above Two Times Background  
Brodie (191)  
Red Mesa Chapter, Navajo Nation**

A total of 33 gamma radiation measurements were collected from the mine site, ranging from 6,939 cpm to 12,506 cpm. The measurements are represented in Figures 1 and 2.

Gamma survey conducted 06/2010  
Measured as counts per minute (cpm)

Average background = 7,709 cpm

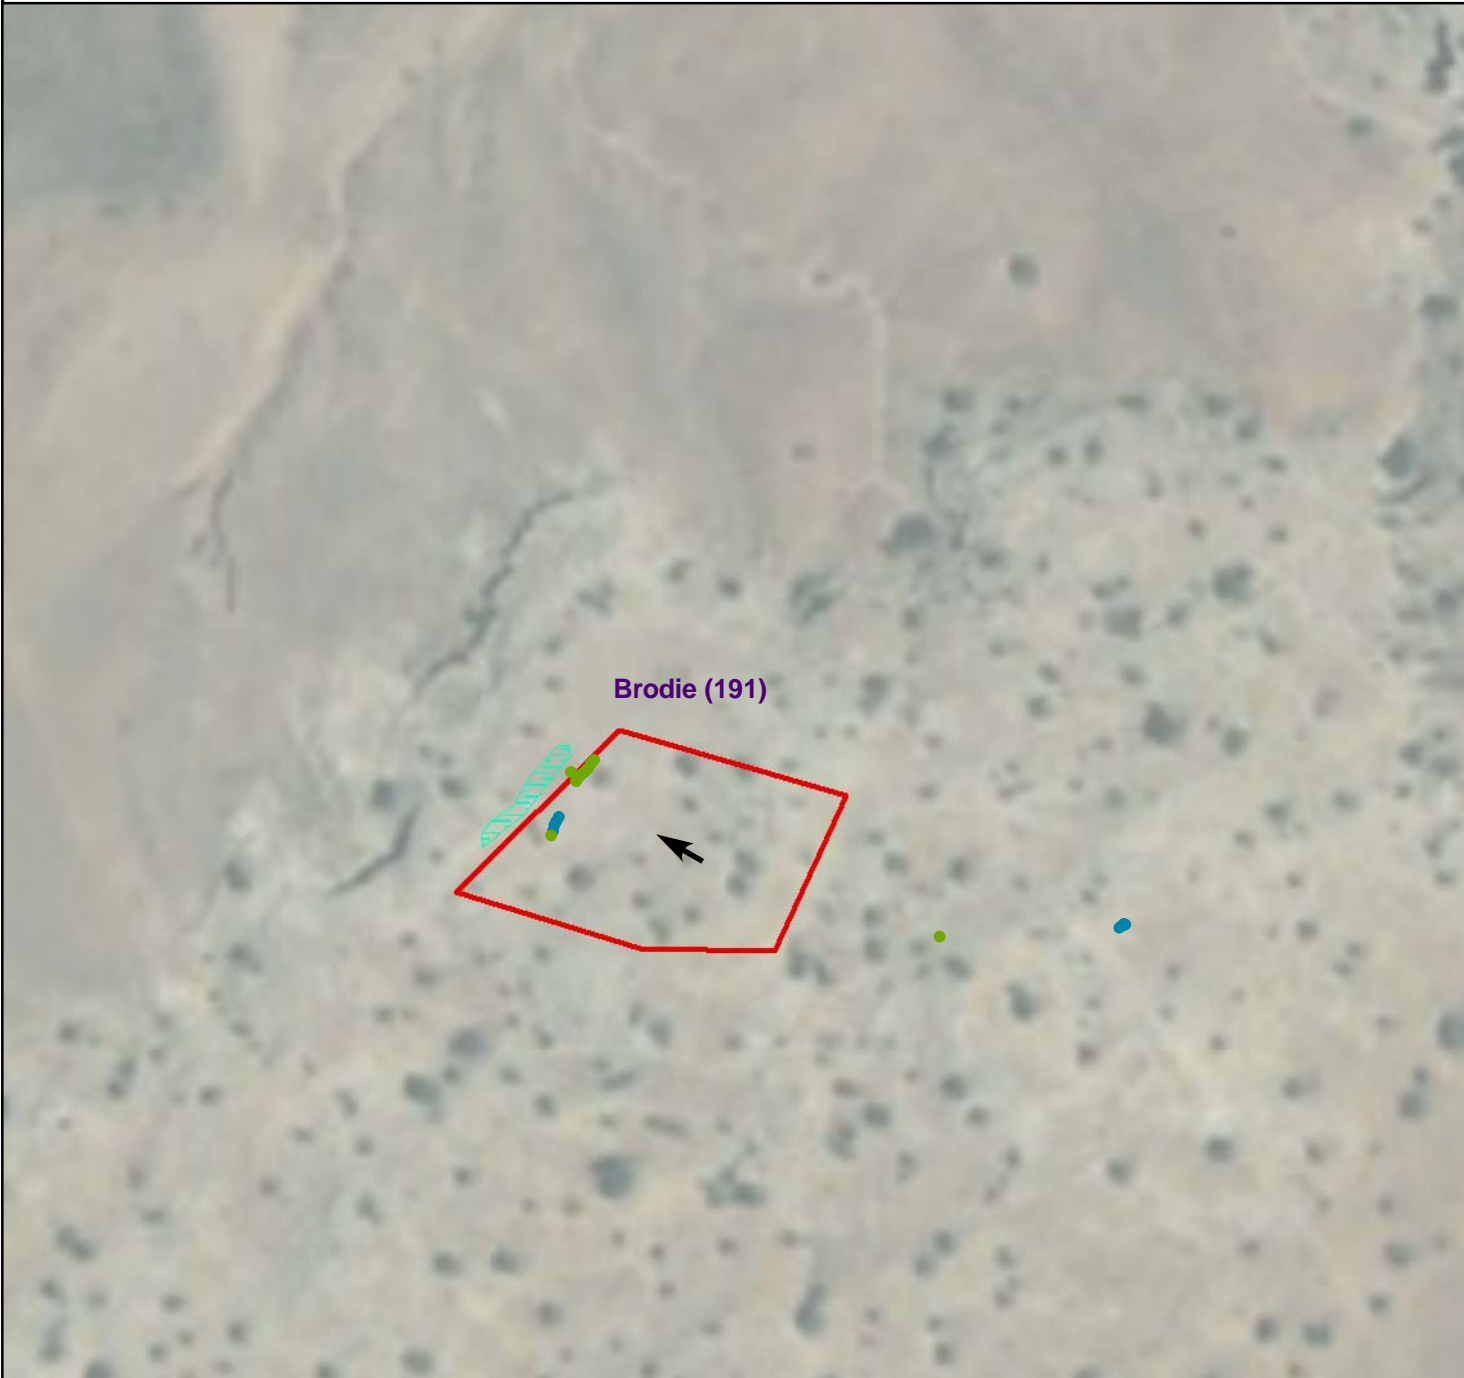
**Figure 2 - Gamma Radiation Measurements  
Brodie (191)  
Red Mesa Chapter, Navajo Nation**

**Note:** Poor satellite coverage was encountered throughout the site.  
Many site readings were not located by the GPS, but are included in the screen report.

**Gamma survey conducted 06/2010  
Measured as counts per minute (cpm)**

**Average background 7,709 cpm**
