Navajo Abandoned Uranium Mine

Site Screen Report

Deneh Nezz 1, 2 AUM Site

March 2010

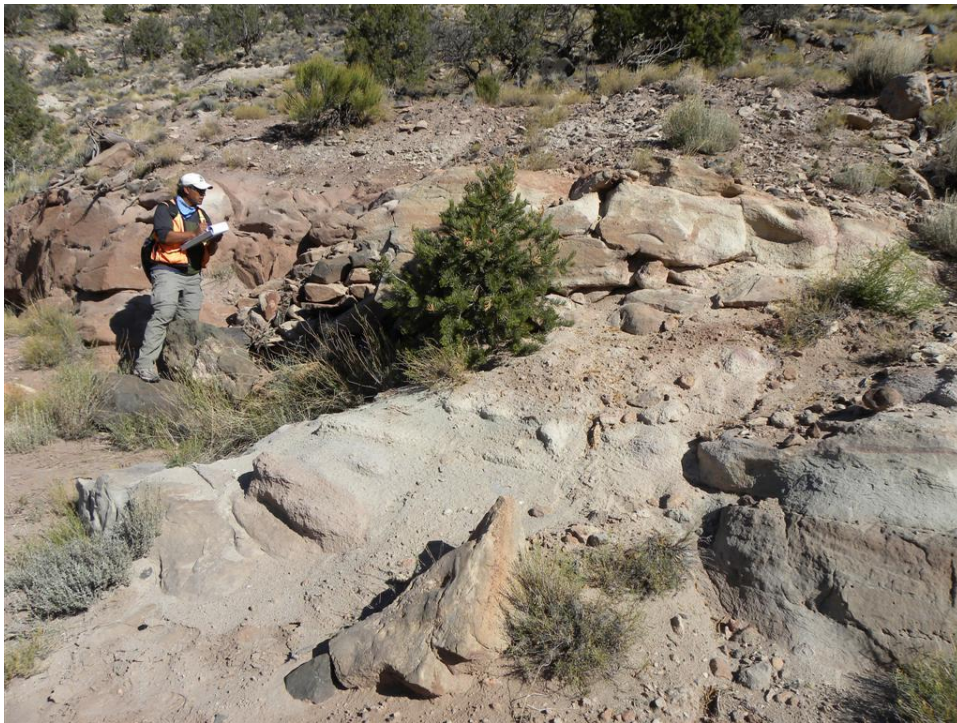
Waste rock pile below of adit, approximately 8' x 8', with a total estimated volume of 12 yd³

Photo 2. Waste rock below adit

Unreclaimed waste pile; sealed adit

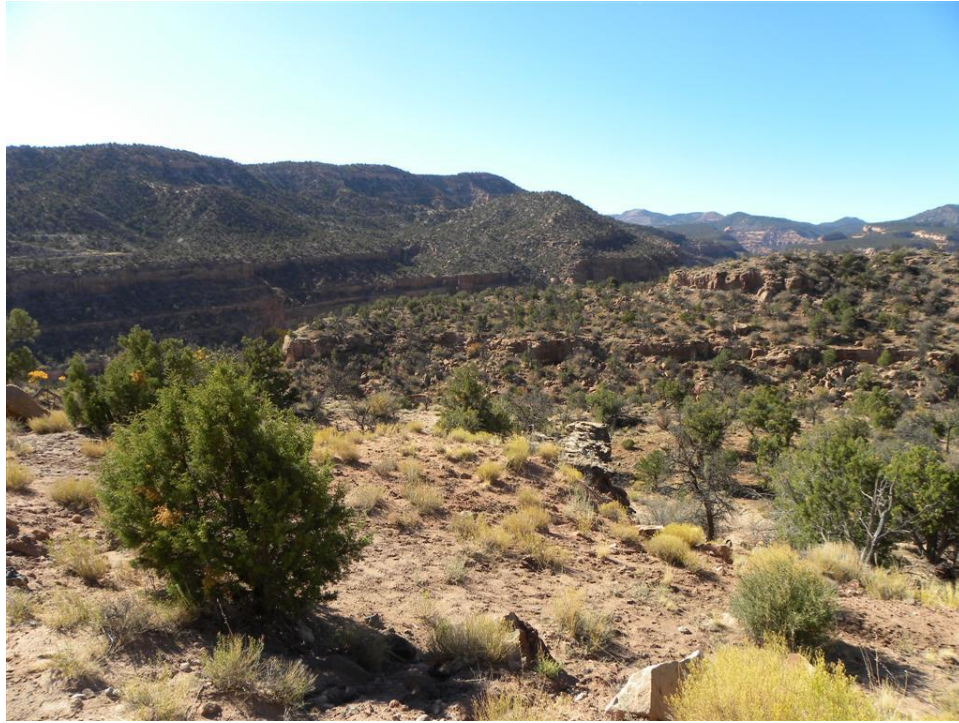
Photo 3. Mine site
