Navajo Abandoned Uranium Mine

Site Screen Report

Mexican Cry Mines AUM Site

March 2010

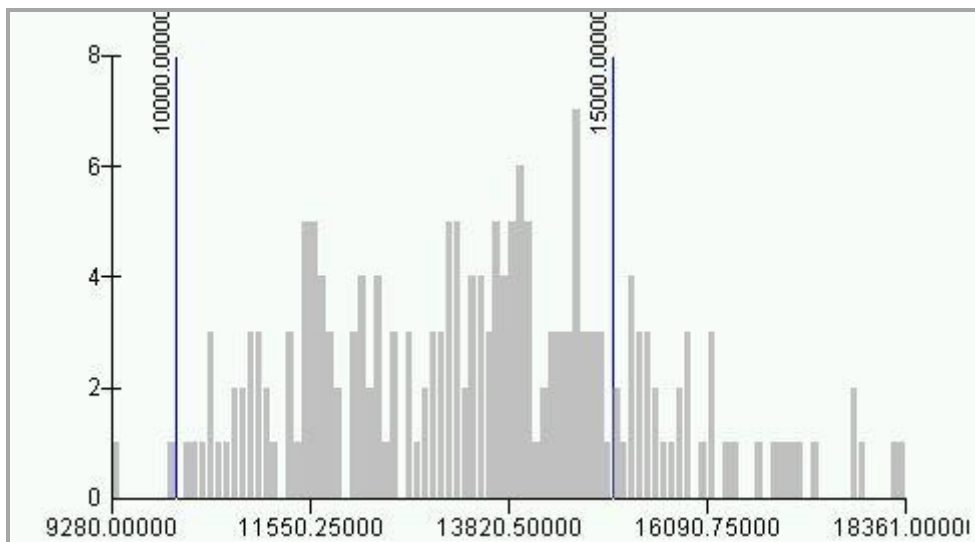
The following chart and statistics were generated by ESRI ArcGIS 9.3.1, and show the general distribution of the site gamma radiation measurements. The horizontal X axis represents the gamma radiation reading levels in cpm (lowest levels to the left). The vertical Y axis represents the frequency of each gamma radiation level.

Count:	191
Minimum:	9280.00000
Maximum:	18361.00000
Sum:	2578729.00000
Mean:	13501.19895
Median:	13576.00000
Standard Deviation:	1850.60006

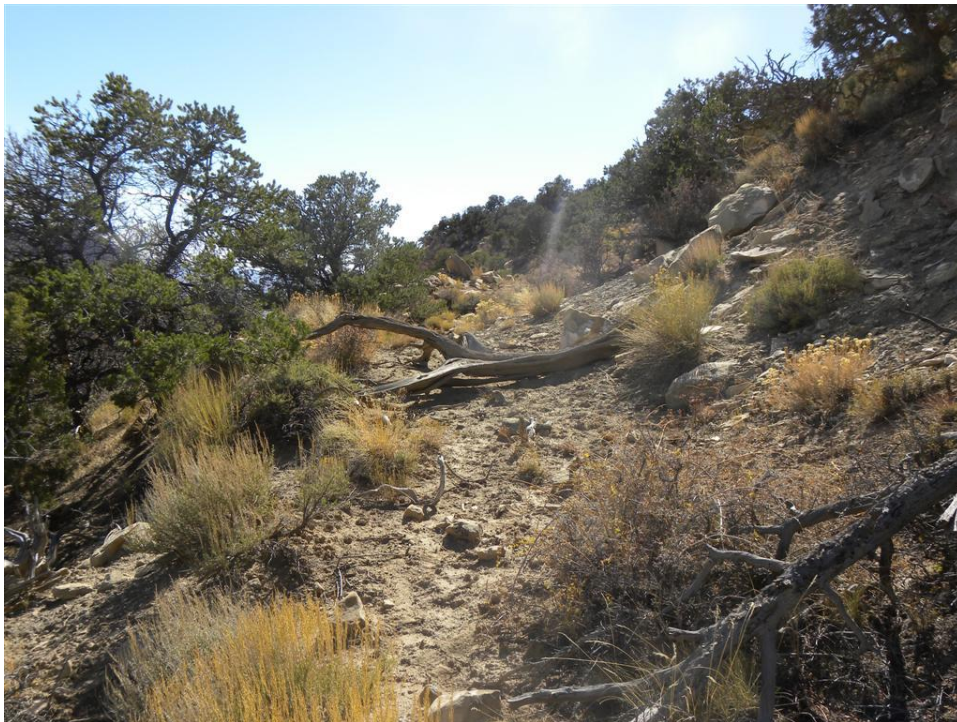
Waste debris extending down inaccessible cliff face, 125' x 25', with a total estimated volume of 579 yd³

Photo 2. Site #197 – Mine site and waste rock

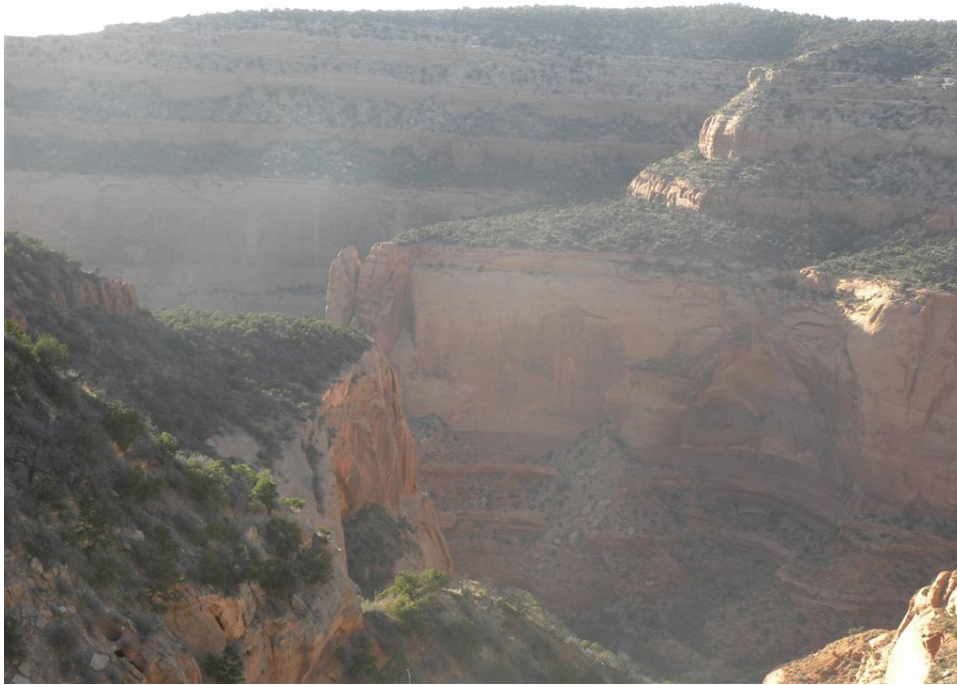
Photo 3. Site #197 – Cliff area and waste debris

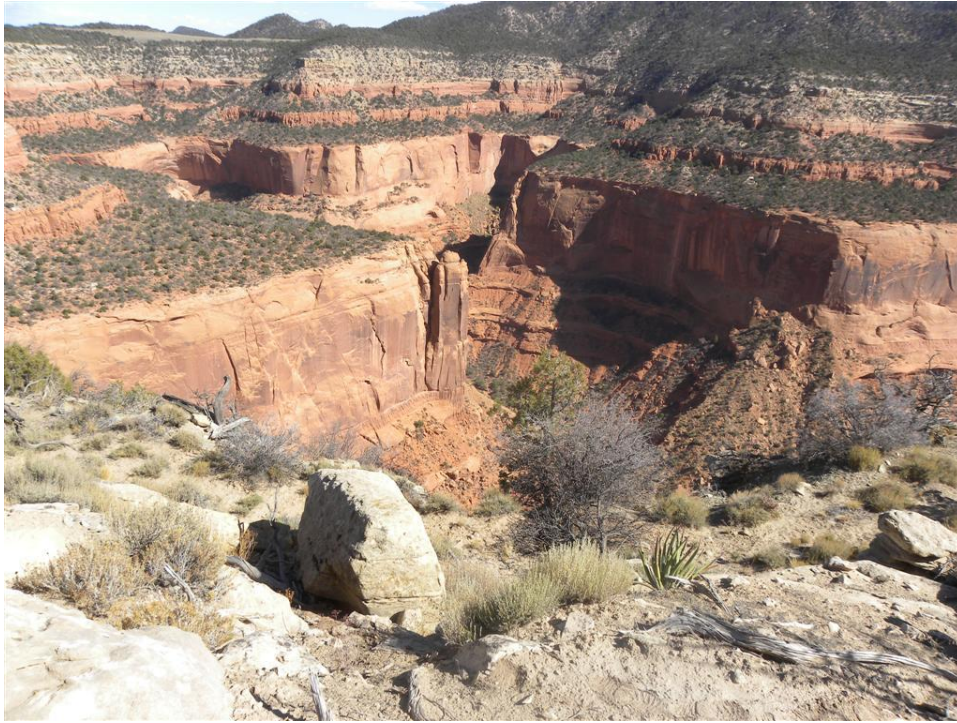
Large waste debris pile cascading down inaccessible cliff face, 250' x 25', with a total estimated volume of 1,157 yd³

Photo 5. Site #198 – Cliff area and waste rock
