# Navajo Abandoned Uranium Mine

## Site Screen Report

### **NA-0504 AUM Site**

**August 2010**

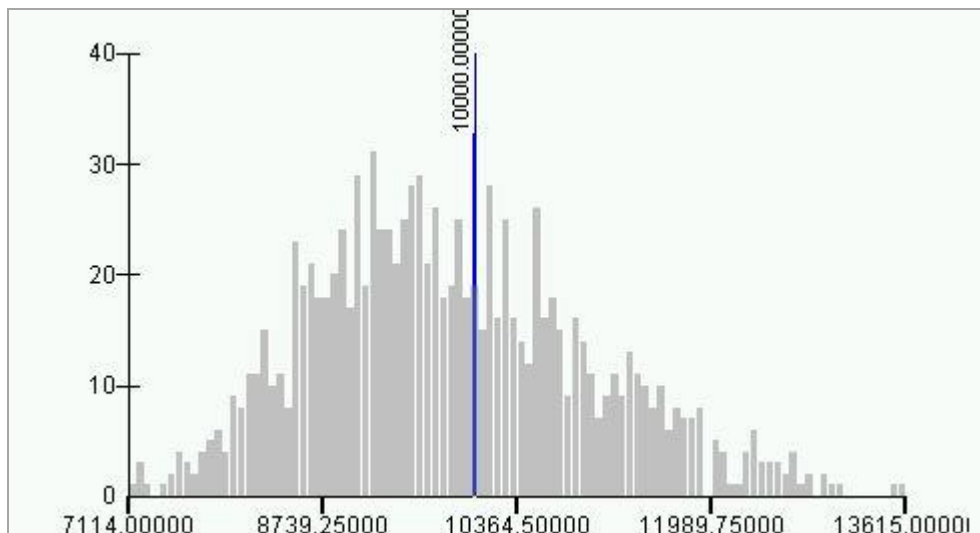
The following chart and statistics were generated by ESRI ArcGIS 9.3.1, and show the general distribution of the site gamma radiation measurements. The horizontal X axis represents the gamma radiation reading levels in cpm (lowest levels to the left). The vertical Y axis represents the frequency of each gamma radiation level.

Count:	1075
Minimum:	7114.00000
Maximum:	13615.00000
Sum:	10538806.00000
Mean:	9803.54047
Median:	9680.00000
Standard Deviation:	1156.03642

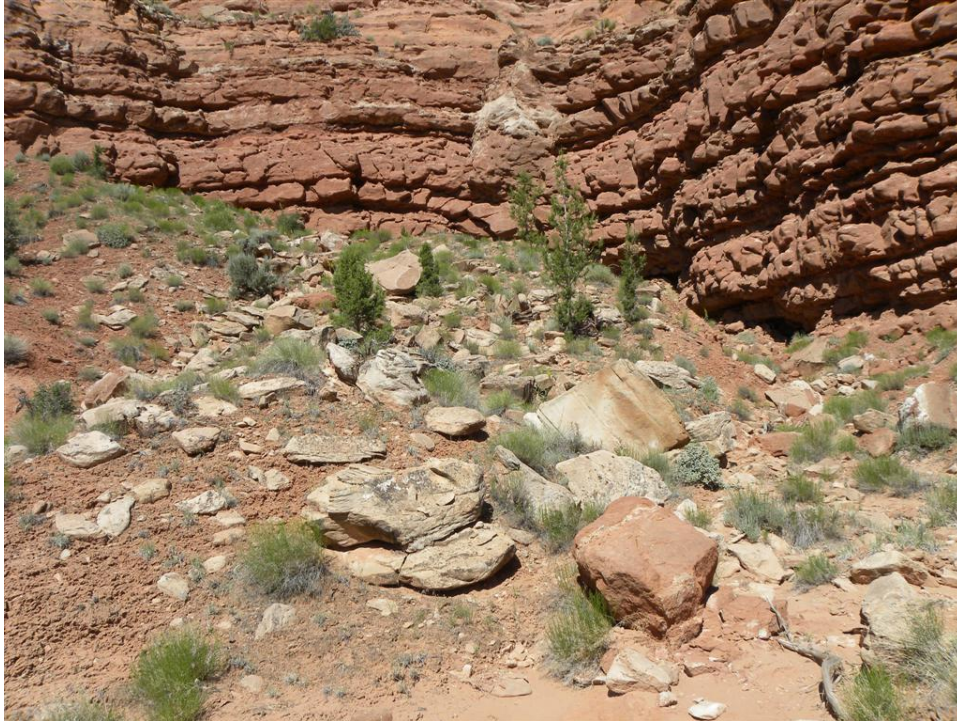
Photo 2. NA-0504 site, waste pile

Rock pile at base of cliff 20'x50'x5'

Unreclaimed waste rock

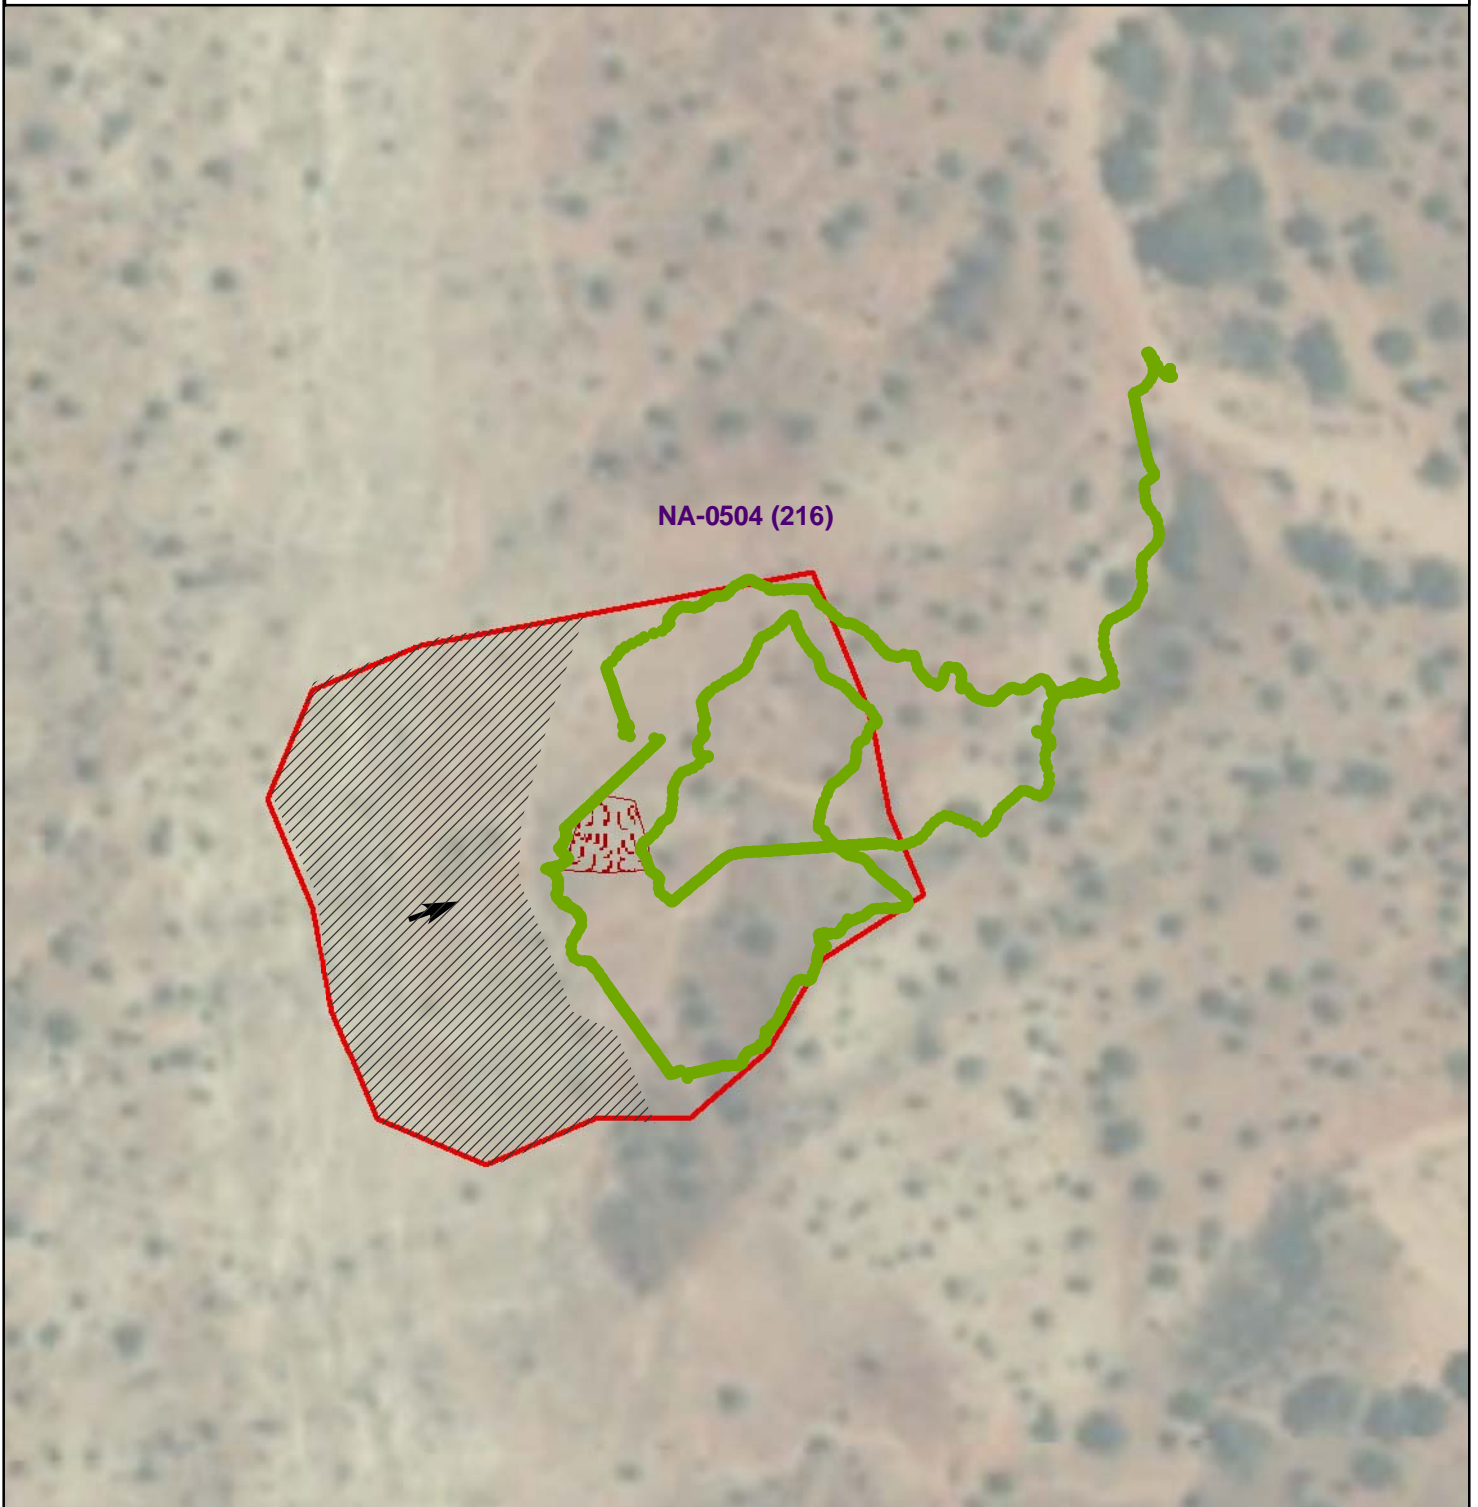
**Figure 1 - Gamma Radiation Measurements, Above Two Times Background  
NA-0504 (216)  
Sweetwater Chapter, Navajo Nation**

A total of 1,075 gamma radiation measurements were collected from the mine site, ranging from 7,114 cpm to 13,615 cpm. Measurements collected in the vicinity of the waste debris were found at levels ranging from approximately 10,000 cpm to 15,000 cpm. The measurements are represented in Figures 1 and 2.

Gamma survey conducted 06/2010  
Measured as counts per minute (cpm)

Average background = 7,491 cpm

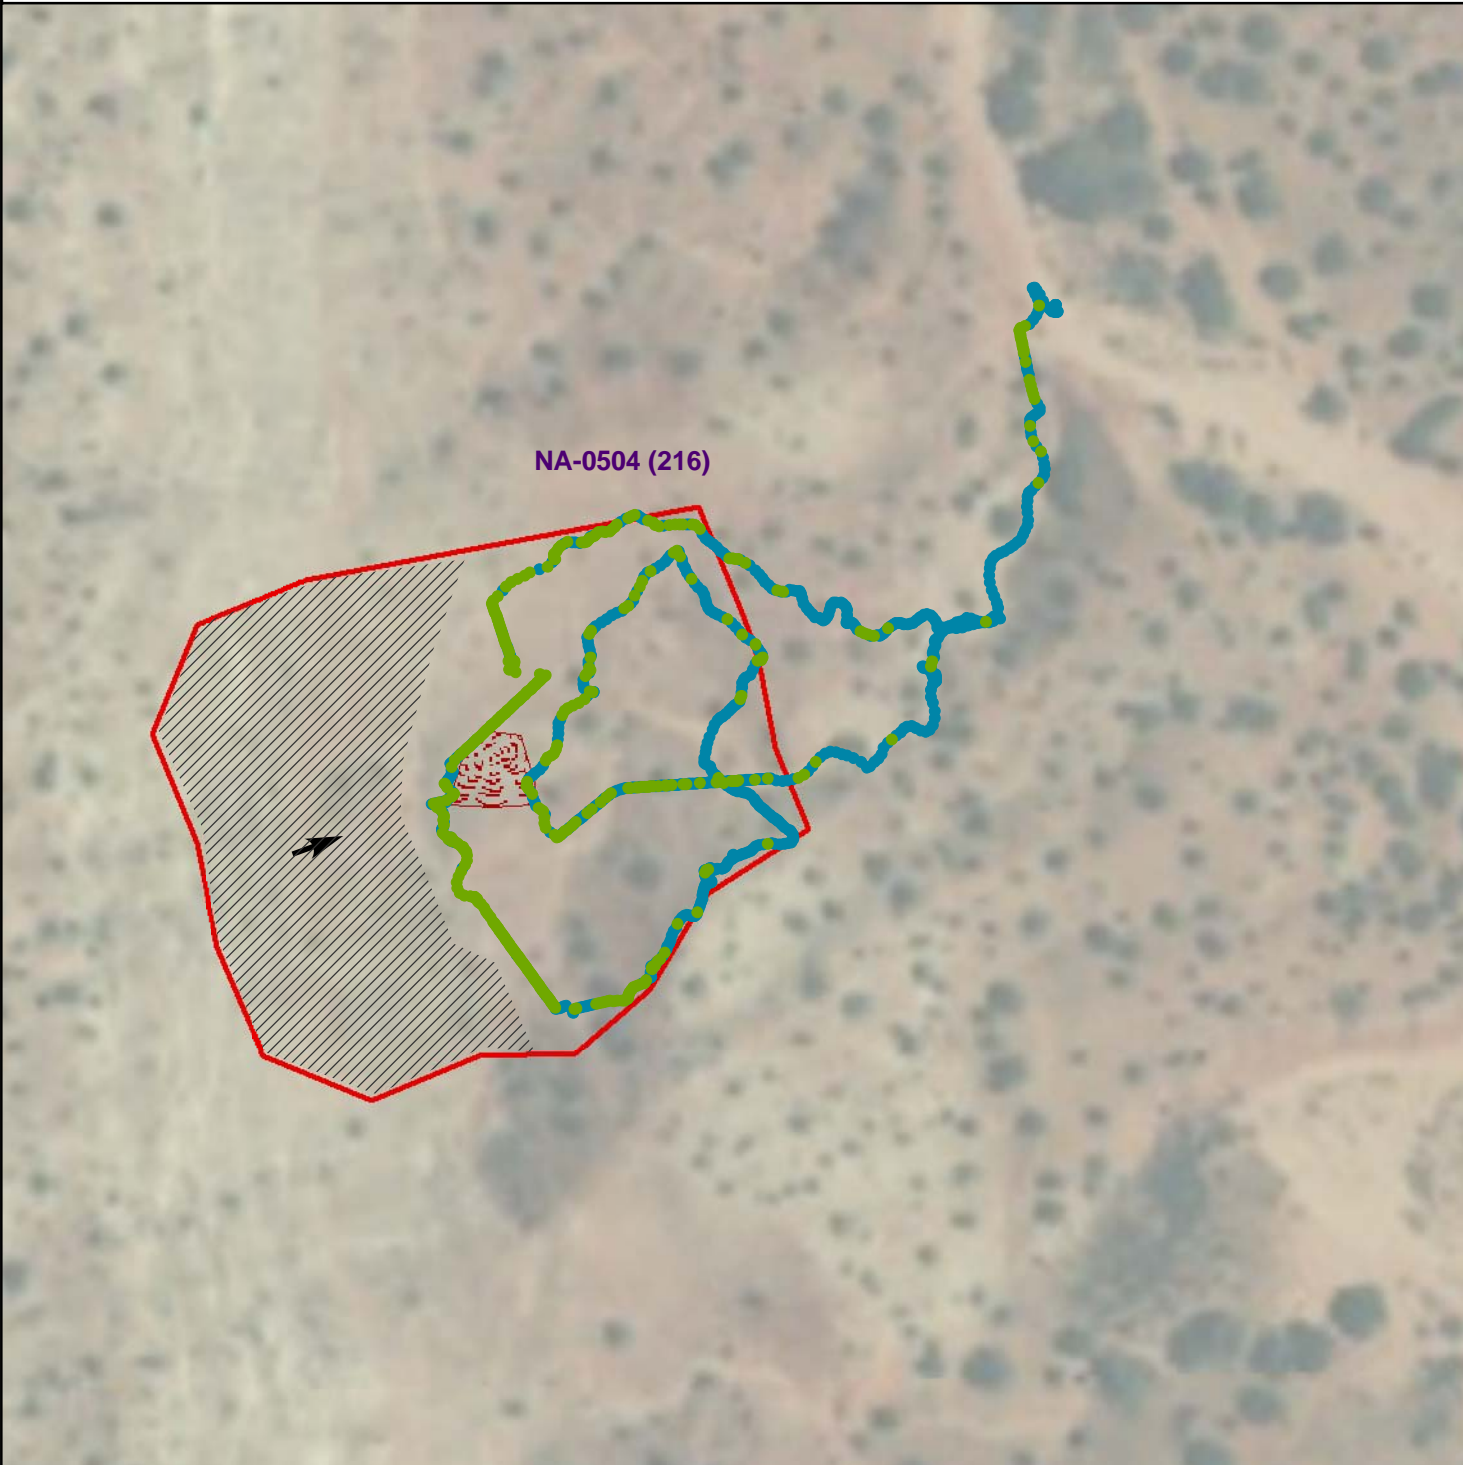
**Figure 2 - Gamma Radiation Measurements  
NA-0504 (216)  
Sweetwater Chapter, Navajo Nation**

**Gamma survey conducted 06/2010  
Measured as counts per minute (cpm)**

**Average background 7,491 cpm**
