Navajo Abandoned Uranium Mine

Site Screen Report

Mine Name: Binale 2

Mine ID: 222

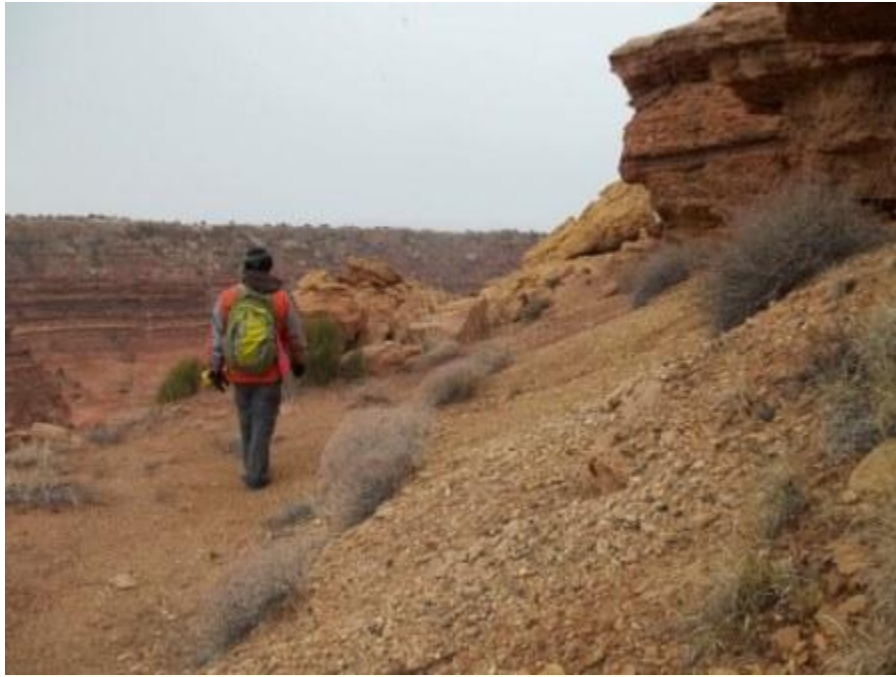
Photo 1

Waste rock along path leading into the site from the east, light grey, fine material

Mine Site #222 – Trail leading into the site

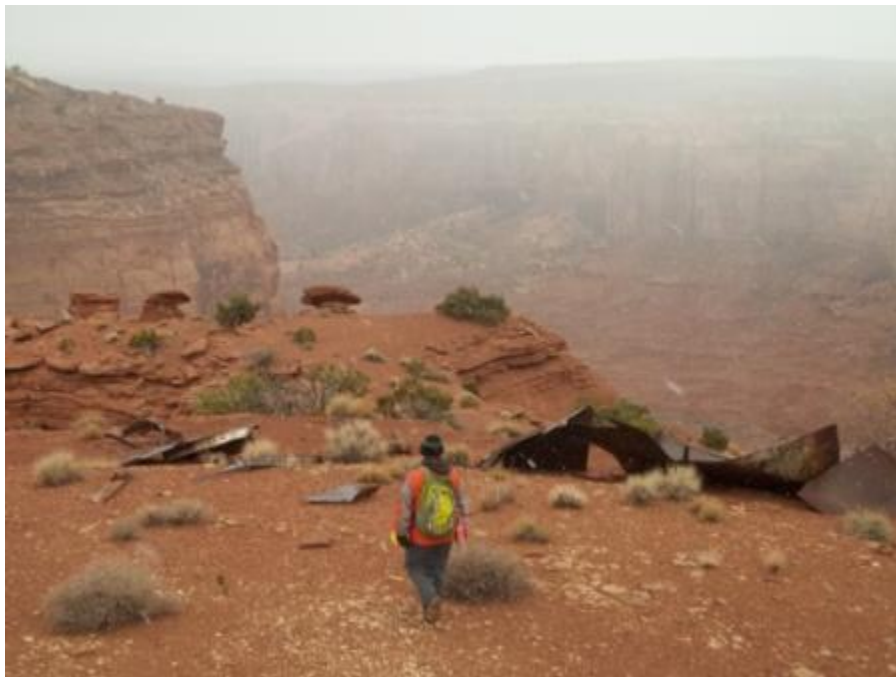
Photo 2

Test holes east of the site; metal debris southeast of the site

Mine Site #222 – Debris southeast of the site

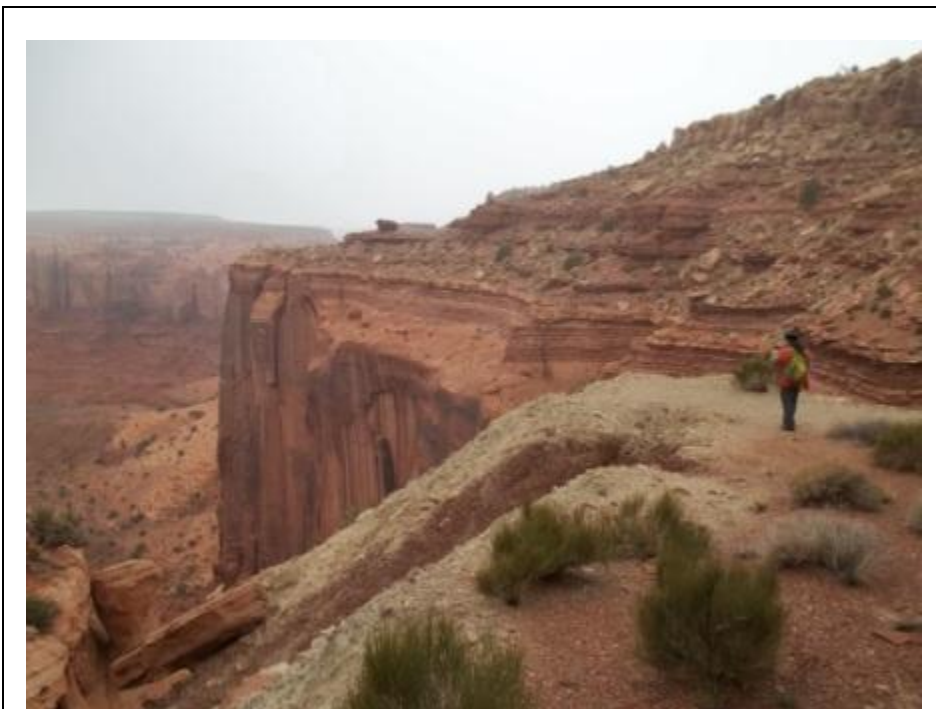
A total of 3,399 gamma radiation measurements were collected from the mine site, ranging from 4,219 cpm to 503,675 cpm. Maximum levels of approximately 500,000 cpm were found in the vicinity of the waste rock and 60,000 cpm were found at the entrance to the adits. The measurements are represented in Figures 1 and 2.

Photo 4	Mine Site #222 - Waste rock
----------------	-----------------------------

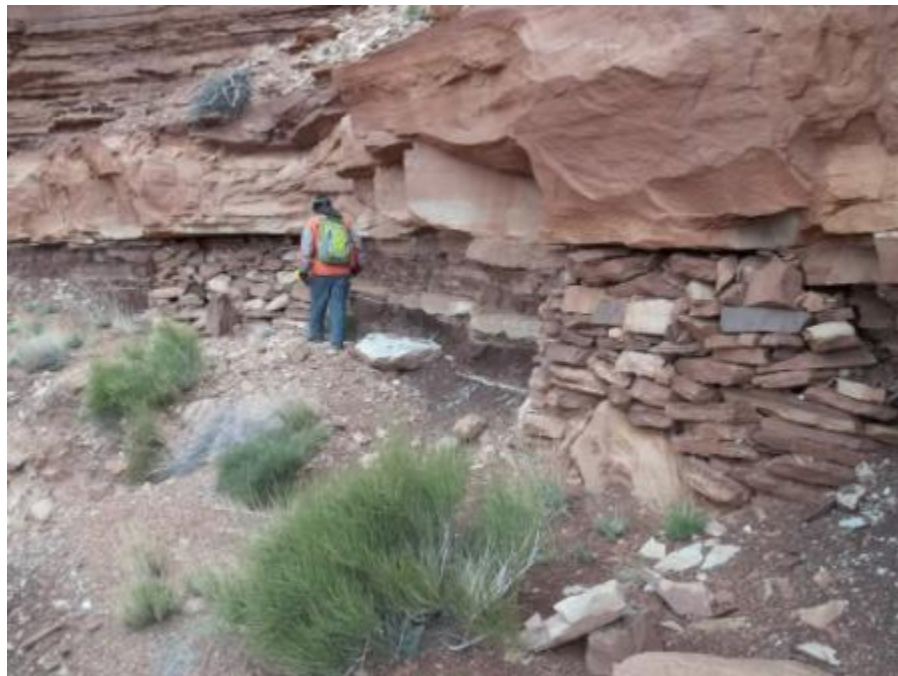
Photo 6

2 adits, both stone sealed, both approximately 5' x 10'

Mine Site #222 - Adits

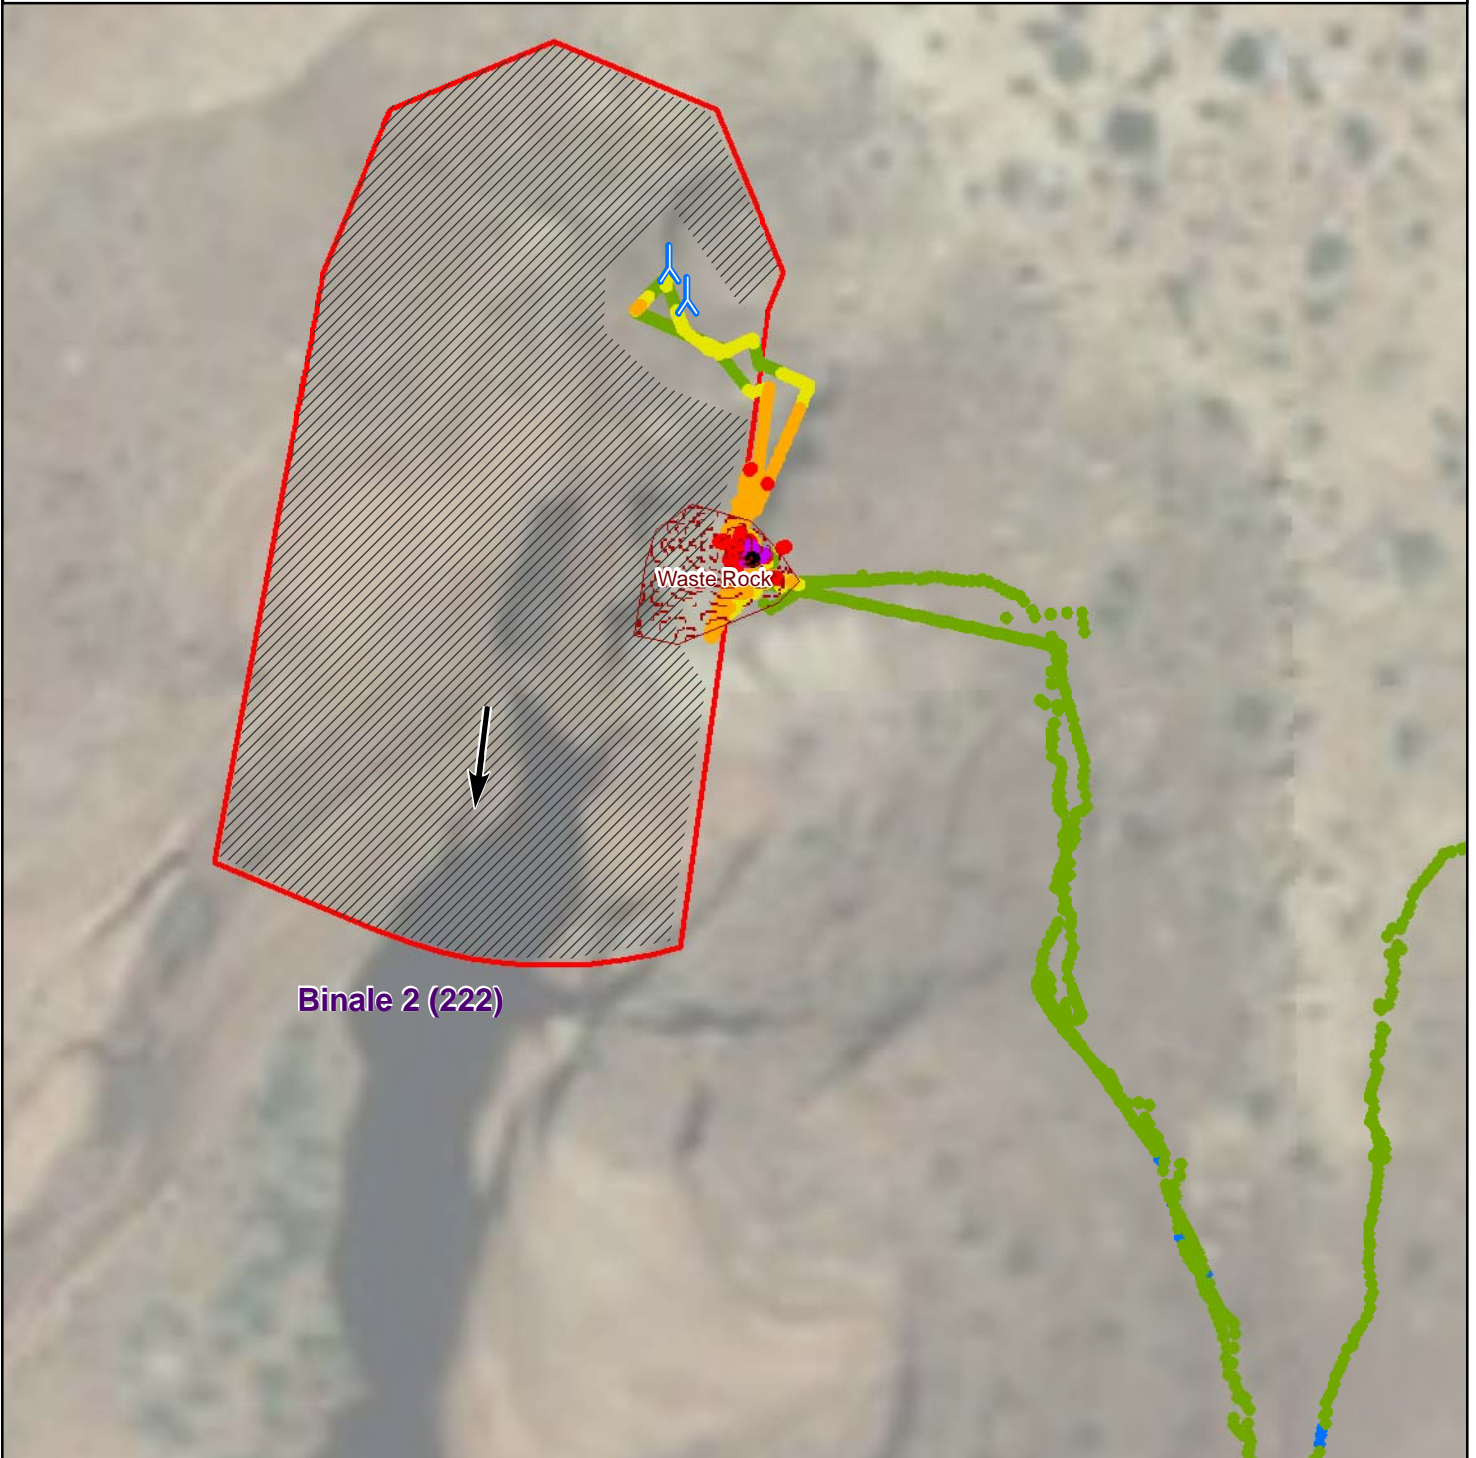
**Figure 2 - Gamma Radiation Measurements
Binale 1 (222)
Oljato Chapter, Navajo Nation**

Gamma Radiation Measurements

- 0 - 10,000 cpm
- 10,000 - 25,000 cpm
- 25,000 - 50,000 cpm
- 50,000 - 100,000 cpm
- 100,000 - 250,000 cpm
- 250,000 - 500,000 cpm
- 500,000 - 1,000,000 cpm

Average background 10,289 cpm
