Navajo Abandoned Uranium Mine

Site Screen Report

Amos Chee No. 8 AUM Site

Navajo AUM Western Region

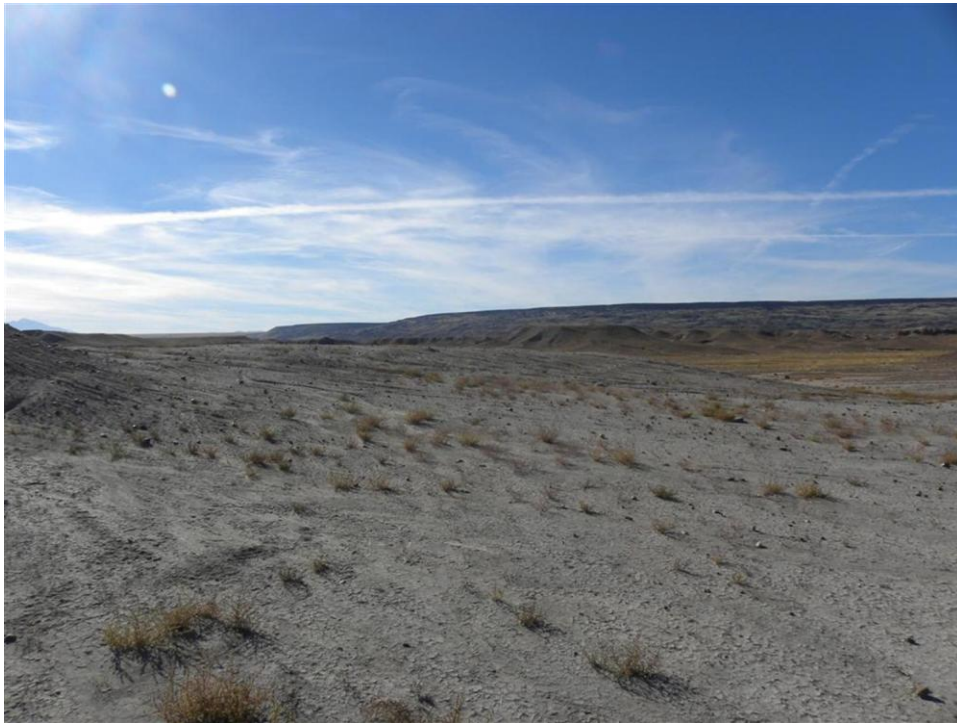
Photo 2. Amos Chee No. 8 mine site, reclamation cap

2 Reclamation caps: north cap 200' x 200'; south cap 200' x 50'
