Navajo Abandoned Uranium Mine

Site Screen Report

Charles Huskon No. 18 AUM Site

Navajo AUM Western Region

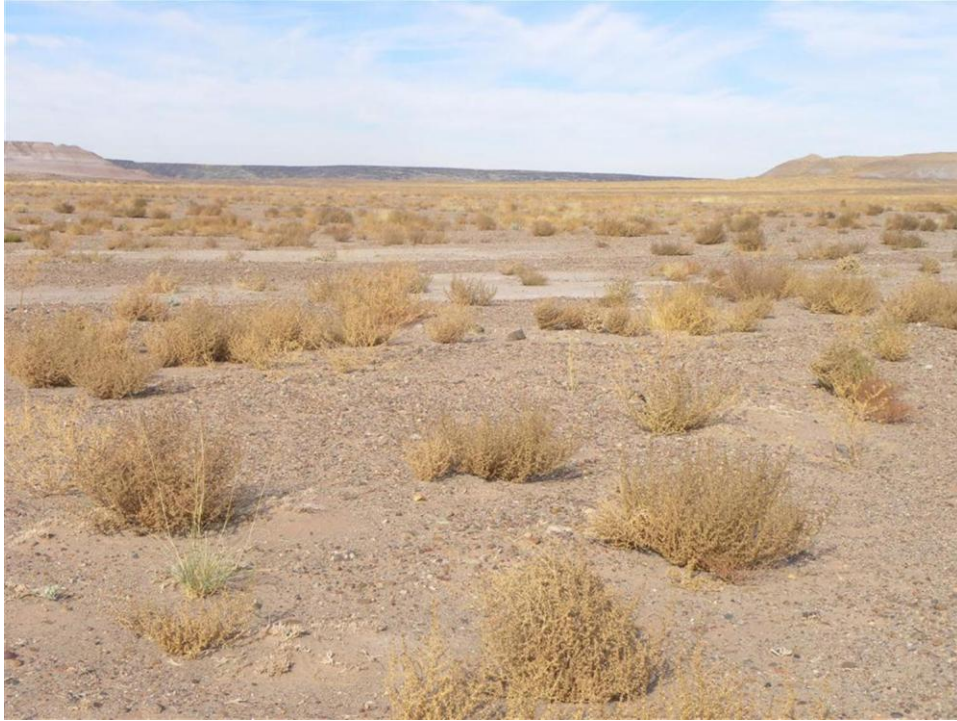
Photo 1. Charles Huskon No. 18 mine site

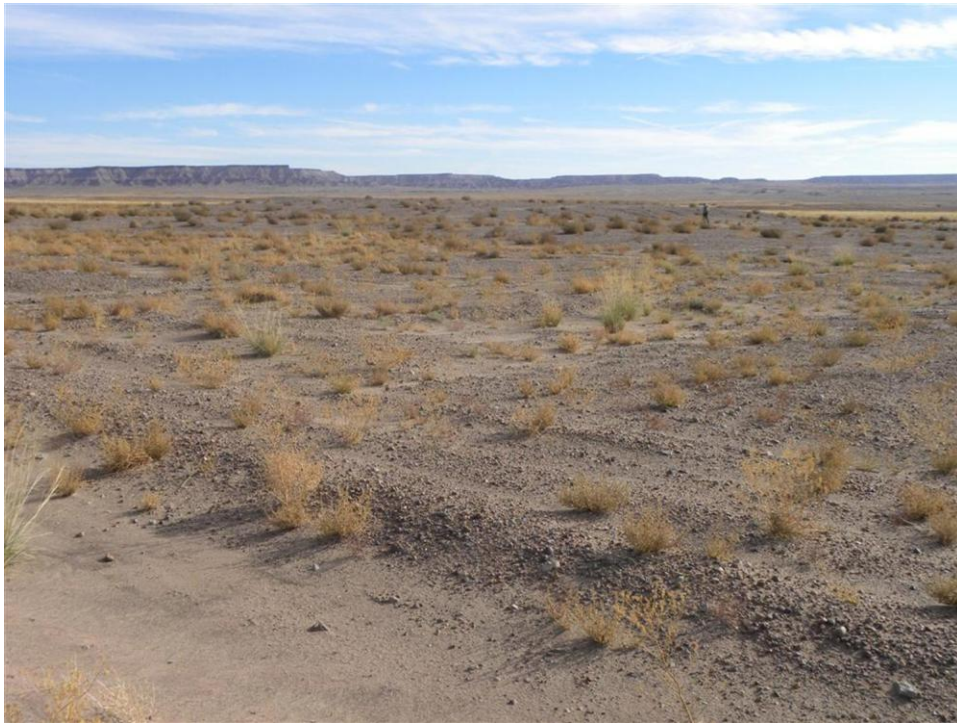
Reclamation cap in NE corner, 300' x 500', berms to west and north to divert drainage away from cap

Photo 2. Charles Huskon No. 18 mine site, reclamation cap

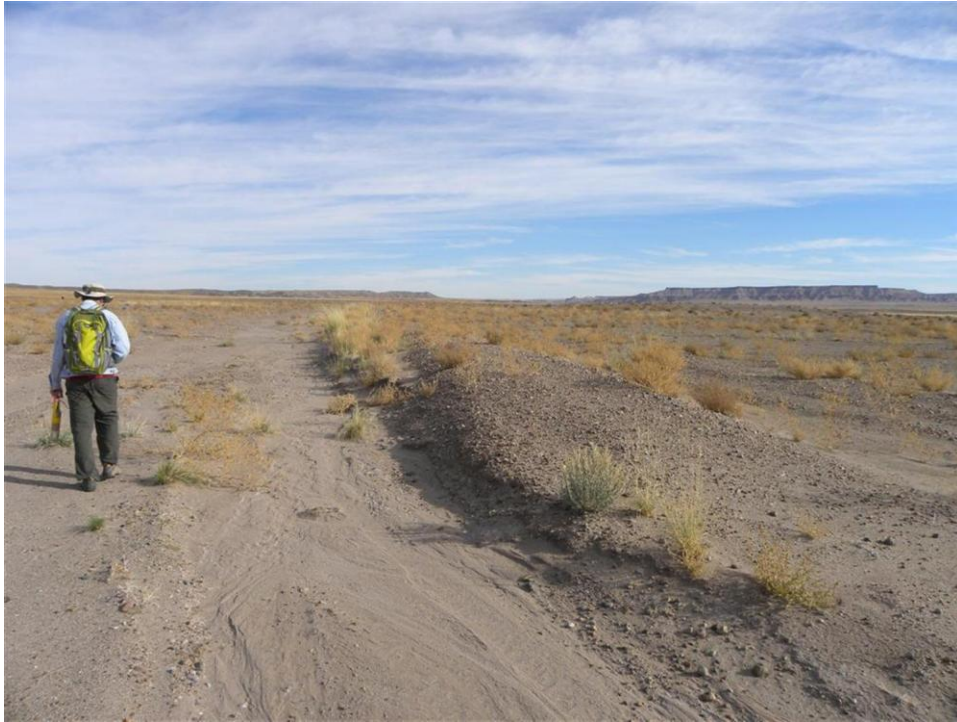
Photo 3. Charles Huskon No. 18 mine site, reclamation berm area
