# Navajo Abandoned Uranium Mine

## Site Screen Report

**Mine Name: Bluestone No. 1**  
**Mine ID: 237**

**April 2012**

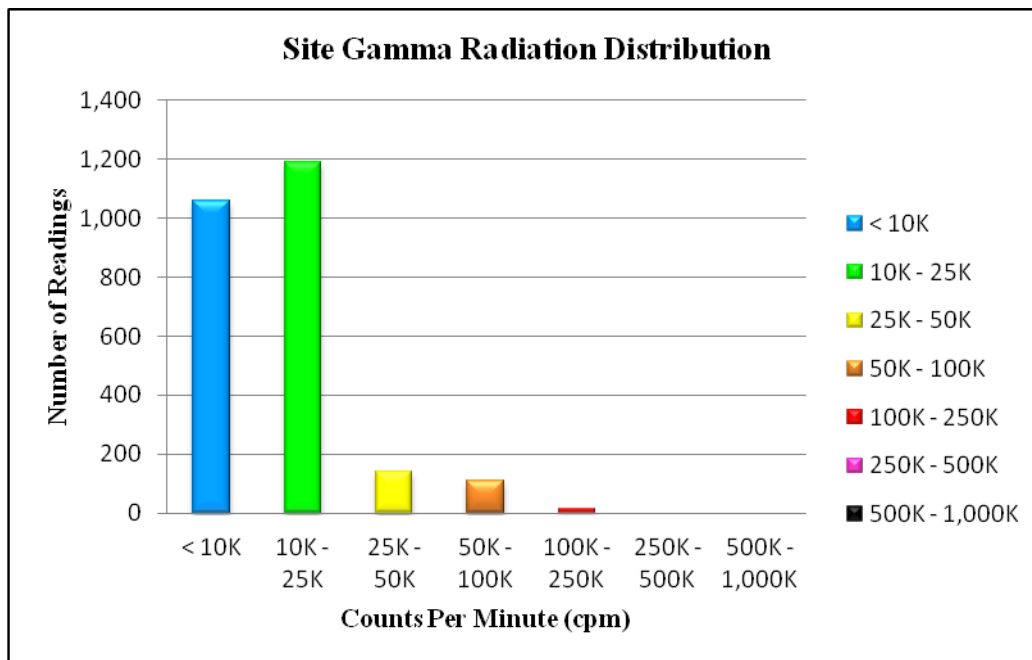
**Distribution Chart and Statistics:**

<b>Site Gamma Radiation Statistics</b>	
Number of Readings	2,511
Minimum (cpm)	6,545
Maximum (cpm)	136,627
Mean (cpm)	15,093
Median (cpm)	10,509
Standard Deviation	14,289

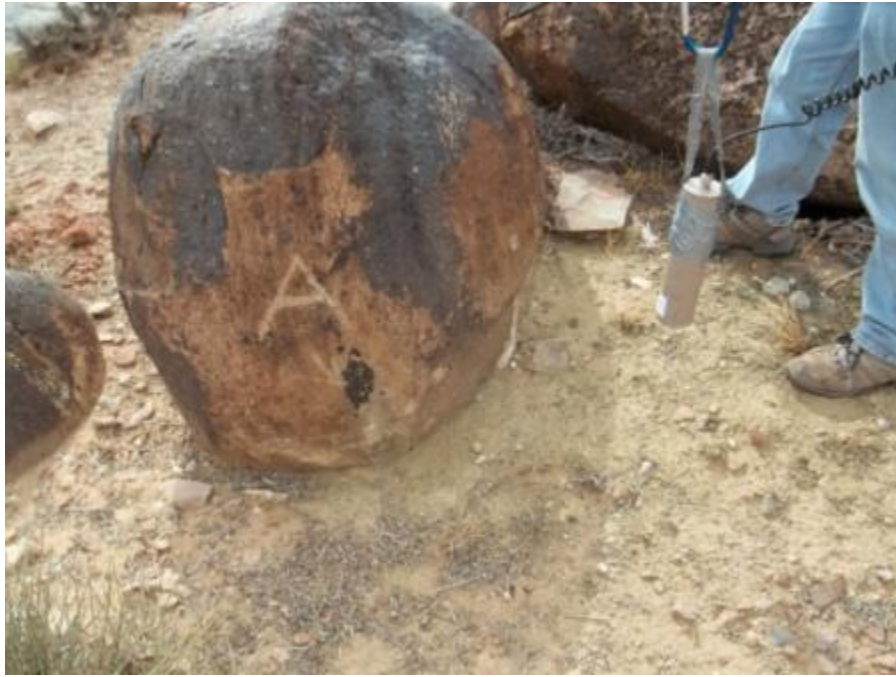
**Photo 1**

Mine Site #237 – Marked rock

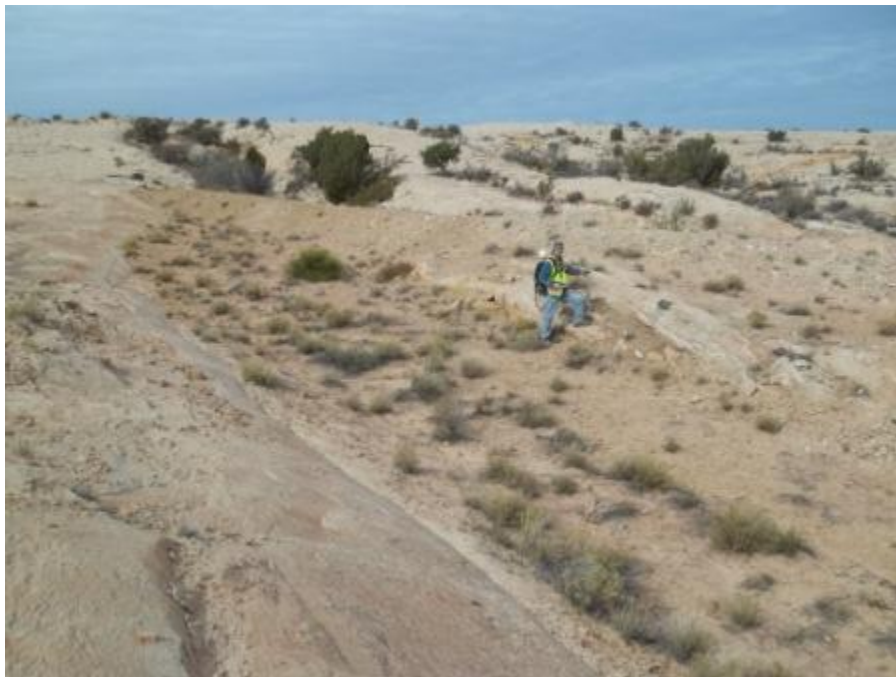
Reclamation berms northwest of the site boundary

Mine Site #237 – Berm area

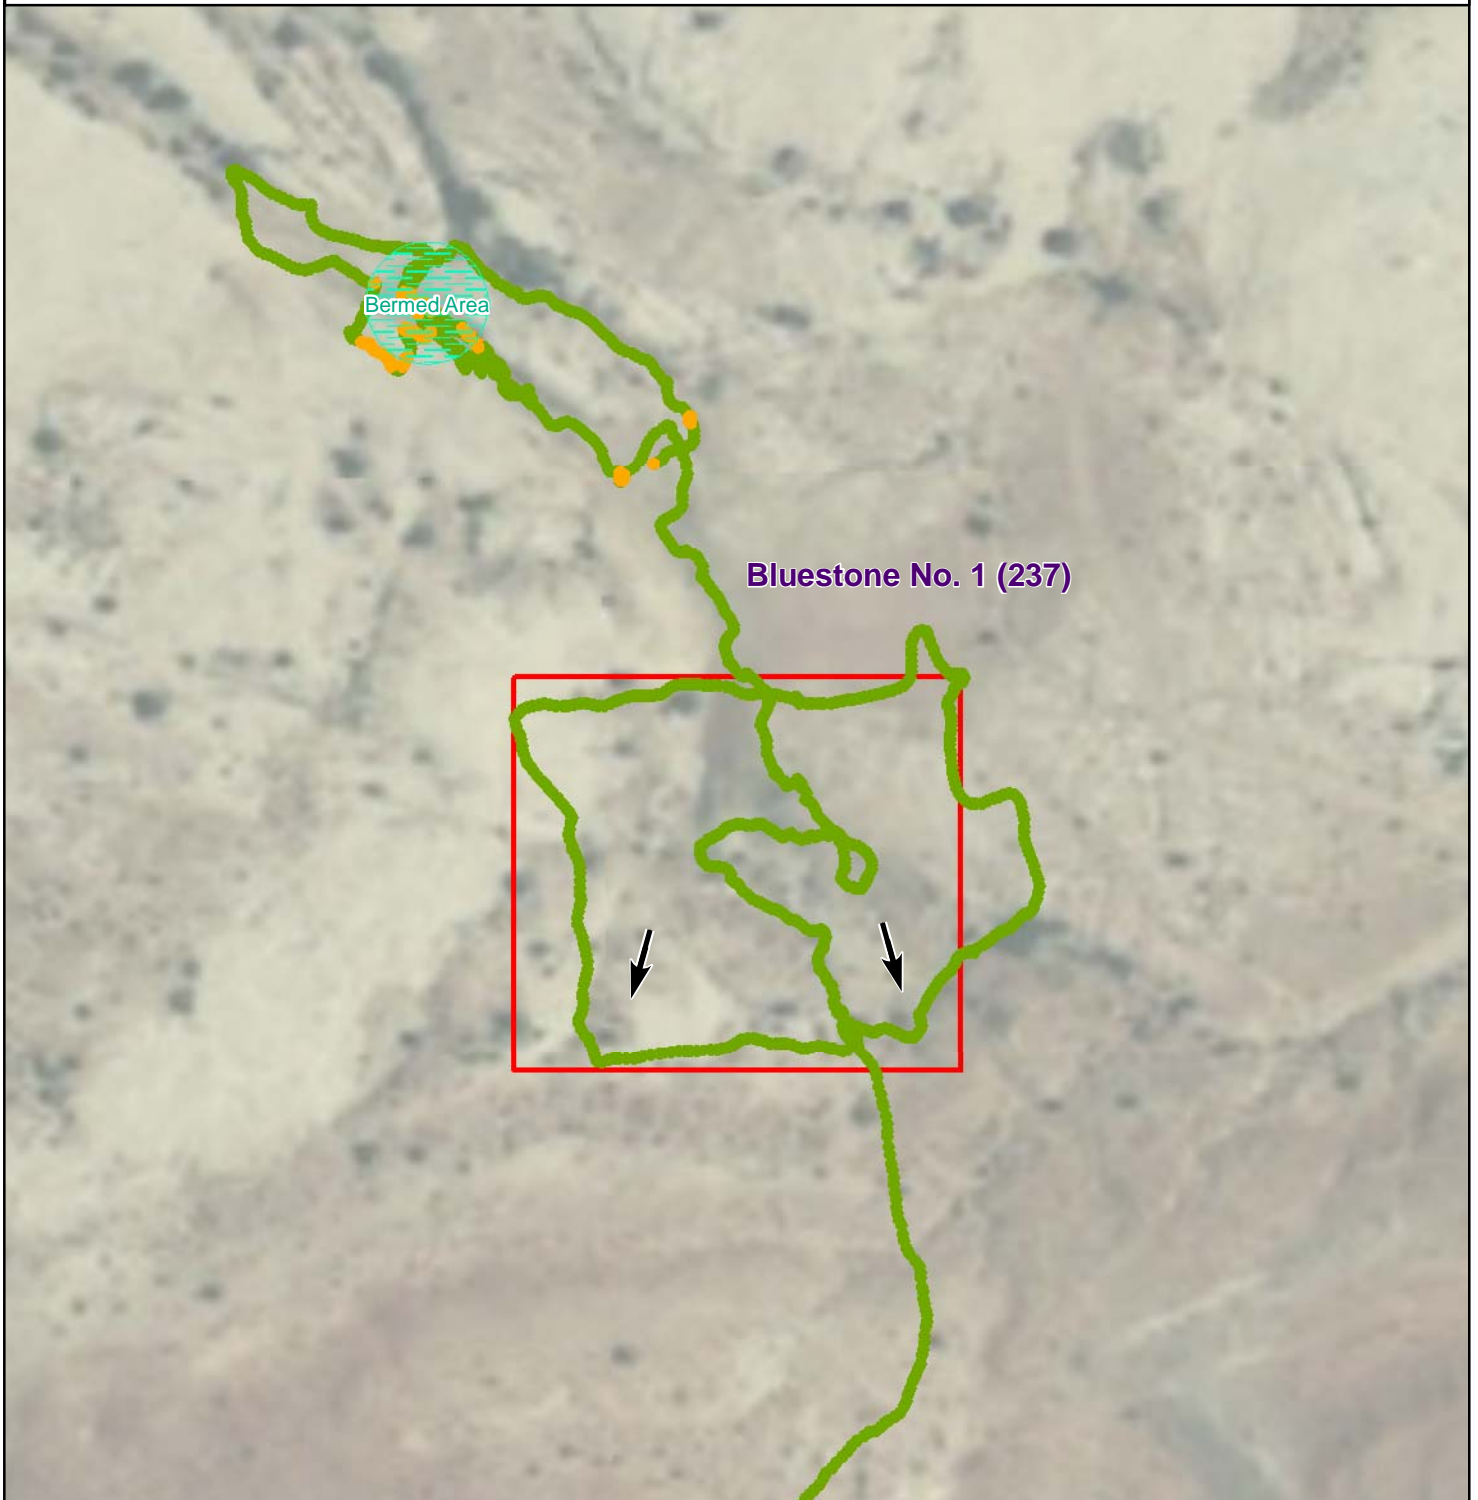
**Figure 1 - Gamma Radiation Measurements, Above Two Times Background  
Bluestone No. 1 (237)  
Dennehotso Chapter, Navajo Nation**

A total of 2,511 gamma radiation measurements were collected from the mine site, ranging from 6,545 cpm to 136,627 cpm. Maximum levels of approximately 75,000 cpm were found in the vicinity of the waste rock, 135,000 cpm were found in the bermed area, and 20,000 cpm near the covered adit. The measurements are represented in Figures 1 and 2.

Average background 8,787 cpm

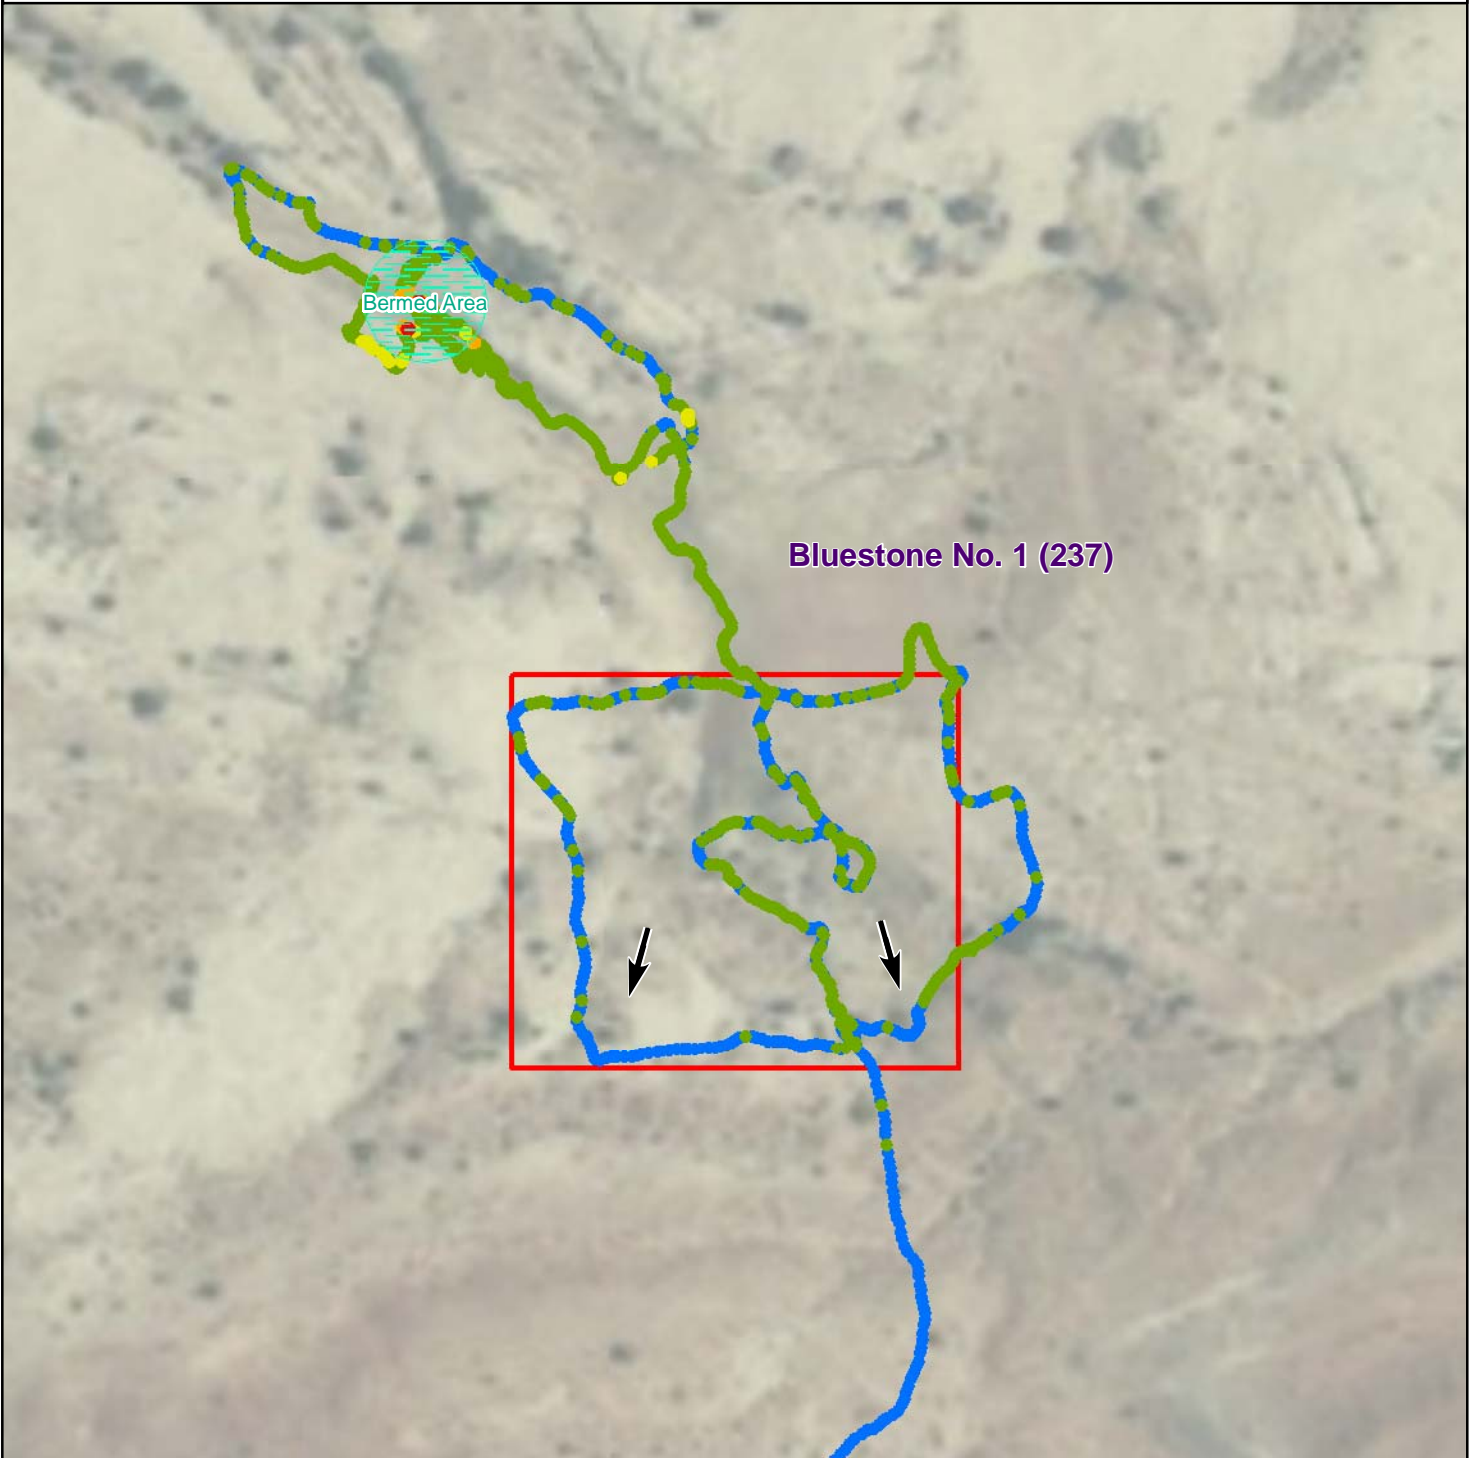
**Figure 2 - Gamma Radiation Measurements  
Bluestone No. 1 (237)  
Dennehotso Chapter, Navajo Nation**

**Average background 8,787 cpm**
