Navajo Abandoned Uranium Mine

Site Screen Report

Mine Name: Monument No. 2

April 2012

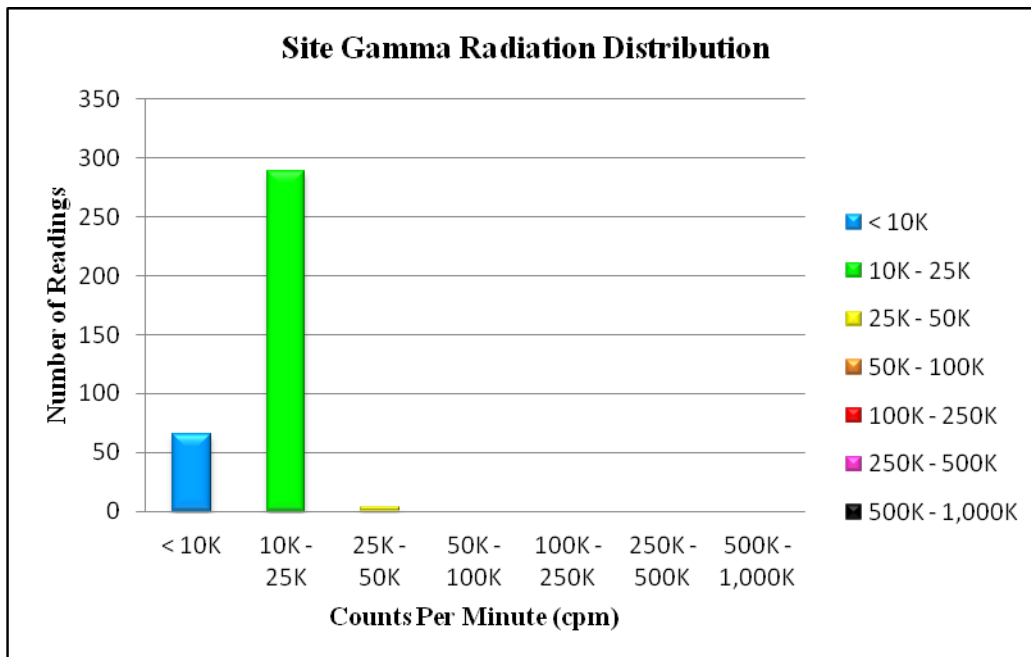
Distribution Chart and Statistics:

A total of 357 gamma radiation measurements were collected from the mine site, ranging from 8,055 cpm to 28,307 cpm. The measurements are represented in Figures 1, 2, 3 and 4.

Site Gamma Radiation Statistics	
Number of Readings	357
Minimum (cpm)	8,055
Maximum (cpm)	28,307
Mean (cpm)	14,251
Median (cpm)	13,611
Standard Deviation	4,092

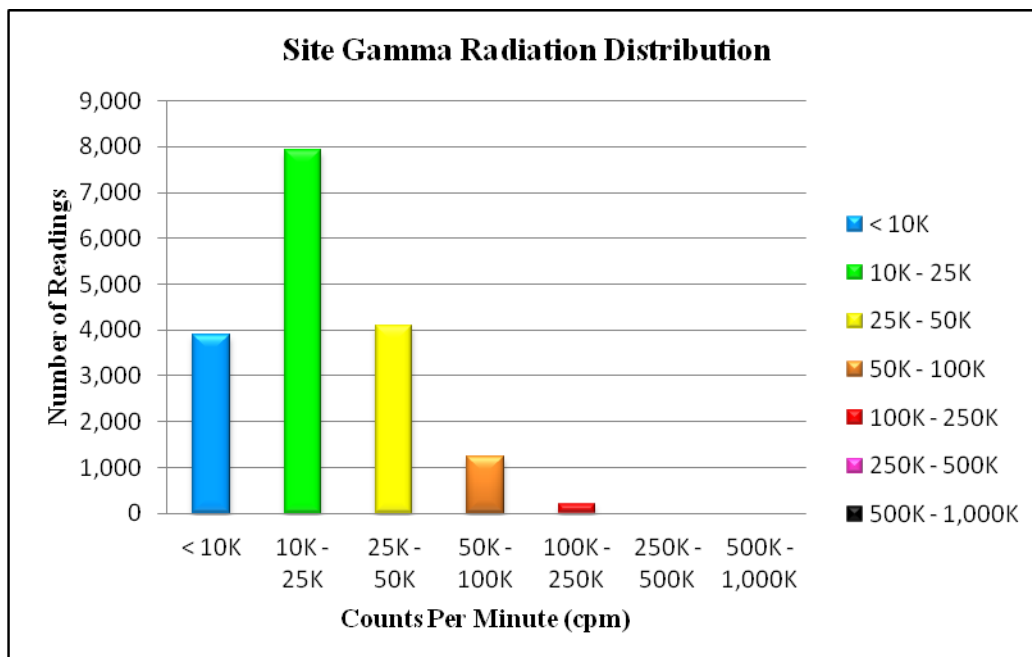
Distribution Chart and Statistics:

A total of 17,777 gamma radiation measurements were collected from the mine site, ranging from 4,158 cpm to 240,322 cpm. Maximum levels of approximately 240,000 cpm were found in the road area. The measurements are represented in Figures 1, 2, 3, 4, 5, and 6.

Site Gamma Radiation Statistics	
Number of Readings	17,777
Minimum (cpm)	4,158
Maximum (cpm)	240,322
Mean (cpm)	23,405
Median (cpm)	17,786
Standard Deviation	20,554

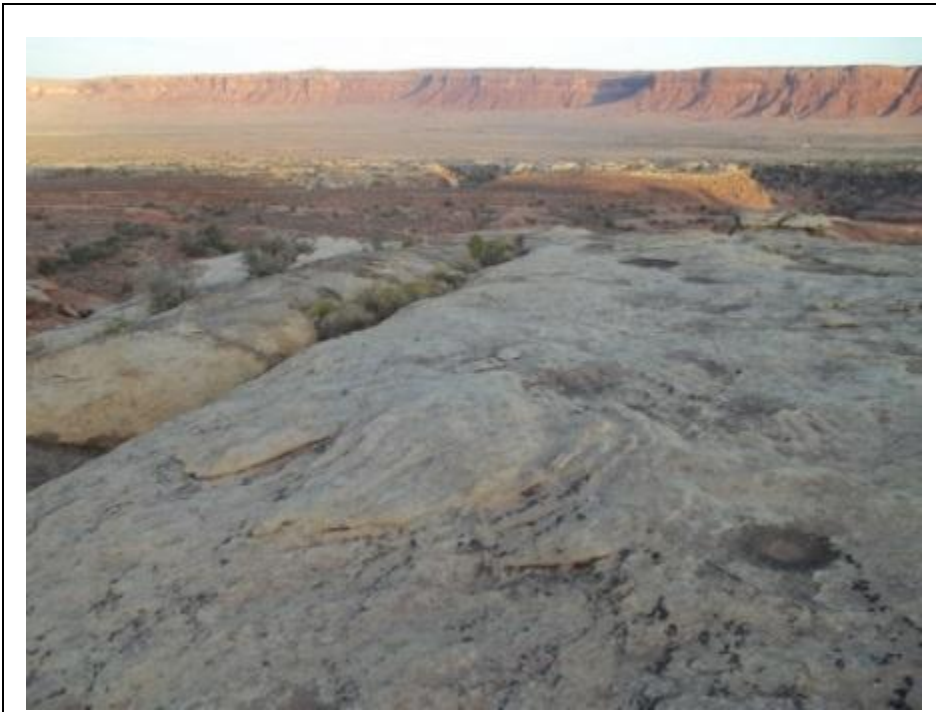
Photo 1	Mine Site #241
----------------	----------------

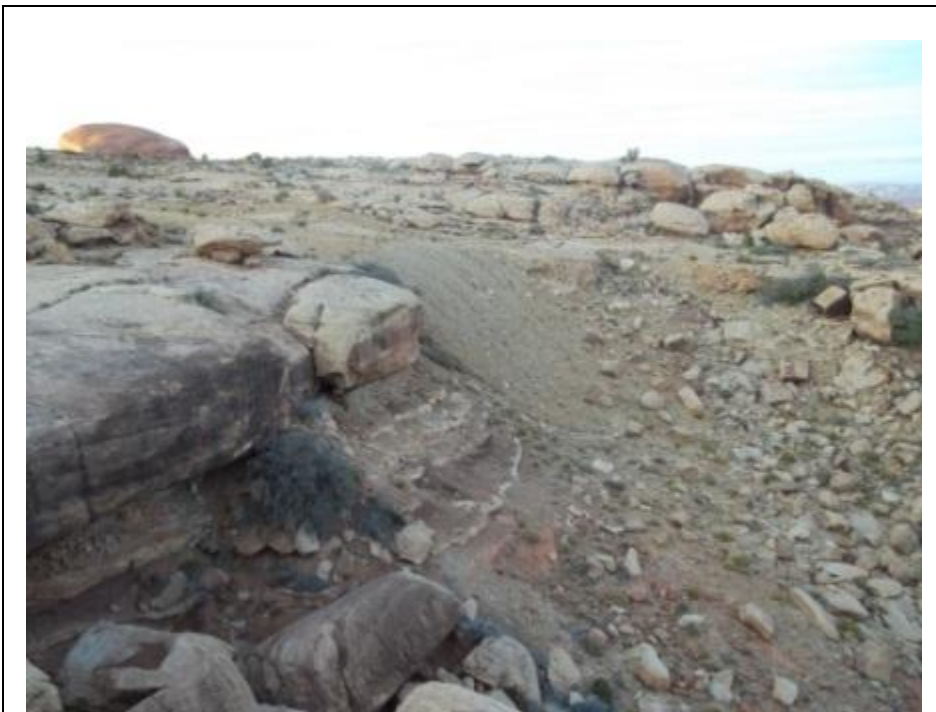
Photo 2	Mine Site #241 – Offsite tailings
----------------	-----------------------------------

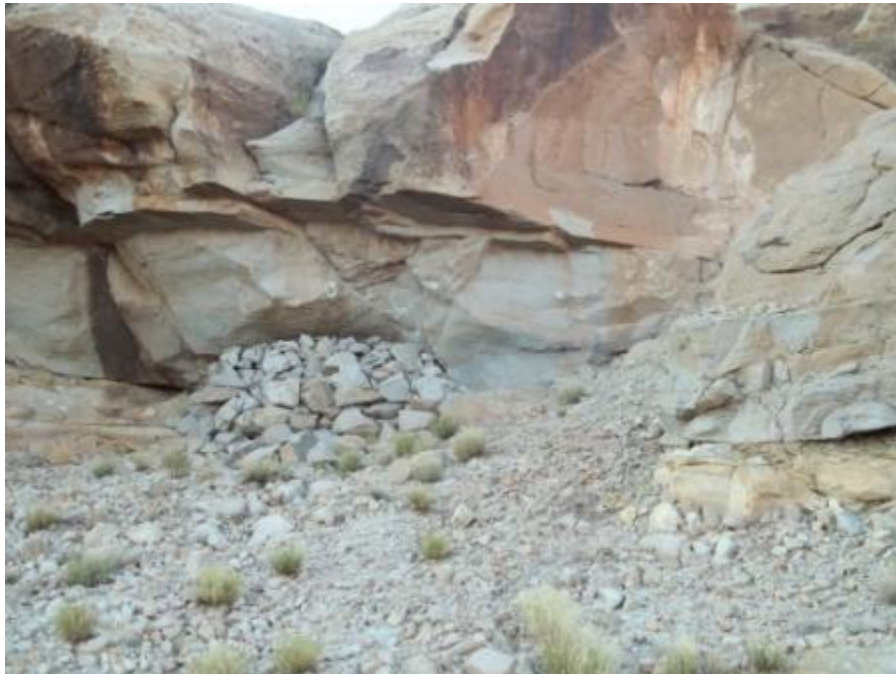
Photo 10

5 adits, all sealed and capped

Mine Site #521 - Adit

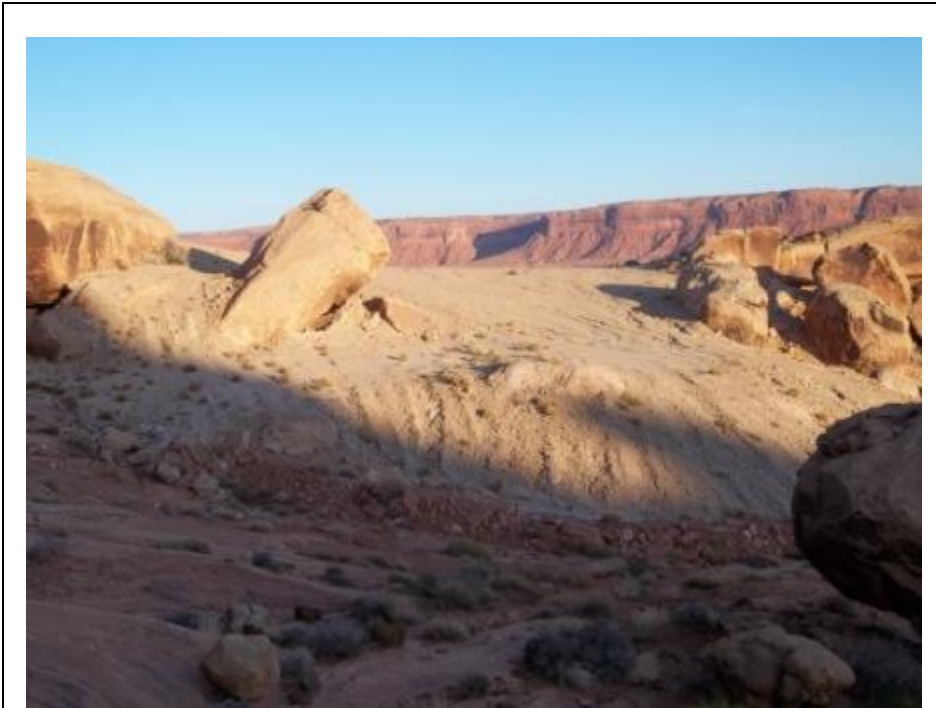
Photo 13

All mine features from topo have been capped including adit and open pits; elevated readings along road; berms have been constructed in at least three locations to limit runoff and overflow; structures have been constructed in the southern wash to capture

Mine Site #521 – Bermed area

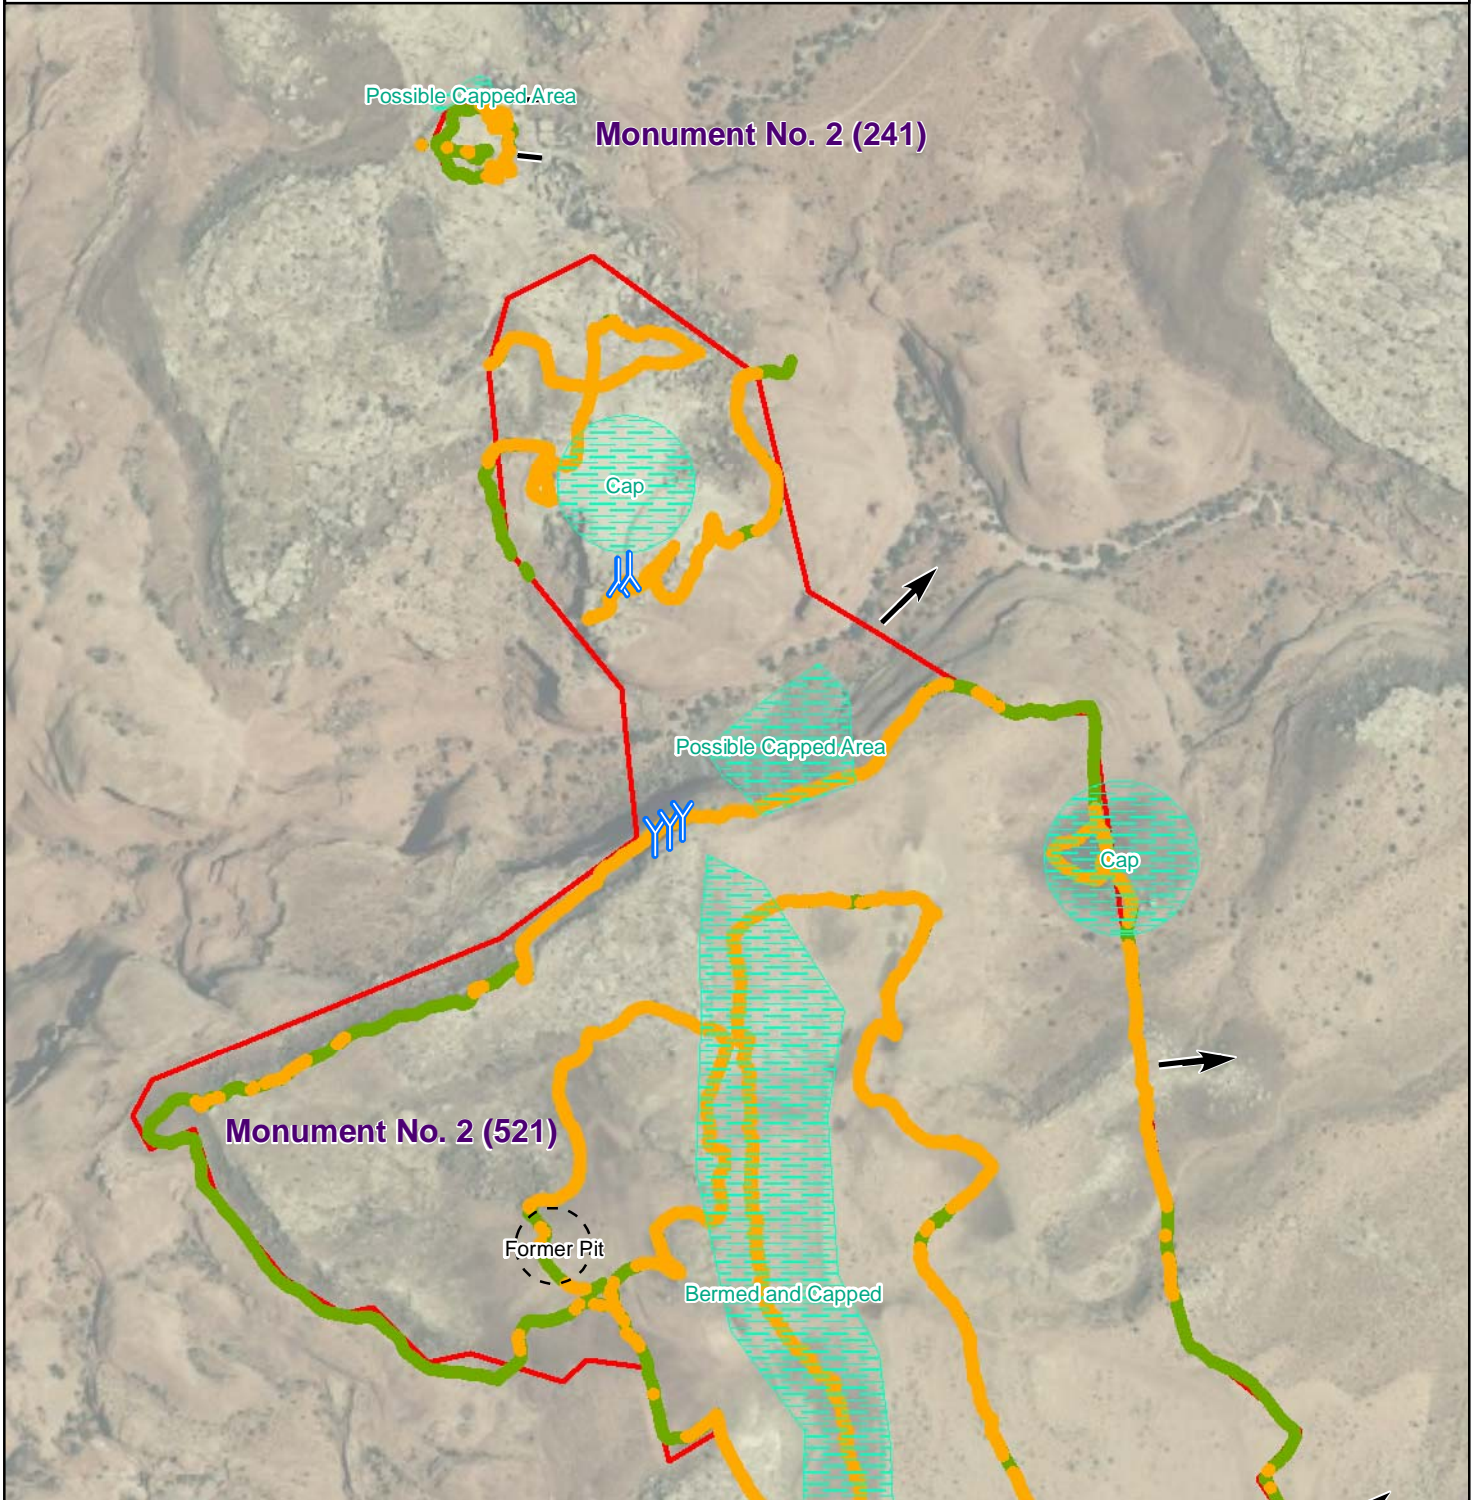
**Figure 3 - Gamma Radiation Measurements, Above Two Times Background
Monument No. 2 (241, 521)
Kayenta Chapter, Navajo Nation**

- < 2X Background
- > 2X Background

Average background 7,393 cpm

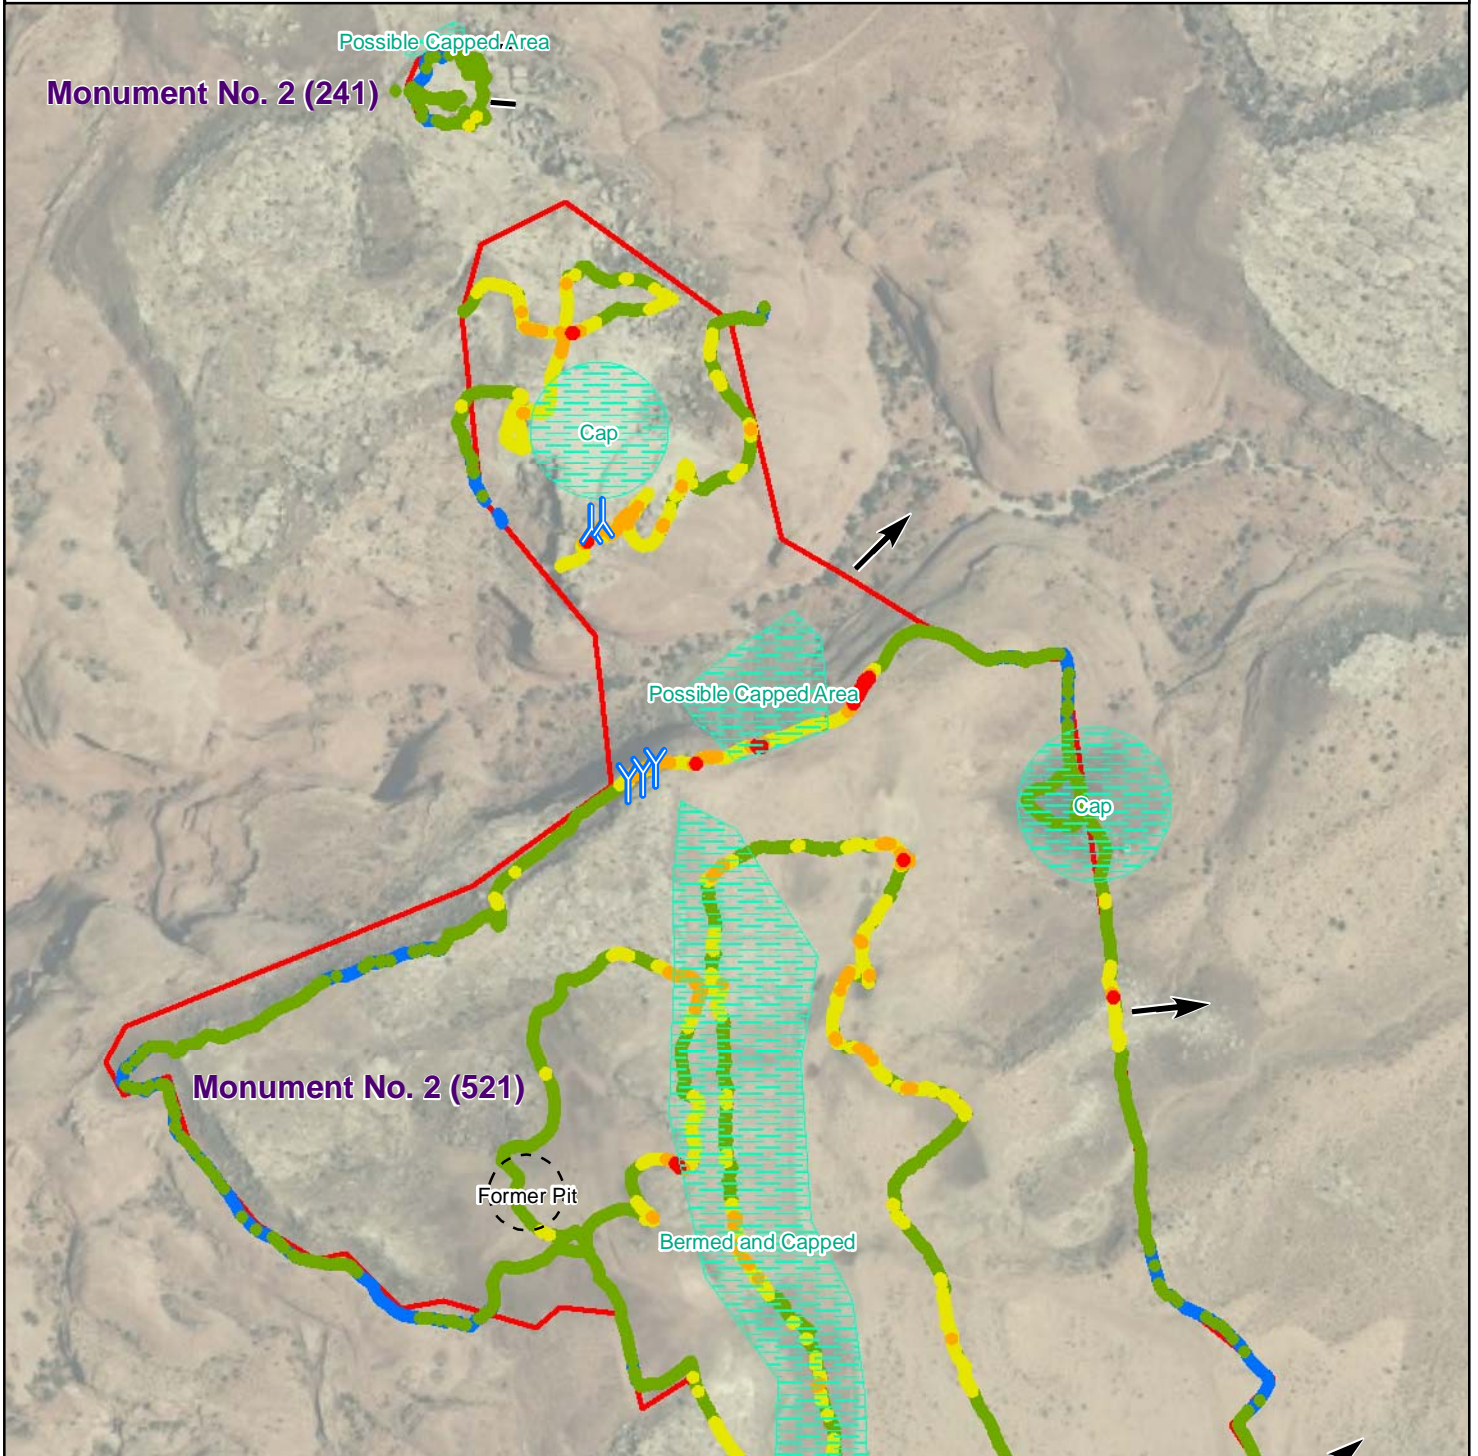
**Figure 4 - Gamma Radiation Measurements
Monument No. 2 (241, 521)
Kayenta Chapter, Navajo Nation**

- 0 - 10,000 cpm
- 10,000 - 25,000 cpm
- 25,000 - 50,000 cpm
- 50,000 - 100,000 cpm
- 100,000 - 250,000 cpm
- 250,000 - 500,000 cpm
- 500,000 - 1,000,000 cpm

Average background 7,393 cpm Measured as counts per minute (cpm)
