Navajo Abandoned Uranium Mine

Site Screen Report

Mine Name: Alma-Seegan
Mine ID: 248

Weston Solutions, Inc.

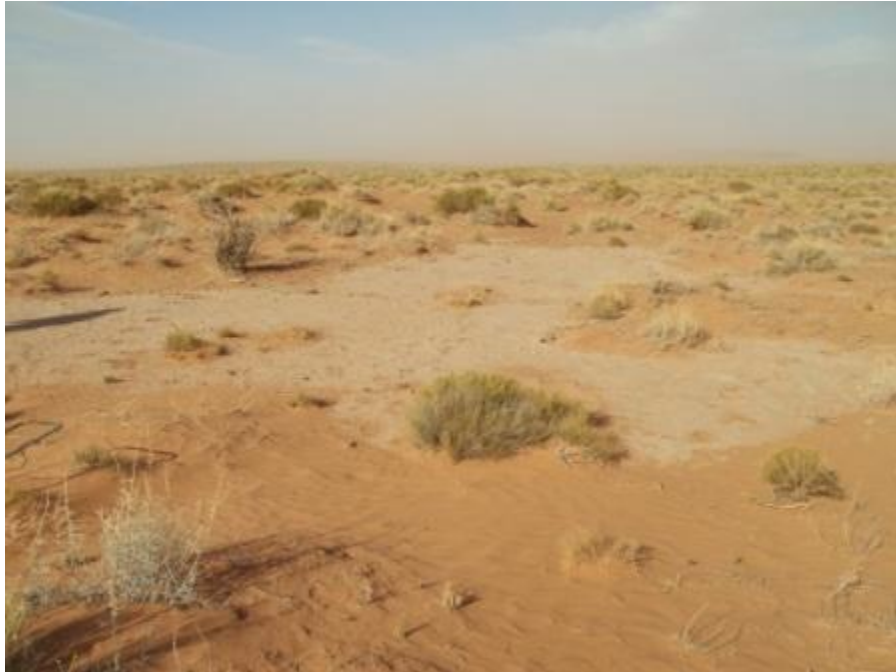
Photo 3

Mine Site #248 - Elevated gamma readings

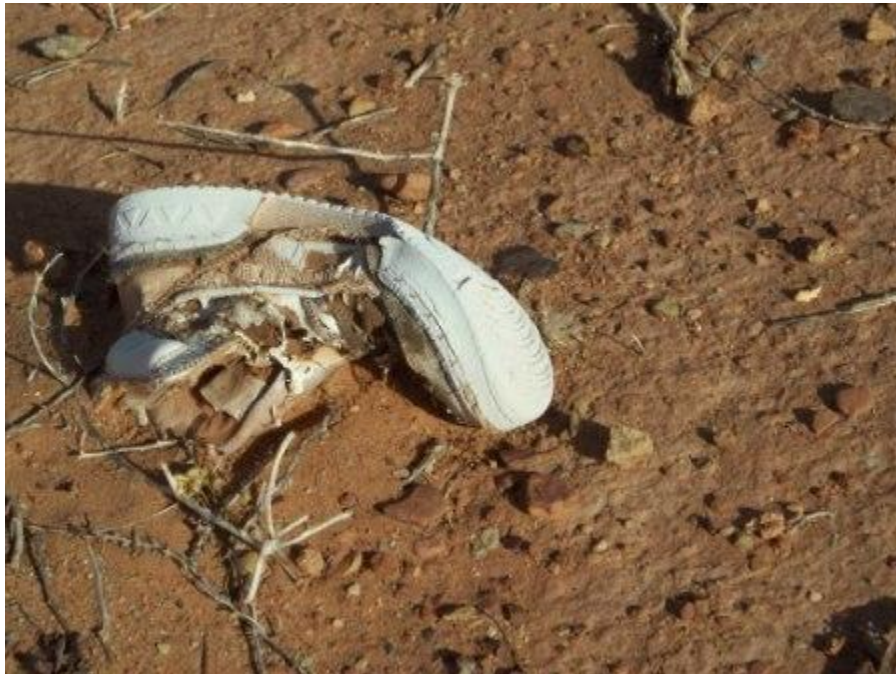
Photo 6

Mine Site #248 – Evidence of human activity

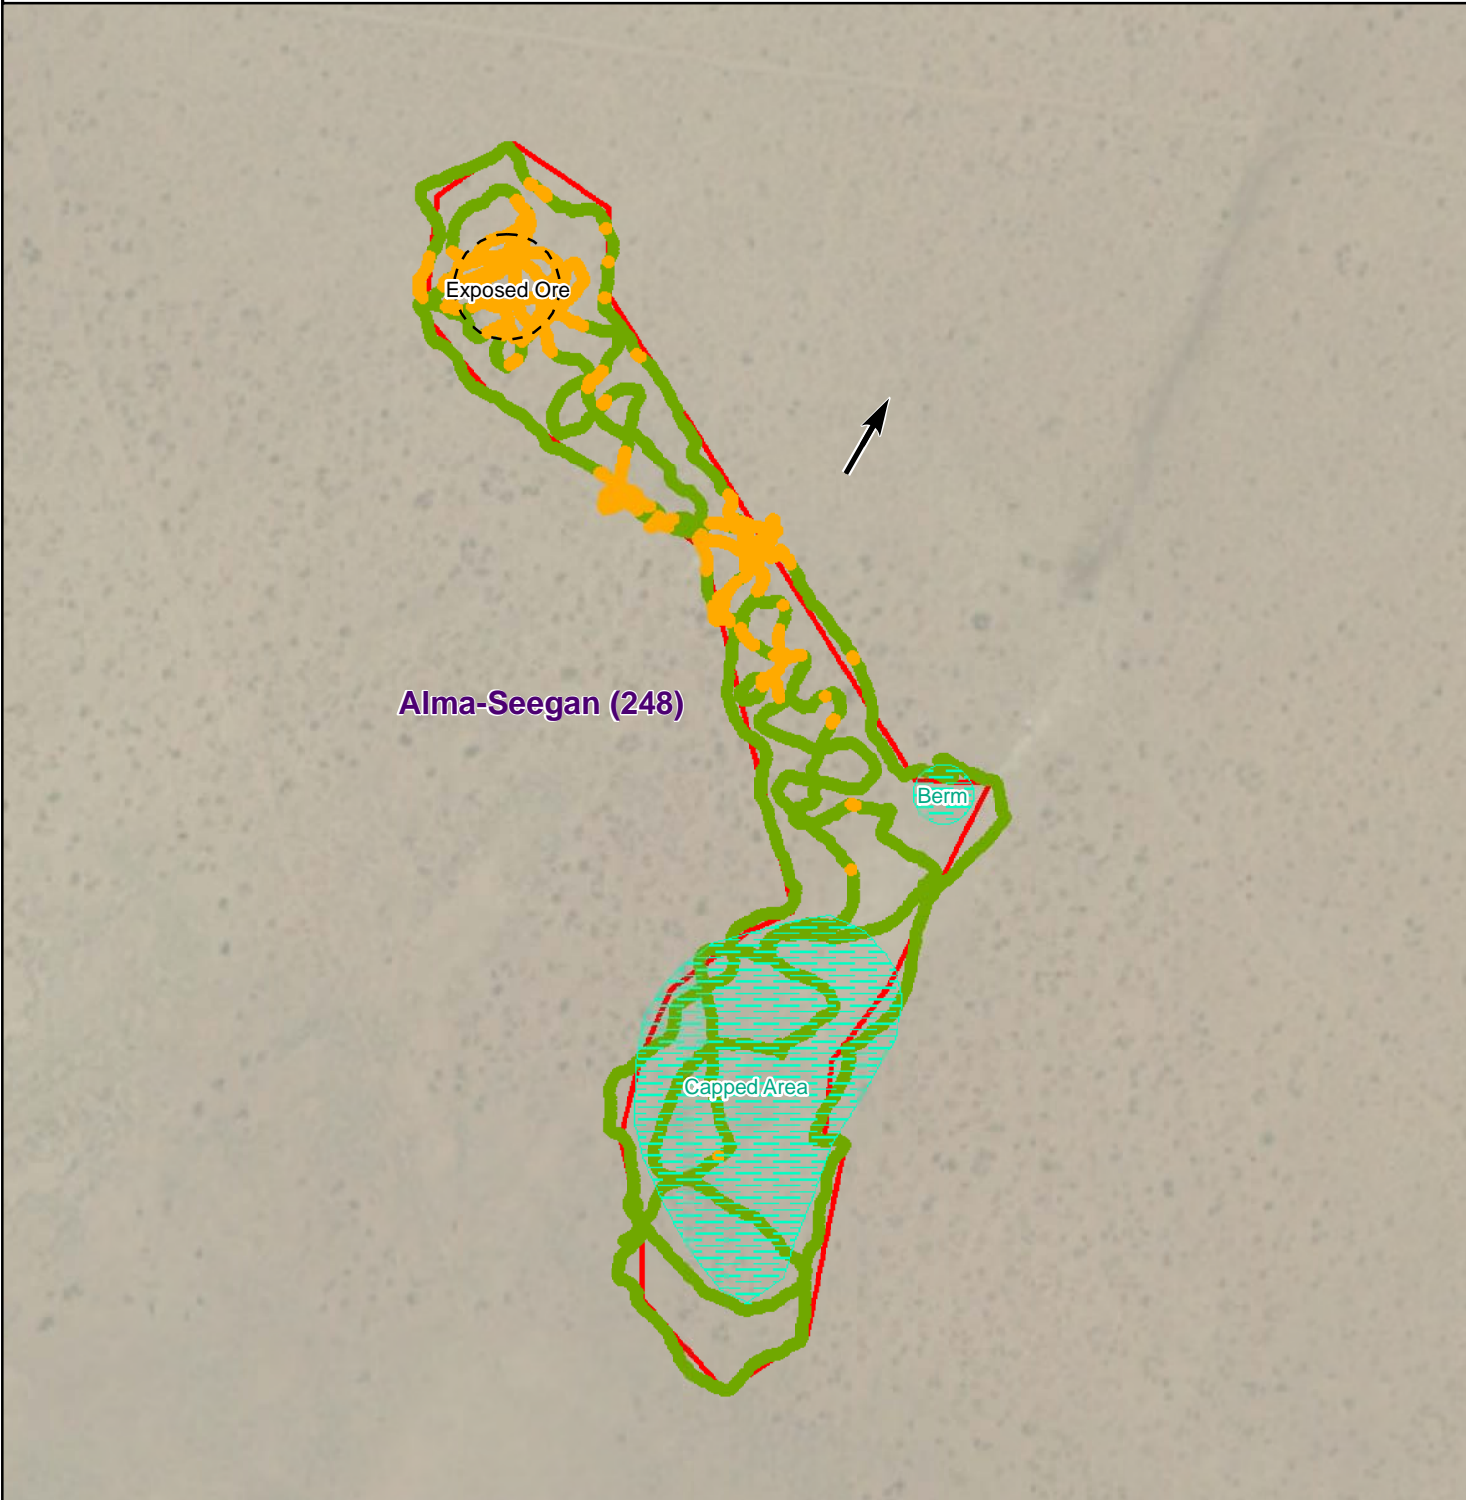
**Figure 1 - Gamma Radiation Measurements, Above Two Times Background
Alma-Seegan (248)
Oljato Chapter, Navajo Nation**

A total of 3,722 gamma radiation measurements were collected from the mine site, ranging from 5,800 cpm to 496,795 cpm. Maximum levels of approximately 500,000 cpm were found in the eroded areas. The measurements are represented in Figures 1 and 2.

Measured as counts per minute (cpm)

Average background 8,025 cpm
