# Navajo Abandoned Uranium Mine

## Site Screen Report

**Mine Name: Bootjack**  
**Mine ID: 252**

**April 2012**

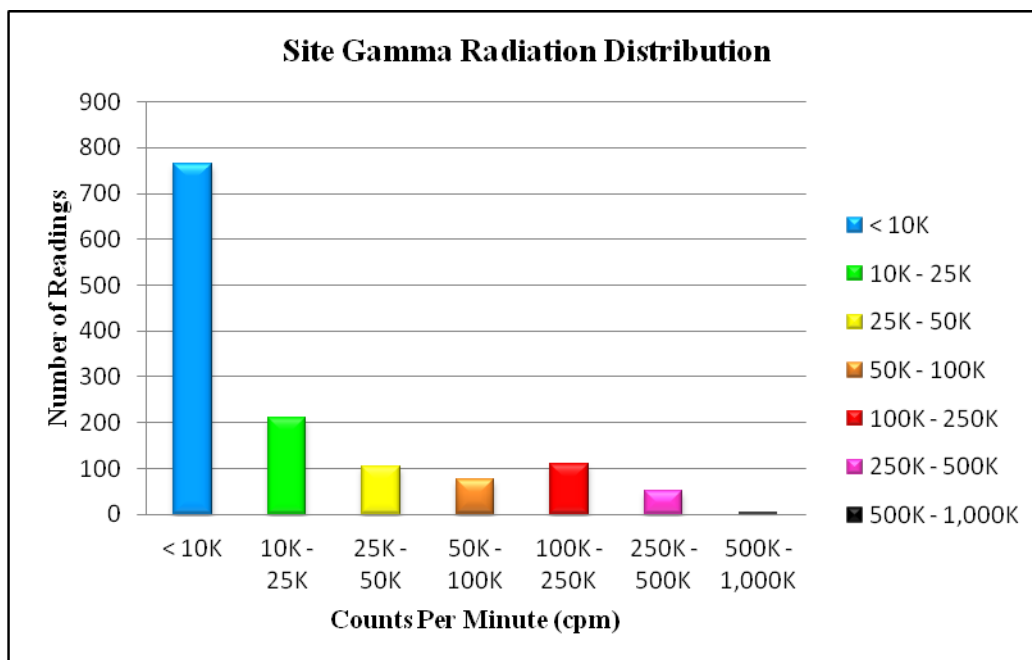
**Distribution Chart and Statistics:**

<b>Site Gamma Radiation Statistics</b>	
Number of Readings	1,333
Minimum (cpm)	4,765
Maximum (cpm)	630,159
Mean (cpm)	43,566
Median (cpm)	9,289
Standard Deviation	83,835

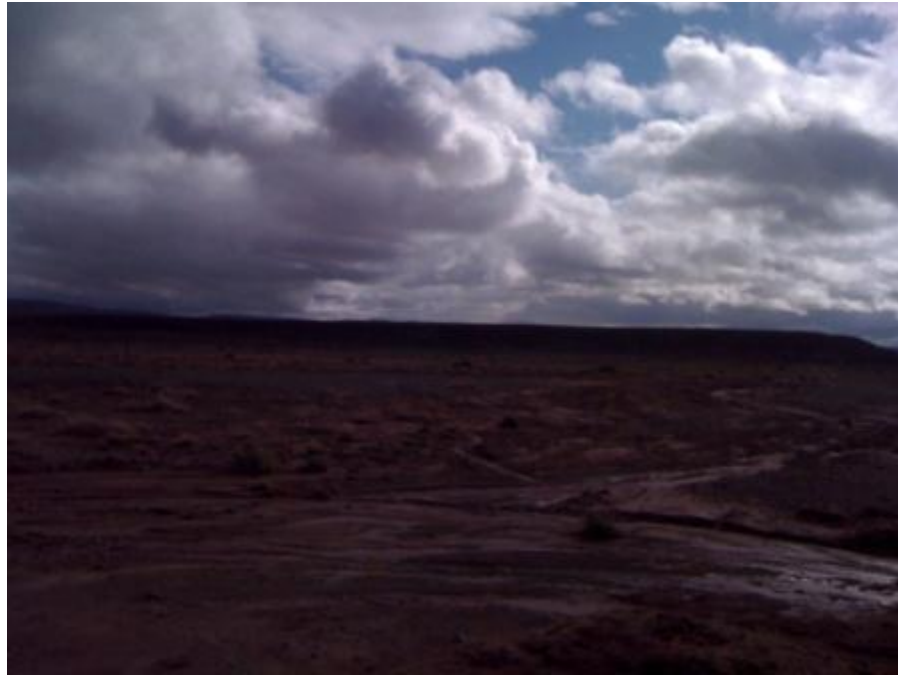
**Photo 1**

Mine Site #252

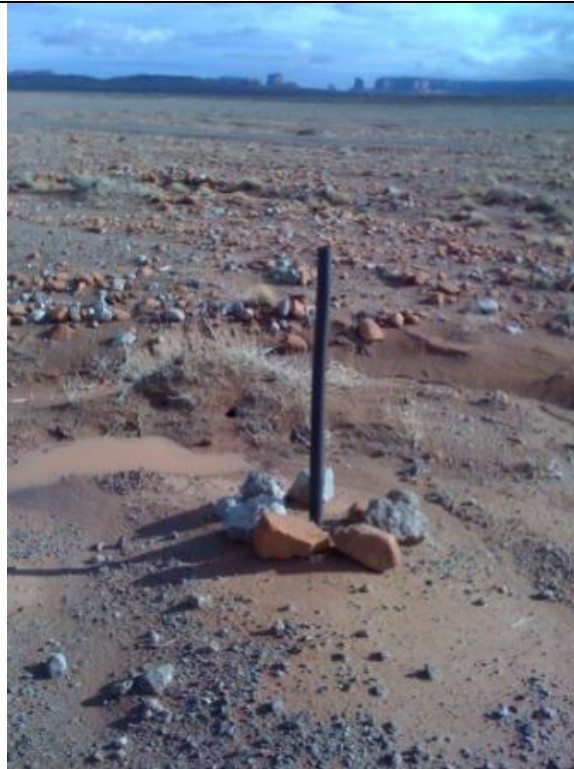
**Photo 2**

Many markers/posts throughout and surrounding the site

Mine Site #252 - Marker

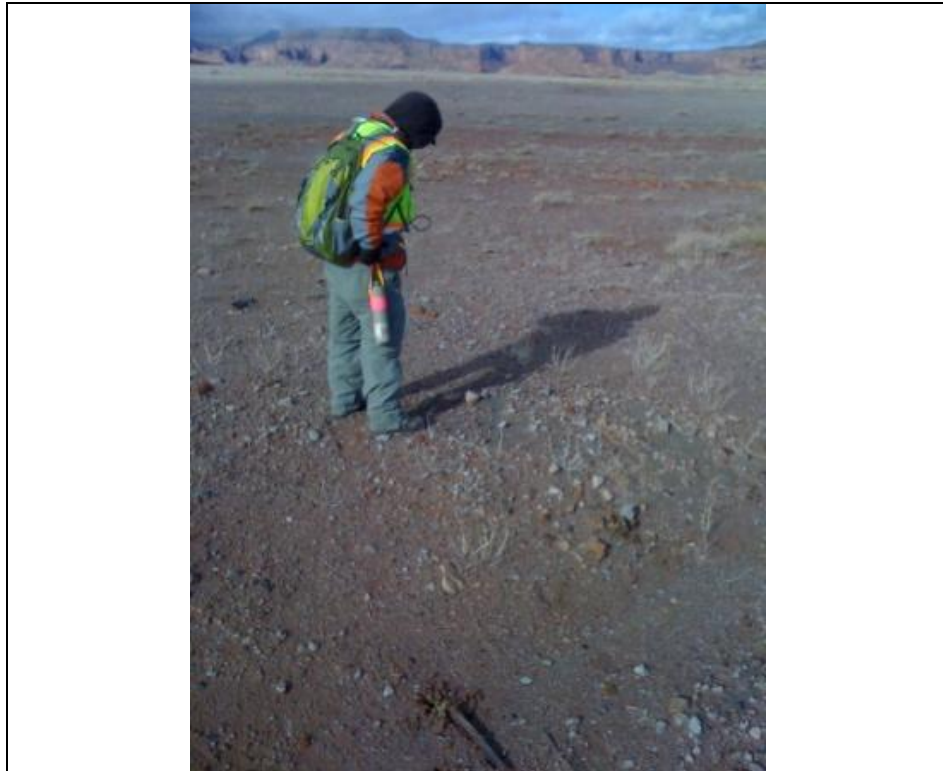
**Photo 3**

A total of 1,333 gamma radiation measurements were collected from the mine site, ranging from 4,765 cpm to 630,159 cpm. Maximum levels of approximately 630,000 cpm were found in the center of the site. The measurements are represented in Figures 1 and 2.

Mine Site #252 – Elevated gamma readings

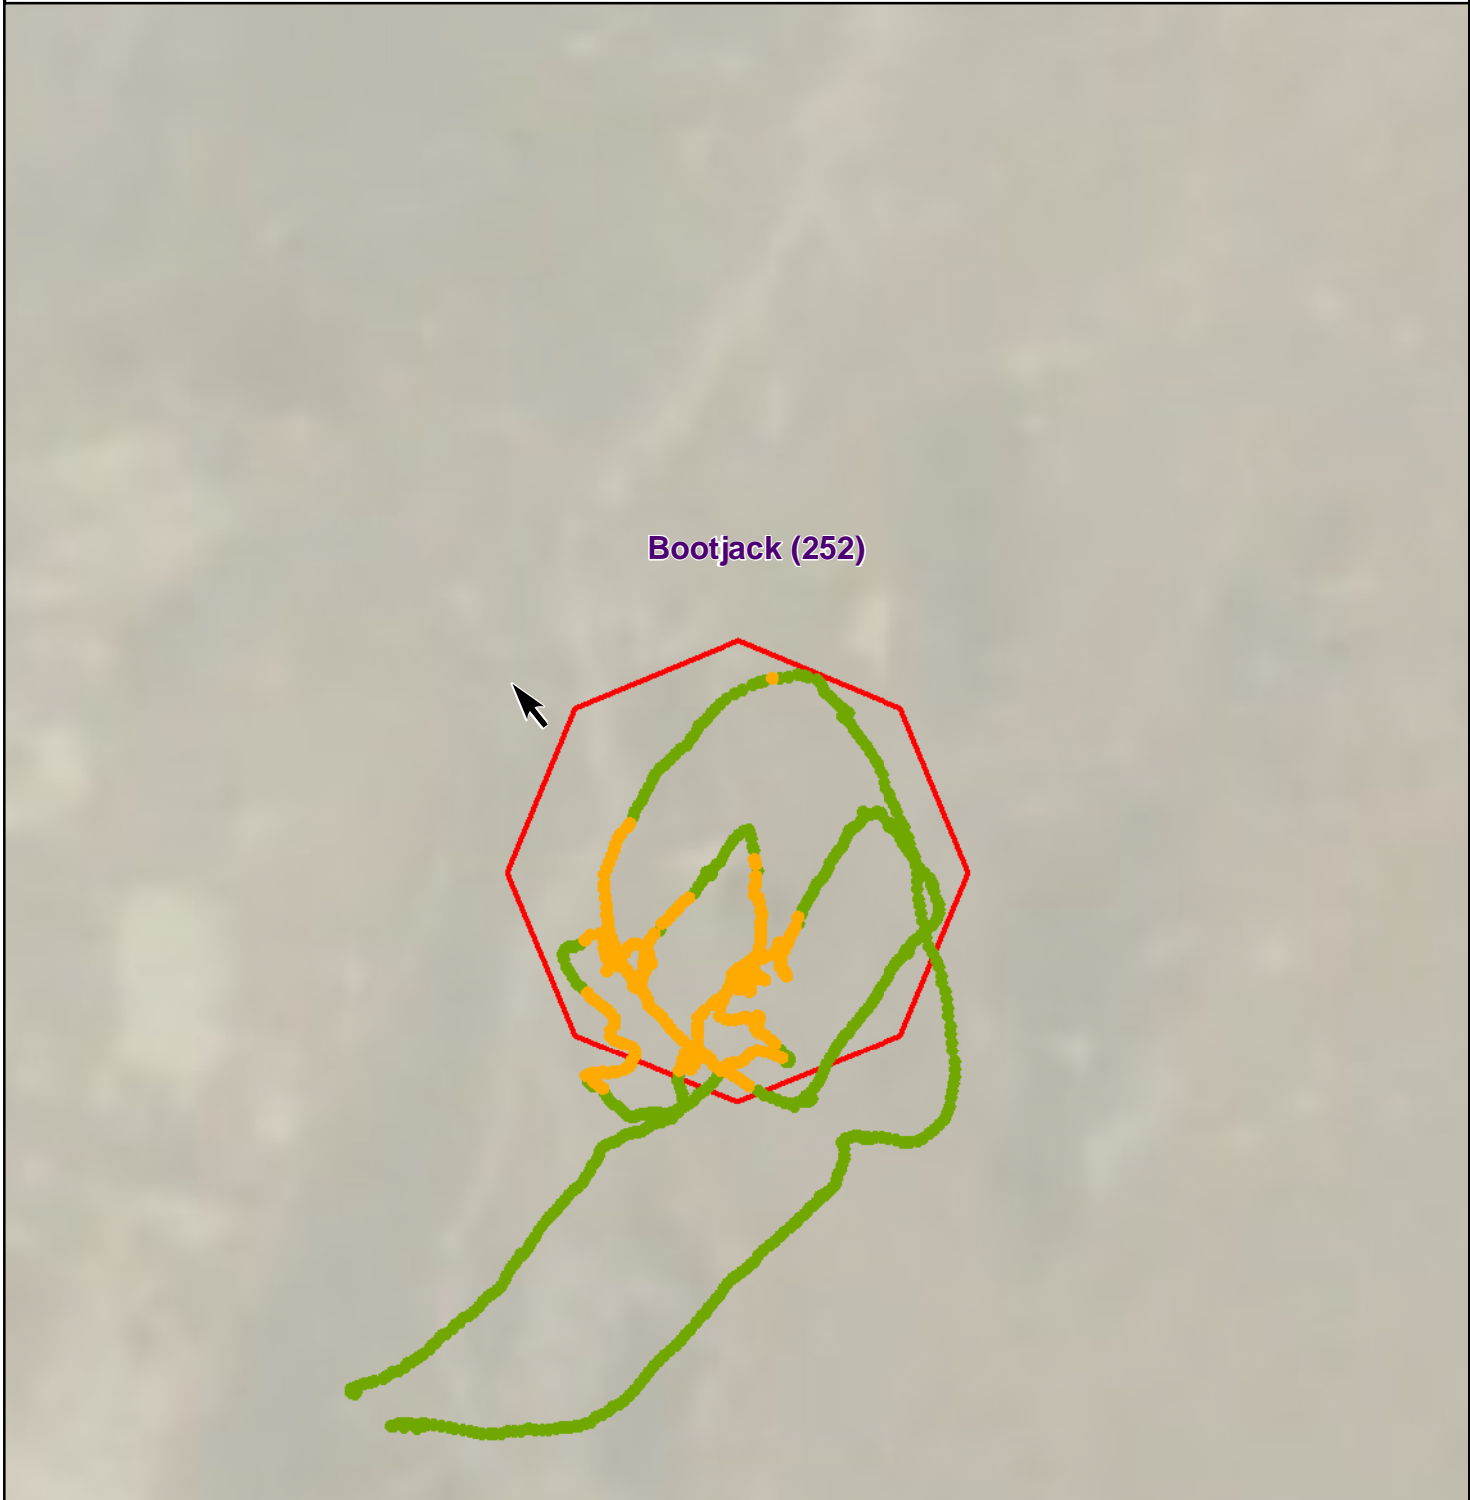
**Figure 1 - Gamma Radiation Measurements, Above Two Times Background  
 Bootjack (252)  
 Oljato Chapter, Navajo Nation**

Average background 6,901 cpm

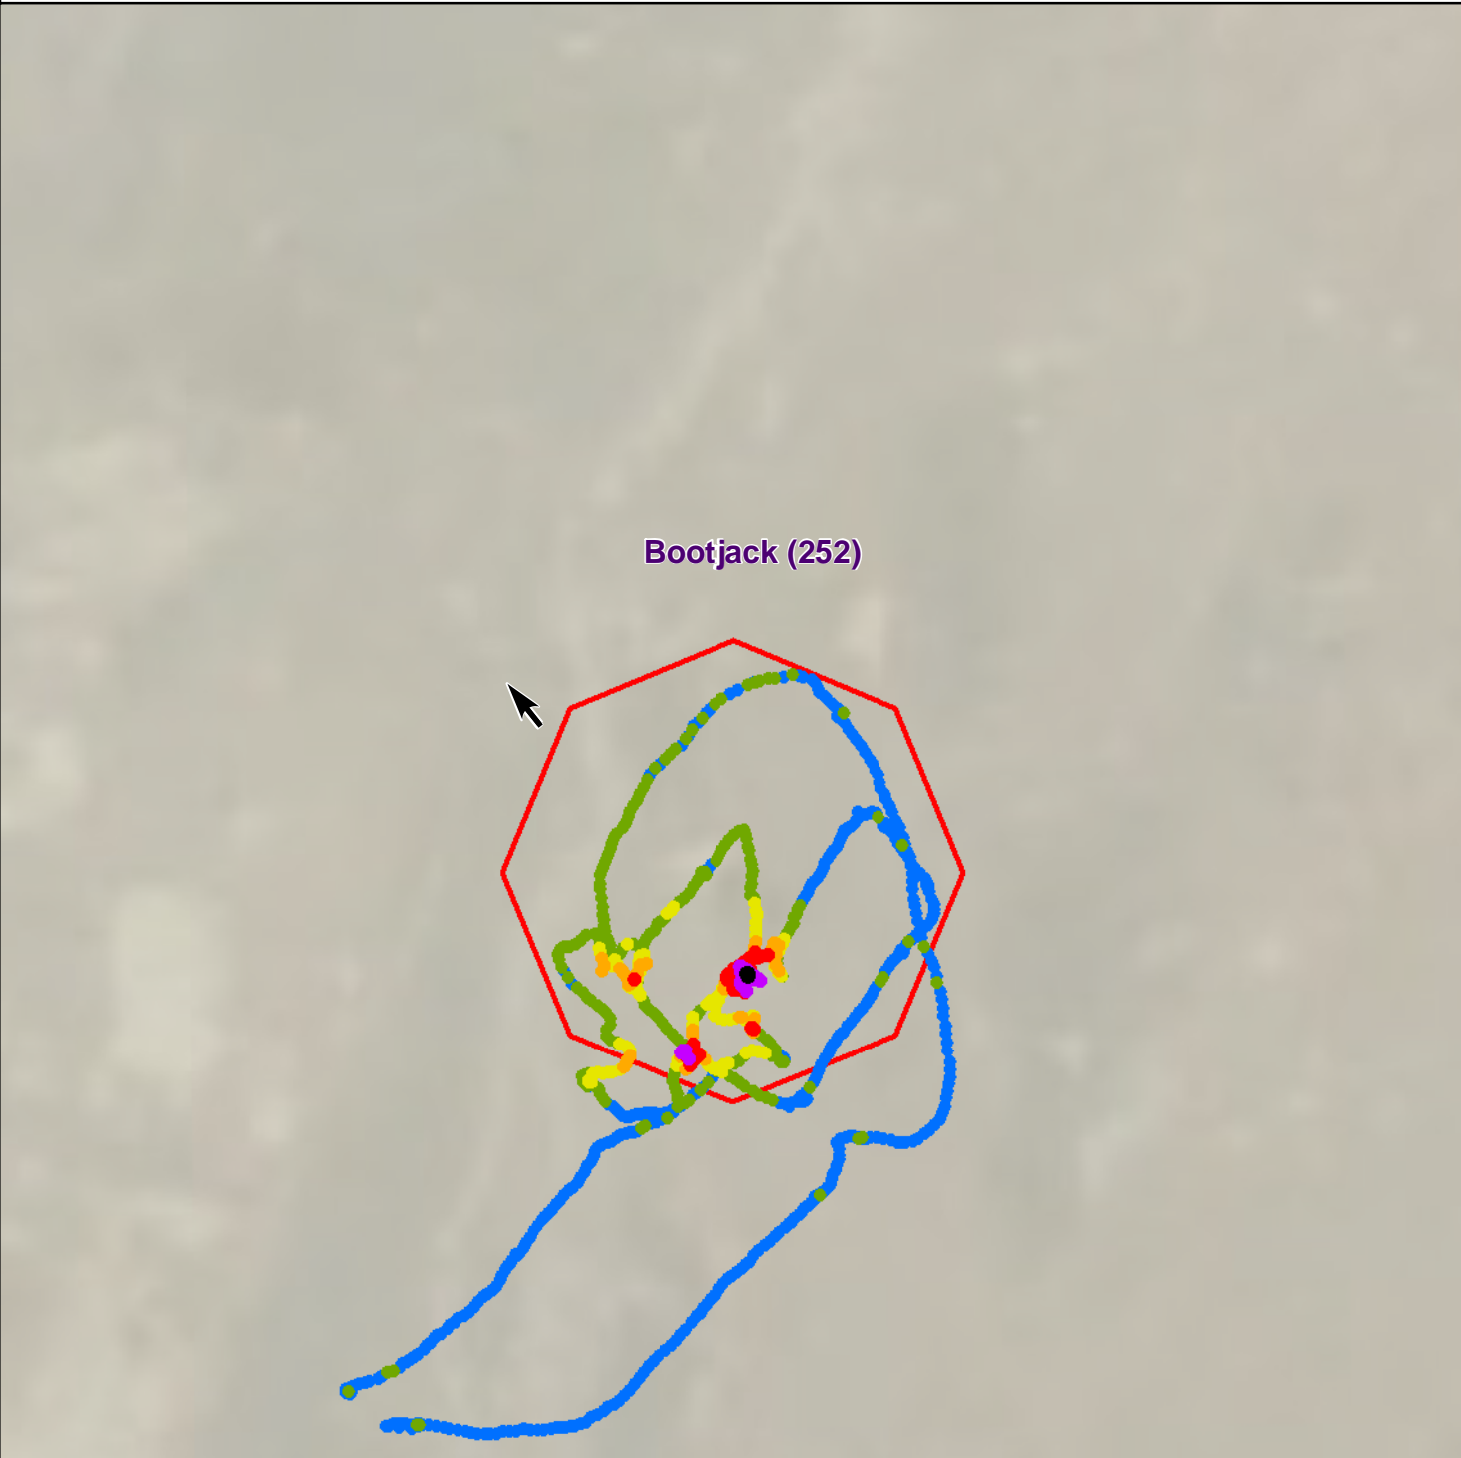
**Figure 2 - Gamma Radiation Measurements  
 Bootjack (252)  
 Oljato Chapter, Navajo Nation**

**Average background 6,901 cpm**
