Navajo Abandoned Uranium Mine

Site Screen Report

Mine Name: Fern No. 1
Mine ID: 257

April 2012

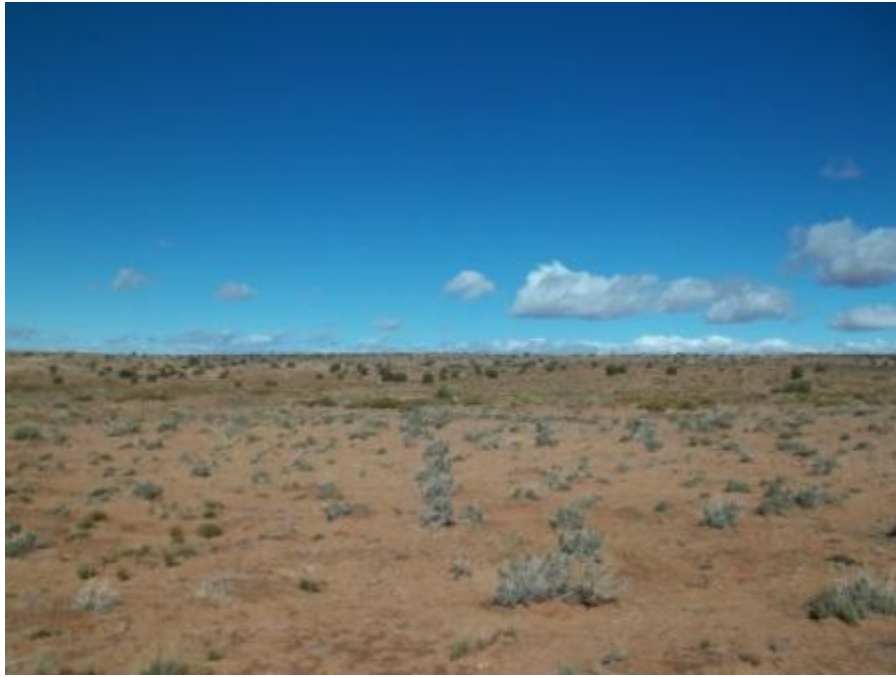
Photo 1

Mine Site #257

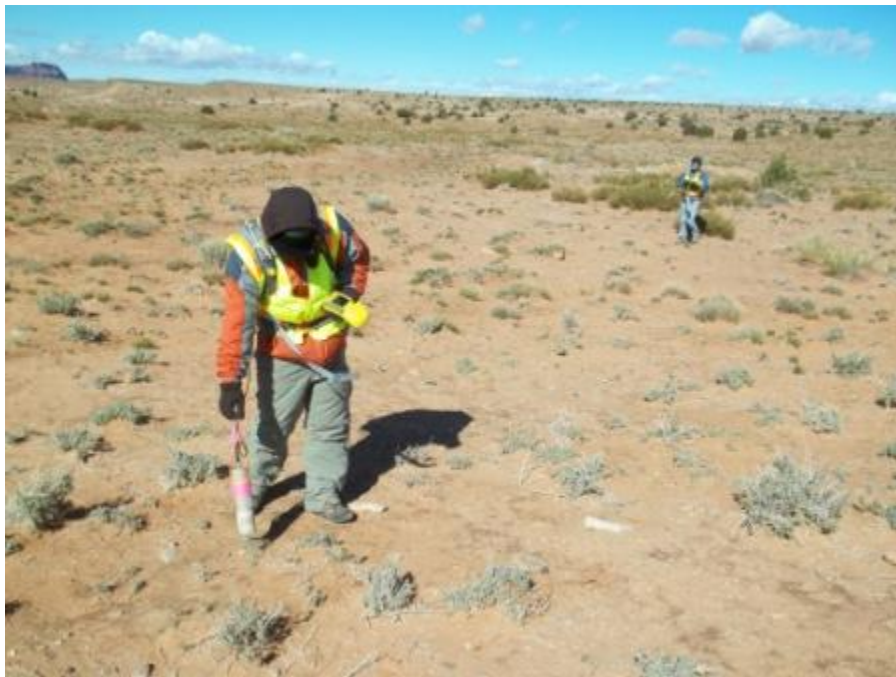
Photo 2

Elevated readings near former adit area (as identified on topo)

Mine Site #257 - Elevated gamma readings

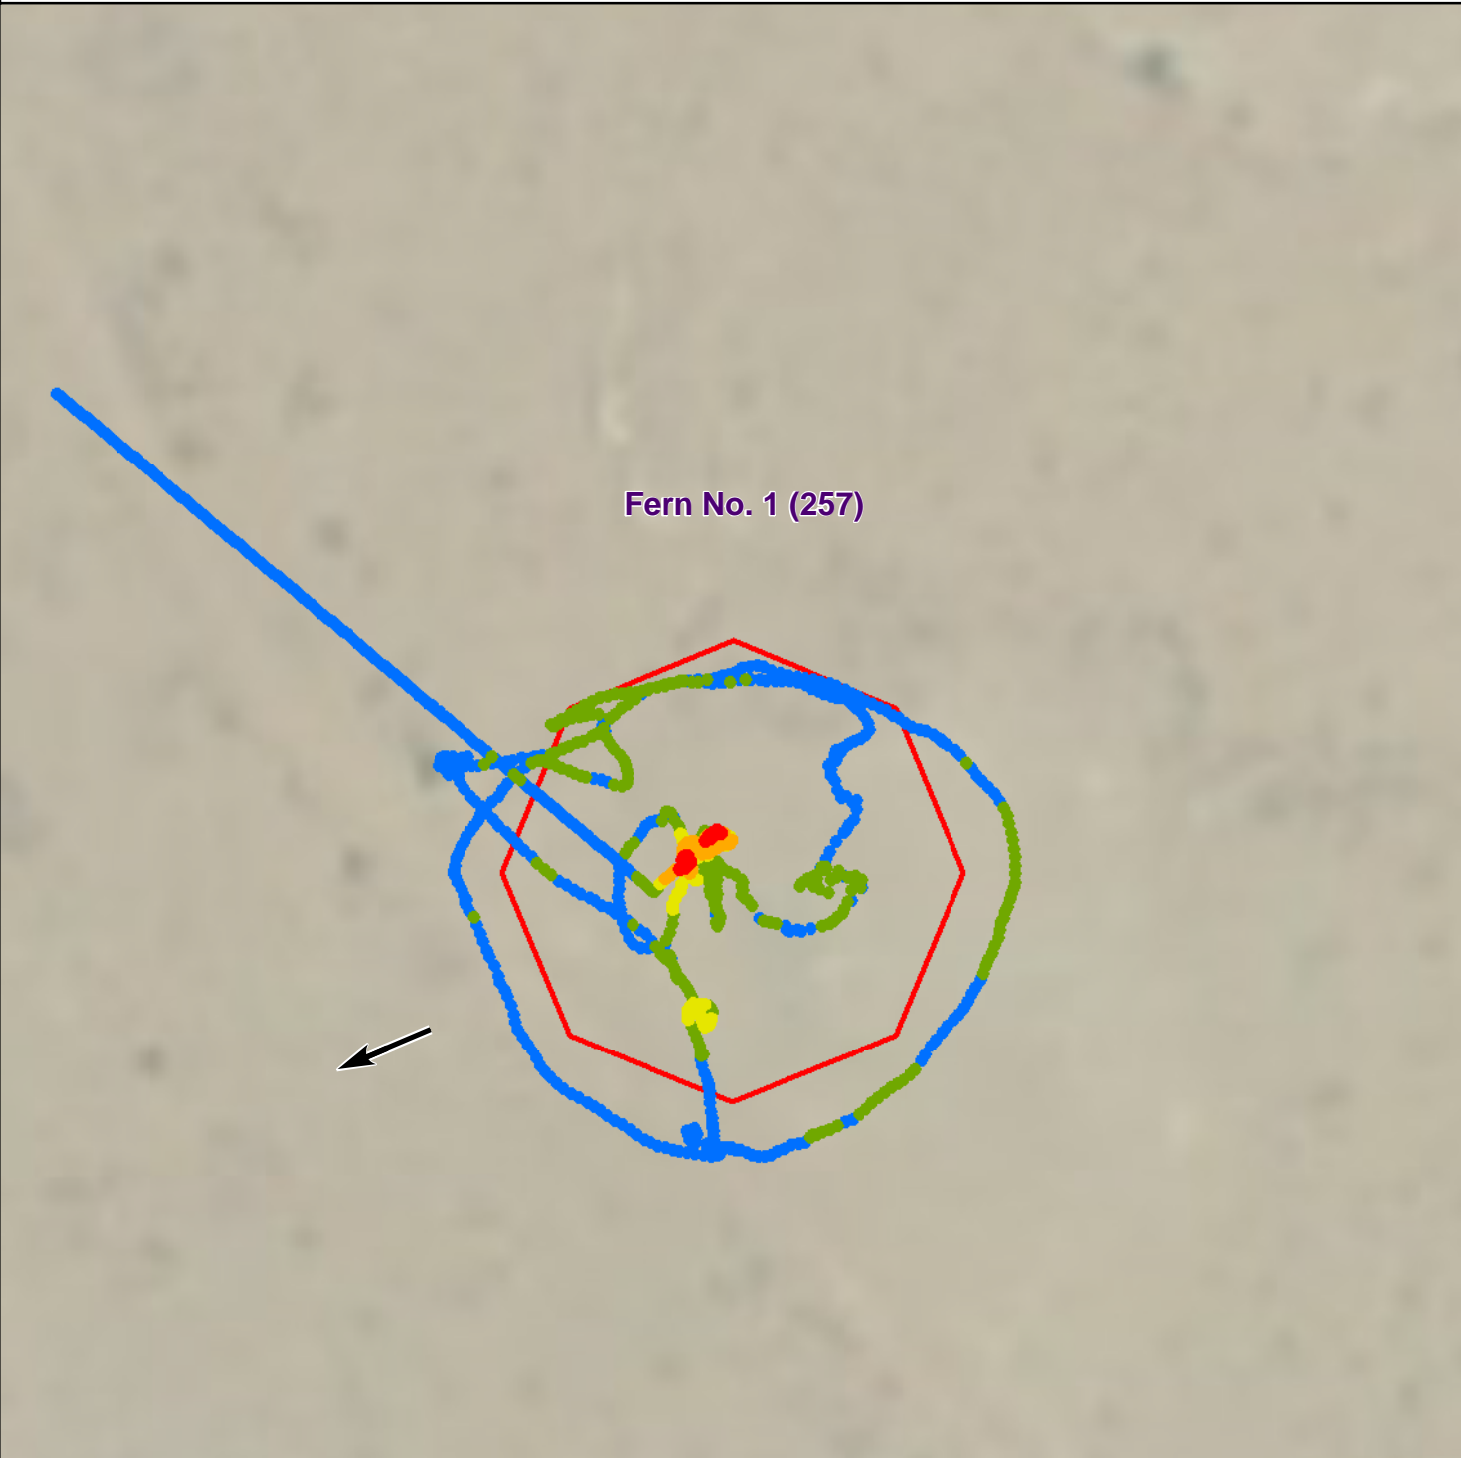
**Figure 2 - Gamma Radiation Measurements
Fern No. 1 (257)
Oljato Chapter, Navajo Nation**

A total of 1,655 gamma radiation measurements were collected from the mine site, ranging from 5,515 cpm to 157,742 cpm. Maximum levels of approximately 155,000 cpm were found near former adit. The measurements are represented in Figures 1 and 2.

Average background 9,505 cpm

Measured as counts per minute (cpm)
