# Navajo Abandoned Uranium Mine

## Site Screen Report

## Kinusta Mesa AUM Site

**August 2010**

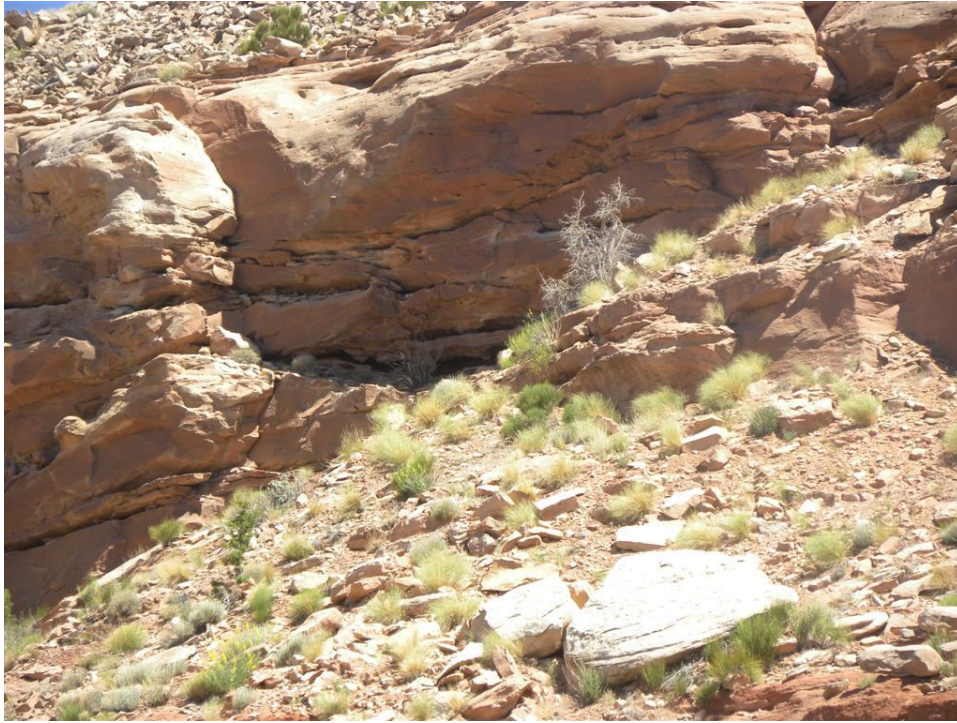
Photo 1. Kinusta Mesa site

Some ambiguous evidence of mining above cliffs with some possible waste, unknown
