Navajo Abandoned Uranium Mine

Site Screen Report

Lone Star AUM Site

March 2010

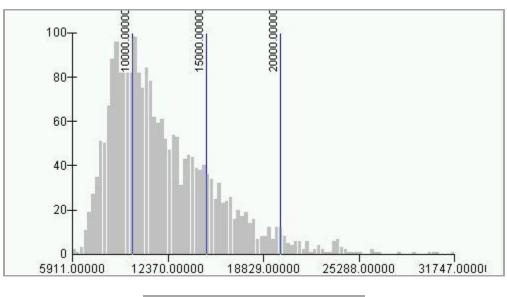
The following chart and statistics were generated by ESRI ArcGIS 9.3.1, and show the general distribution of the site gamma radiation measurements. The horizontal X axis represents the gamma radiation reading levels in cpm (lowest levels to the left). The vertical Y axis represents the frequency of each gamma radiation level.

Count:	2373
Minimum:	5911.00000
Maximum:	31747.00000
Sum:	28593784.00000
Mean:	12049.63506
Median:	11102.00000
Standard Deviation:	3621.21648

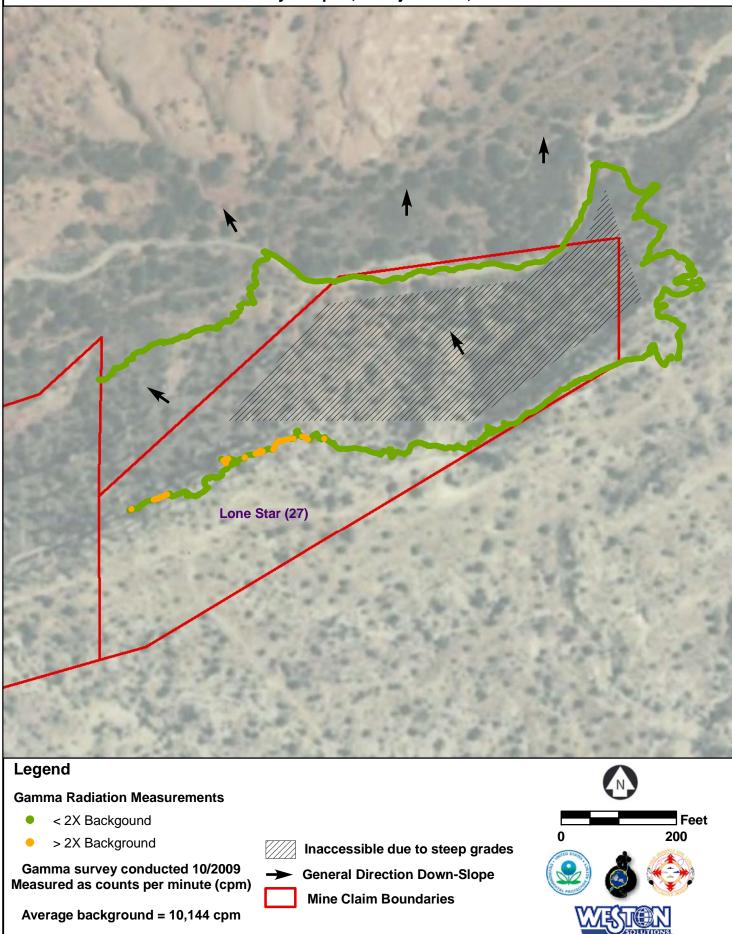
Figure 1 - Gamma Radiation Measurements, Above Two Times Background Lone Star (27) Red Valley Chapter, Navajo Nation, Arizona

A total of 2,373 gamma radiation measurements were collected from the mine site, ranging from 5,911 cpm to 31,747 cpm. The measurements are represented in Figures 1 and 2.

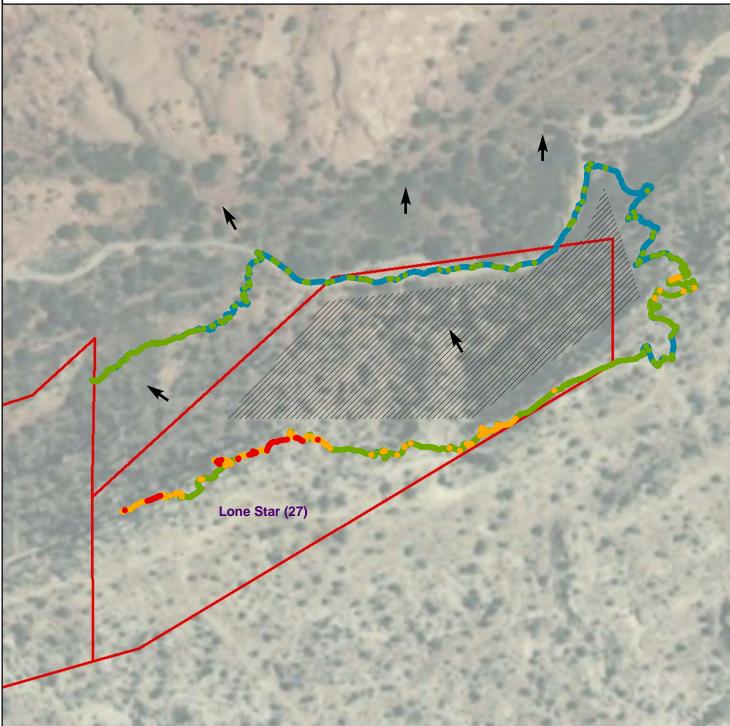
Figure 2 - Gamma Radiation Measurements Lone Star (27) Red Valley Chapter, Navajo Nation, Arizona

Average background 10,144 cpm
