Navajo Abandoned Uranium Mine

Site Screen Report

Mine Name: Morale Mine
Mine ID: 291

April 2012

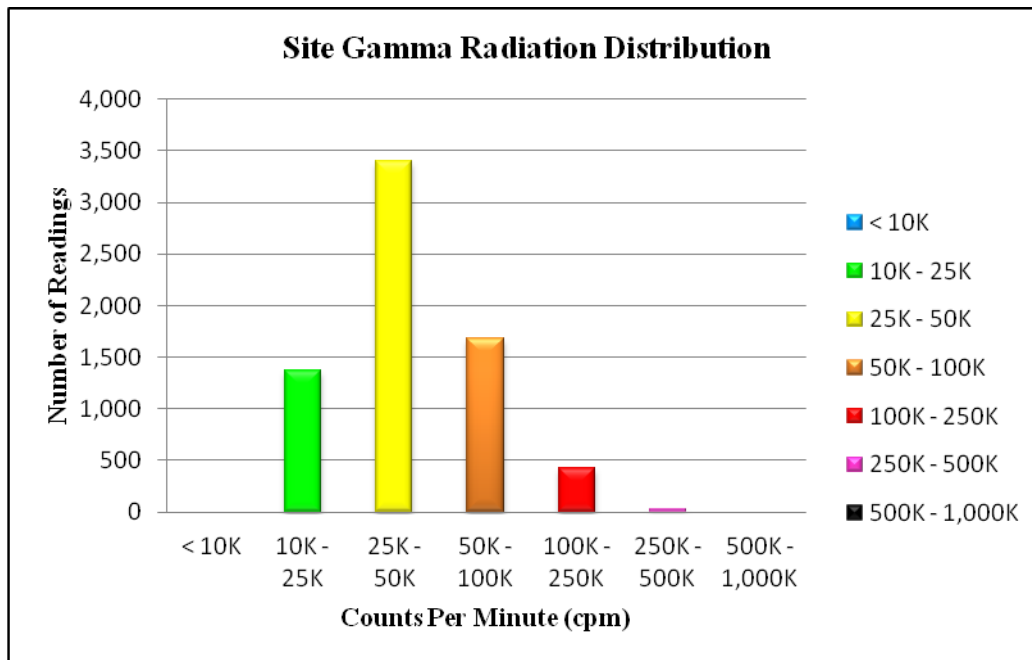
Distribution Chart and Statistics:

Site Gamma Radiation Statistics	
Number of Readings	6,903
Minimum (cpm)	15,011
Maximum (cpm)	407,775
Mean (cpm)	48,134
Median (cpm)	39,211
Standard Deviation	34,163

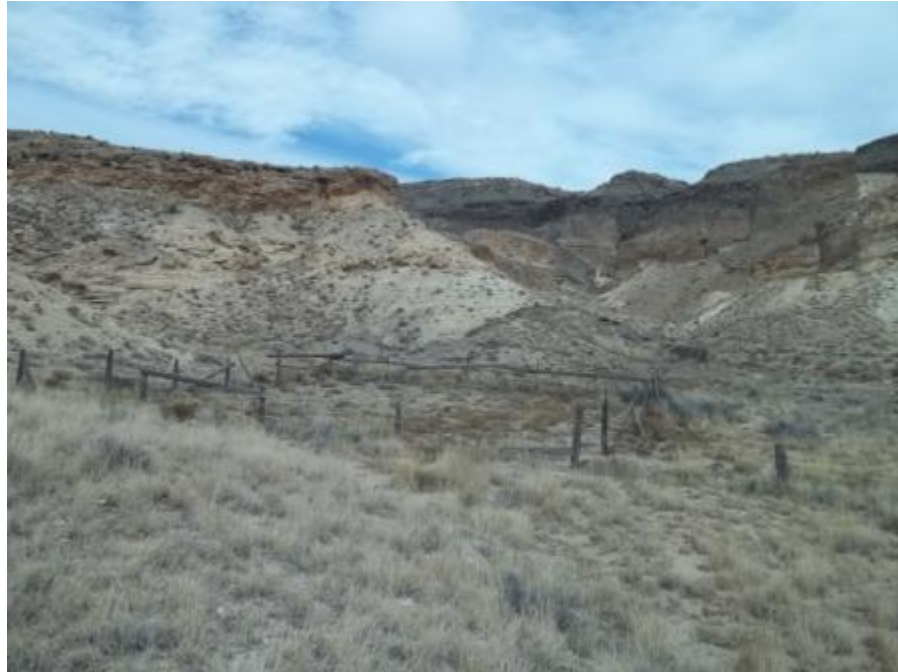
Photo 3

Mine Site #291 –Fenced corral

A total of 6,903 gamma radiation measurements were collected from the mine site, ranging from 15,011 cpm to 407,775 cpm. Maximum levels of approximately 350,000 cpm were found in the vicinity of the waste rock, 70,000 cpm were found near the fenced corral, 110,000 cpm along the eastern slope, and 400,000 cpm were found in the northeast drainage. The measurements are represented in Figures 1 and 2.

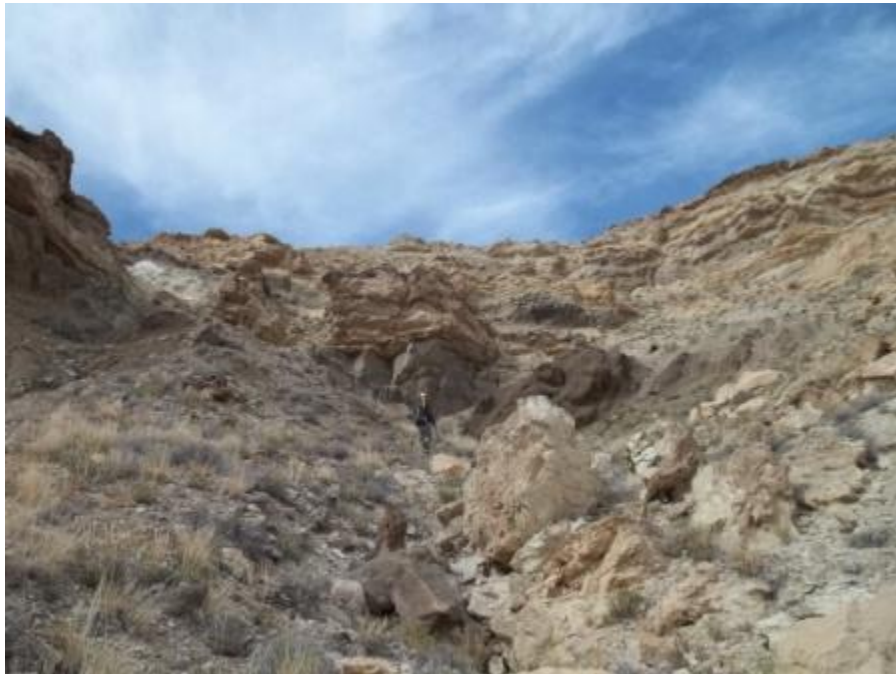
Photo 6

Mine Site #291 – Drainage with elevated gamma

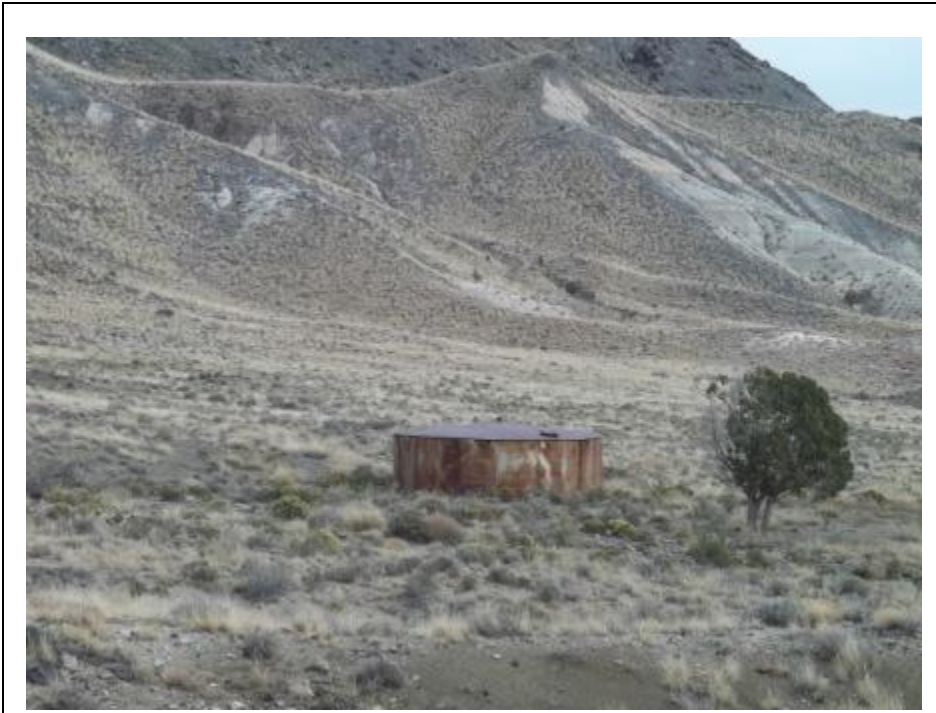
Photo 7	Mine Site #291 – Water tank
----------------	-----------------------------

0 to 0.25 miles: Onsite - Windmill pump atop site mesa, associated water Tank at bottom of the mesa, on the eastern side of the site

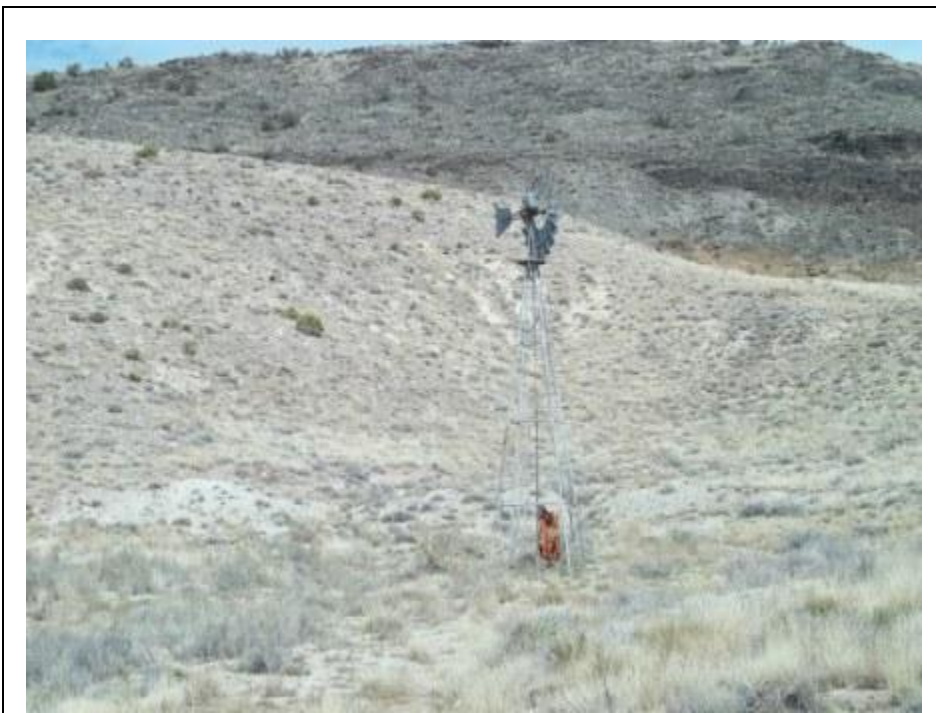
Photo 8	Mine Site #291 – Windmill pump
----------------	--------------------------------

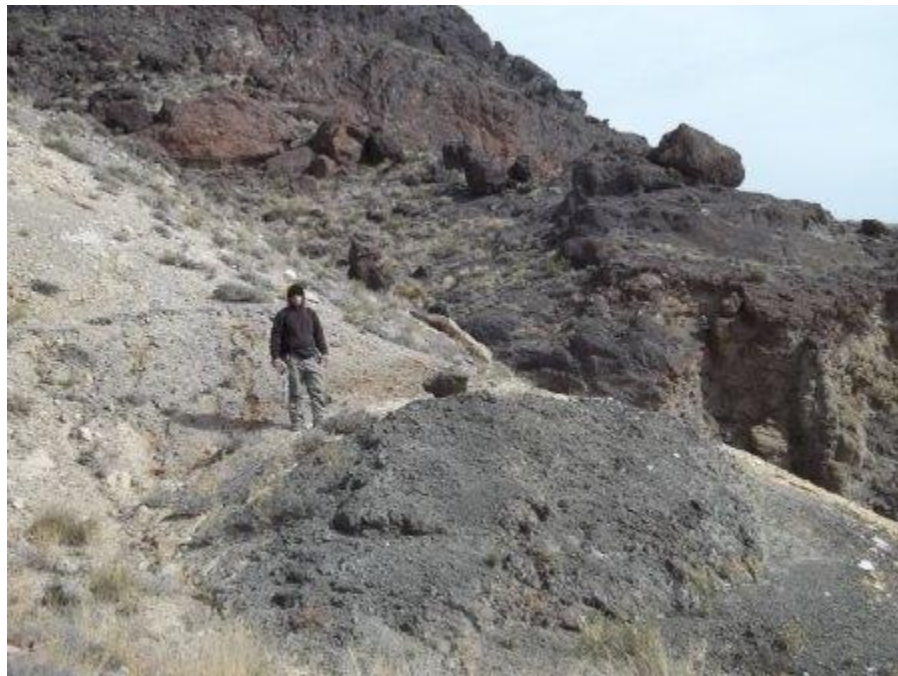
Photo 12

Mine Site #291 – Waste pile

Waste pile, approximately 15' x 15', black rock and white dirt

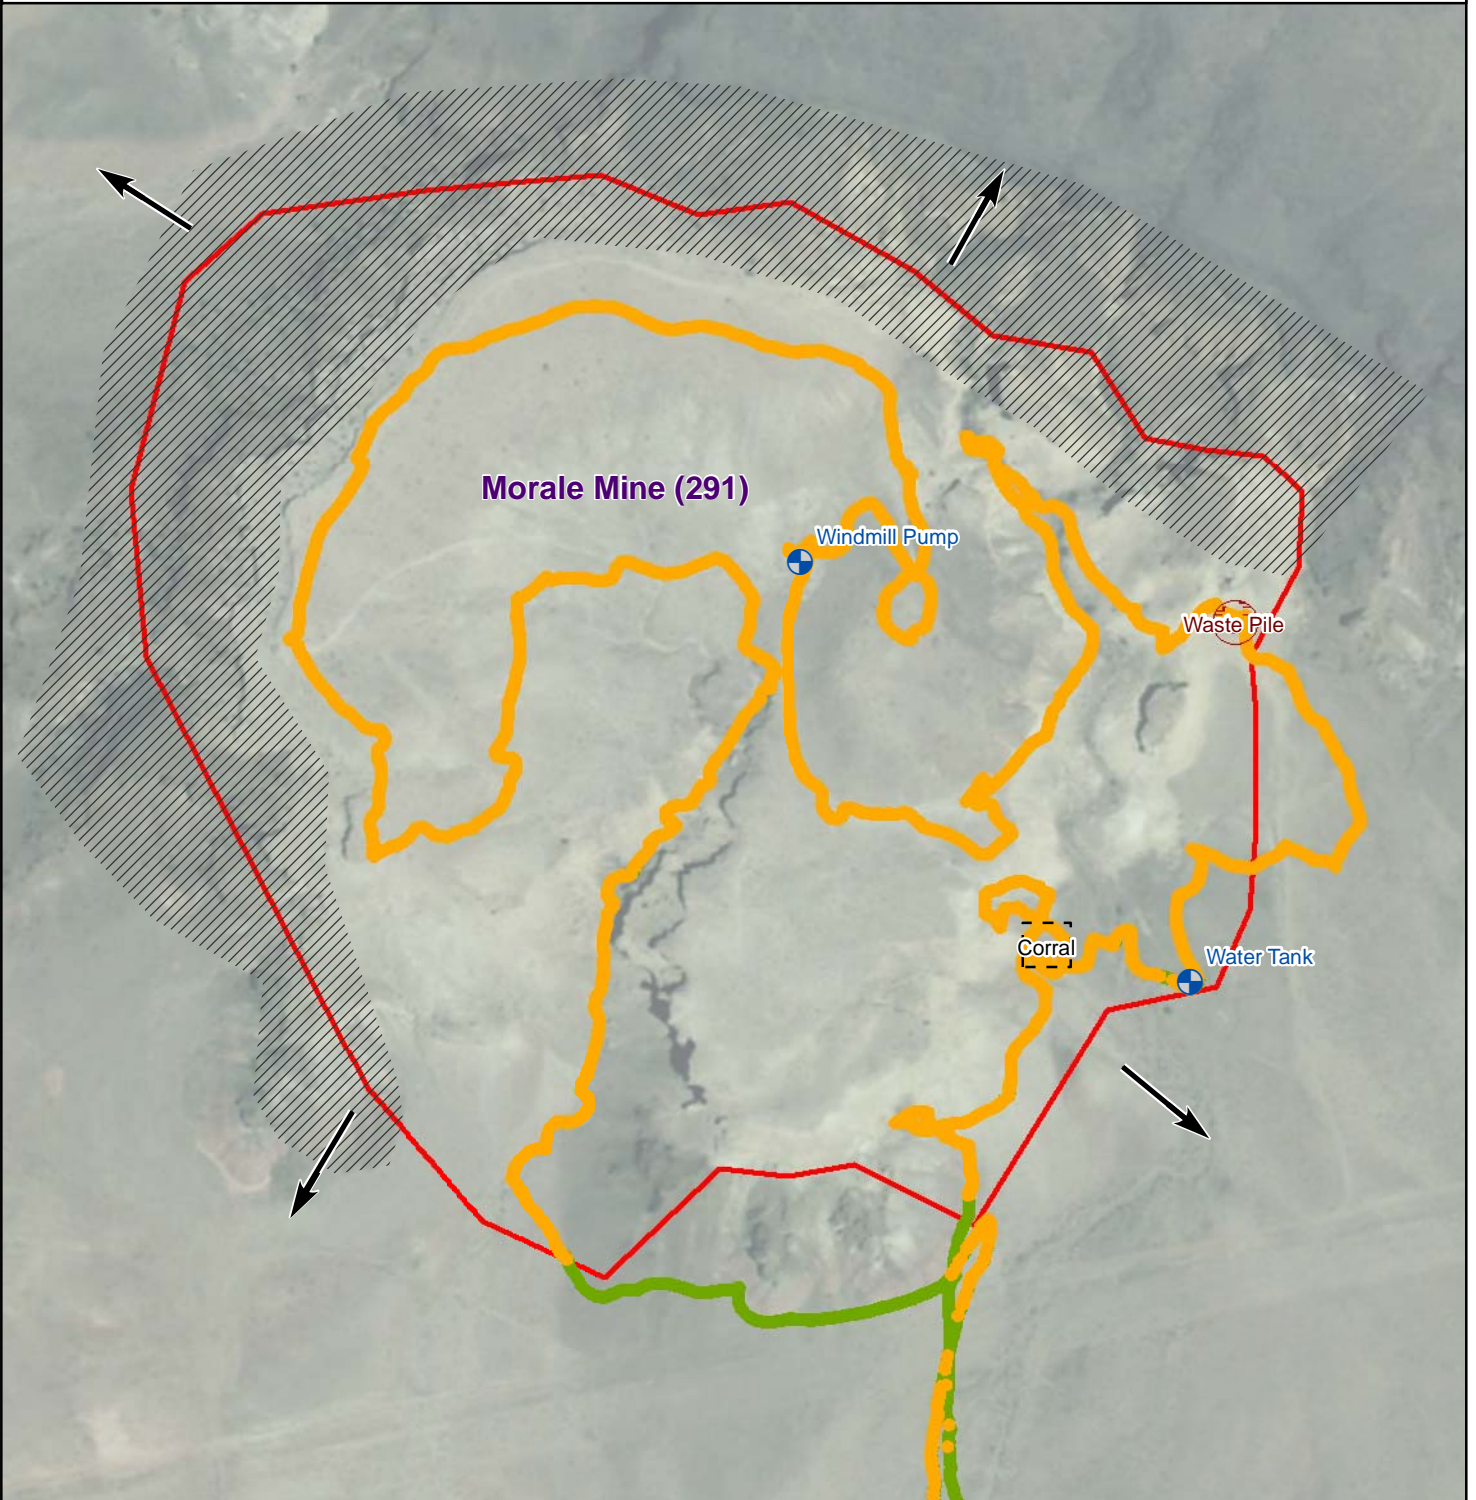
**Figure 1 - Gamma Radiation Measurements, Above Two Times Background
Morale Mine (291)
Indian Wells Chapter, Navajo Nation**

Average background 12,416 cpm

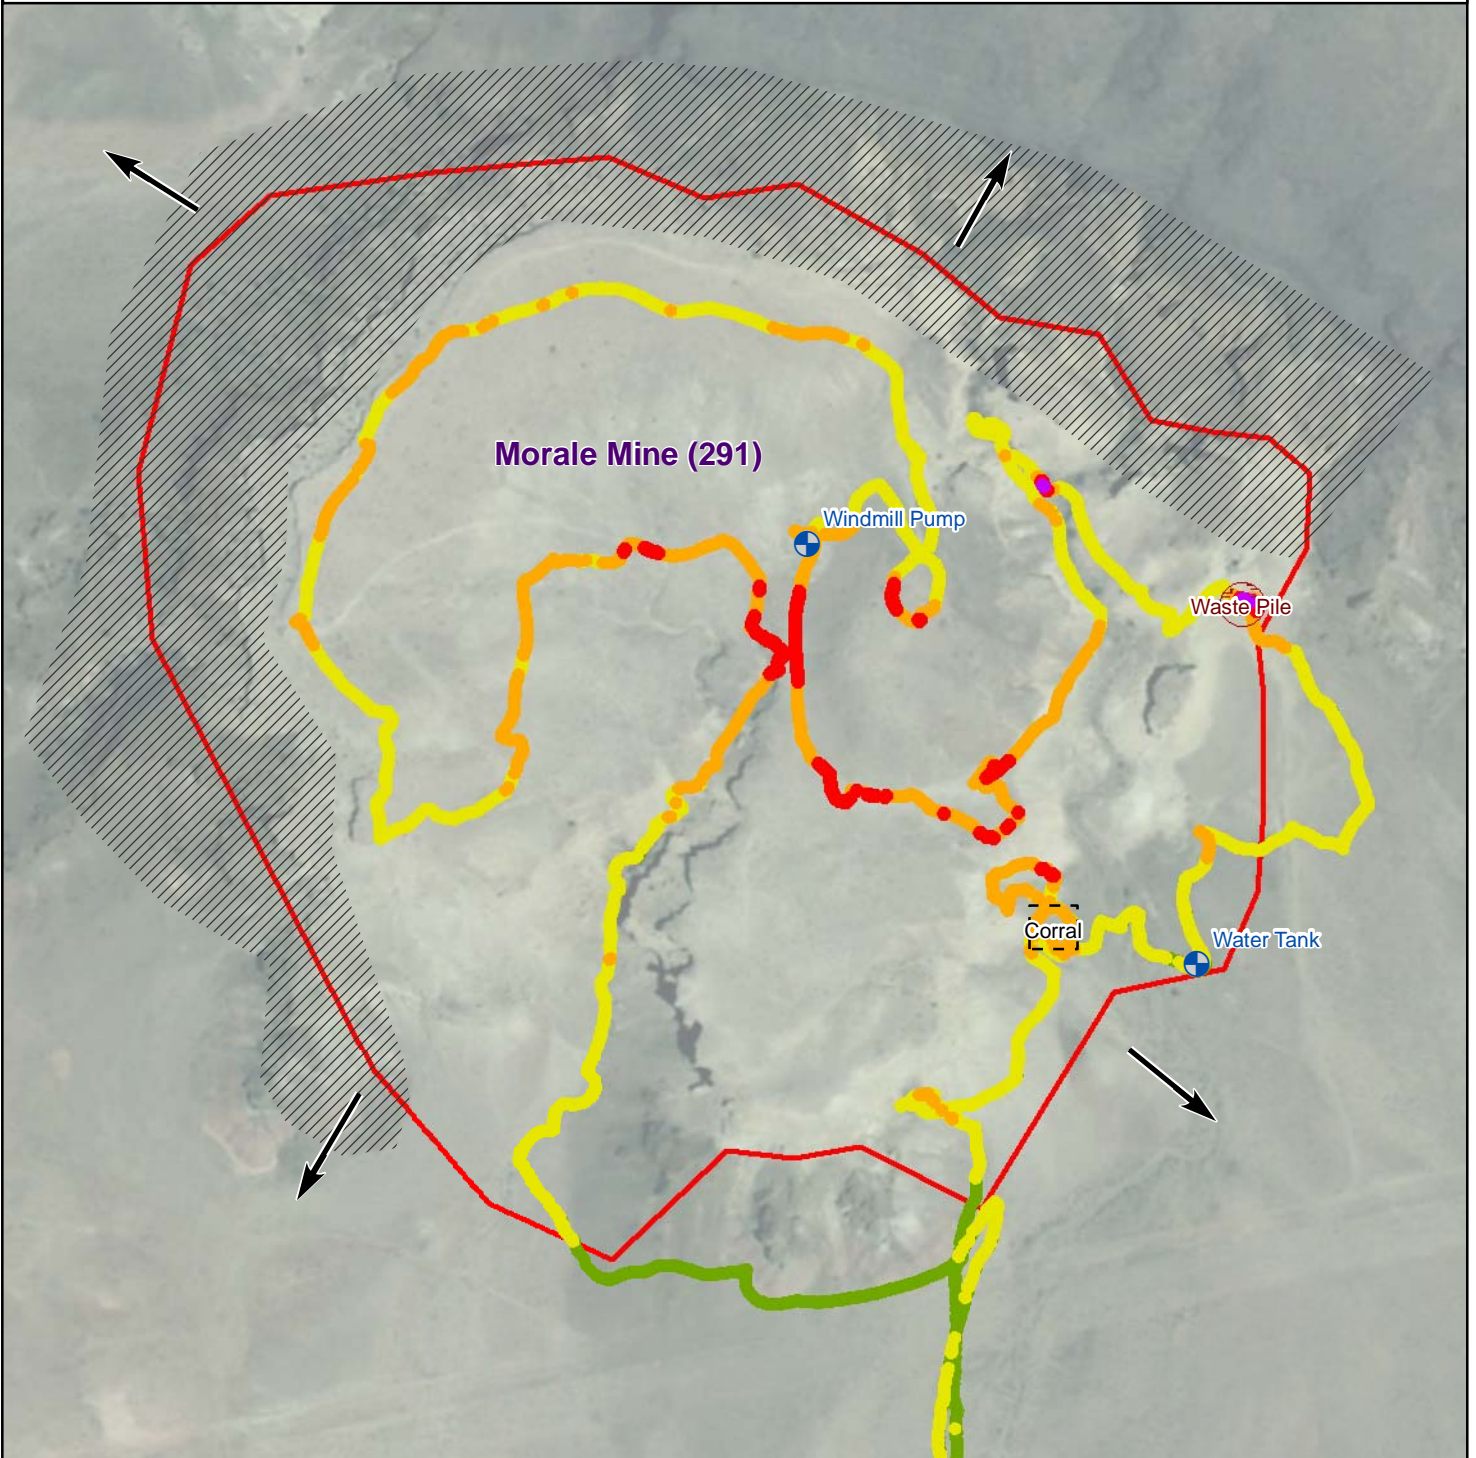
**Figure 2 - Gamma Radiation Measurements
Morale Mine (291)
Indian Wells Chapter, Navajo Nation**

- 0 - 10,000 cpm
- 10,000 - 25,000 cpm
- 25,000 - 50,000 cpm
- 50,000 - 100,000 cpm
- 100,000 - 250,000 cpm
- 250,000 - 500,000 cpm
- 500,000 - 1,000,000 cpm

Average background 12,416 cpm Measured as counts per minute (cpm)
