Navajo Abandoned Uranium Mine

Site Screen Report

Mine Name: Occurrence B
Mine ID: 296

August 2011

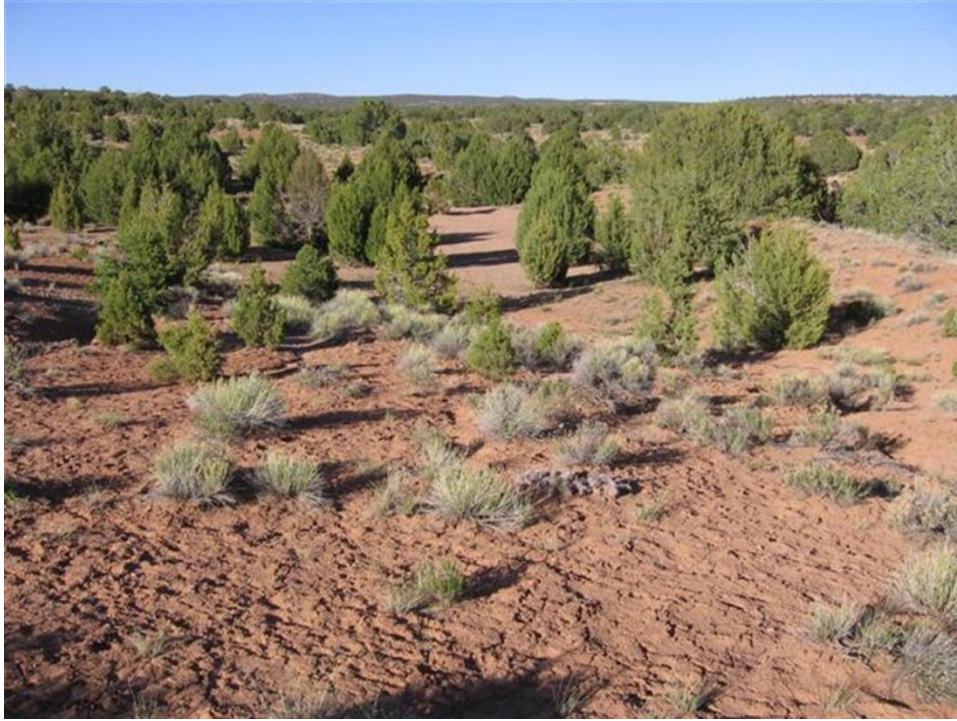
Photo 1: Mine Site #296

Mining pit/depression, 375'x100' oval, berms surrounding pit, appears to be reclaimed
