# Navajo Abandoned Uranium Mine Site Screen Report

## **Ruby No. 1 AUM Site**

### **Navajo AUM Eastern Region**

**May 2009**

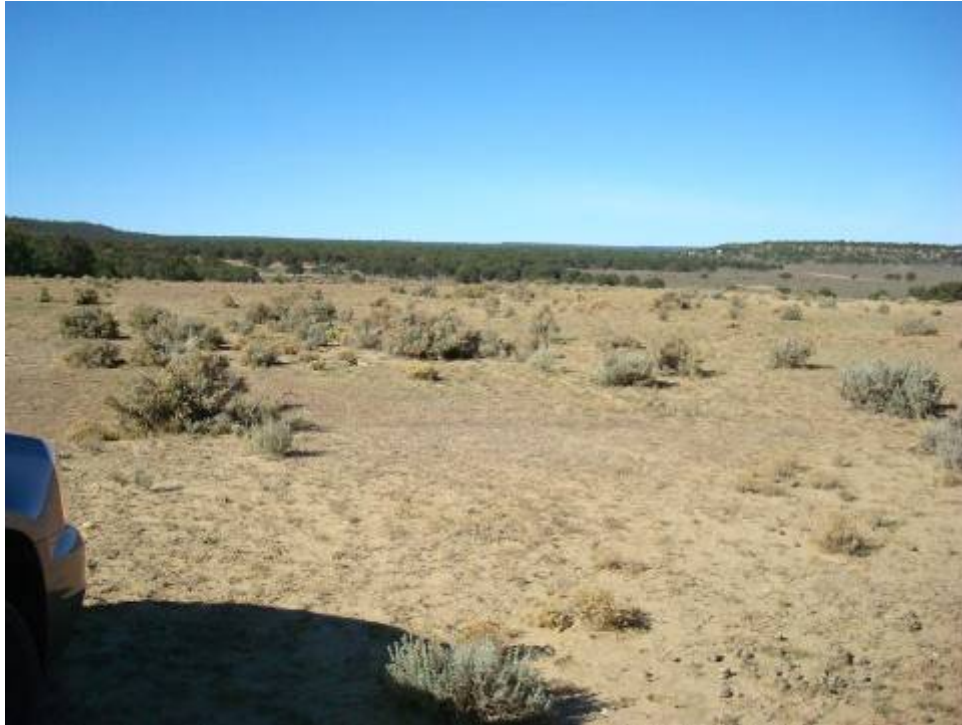
Reclamation status of the mine site is currently unknown. It appears a thin layer of cover soil may have been placed over waste rock. A concrete slab is located at the eastern end of the site and one adit was observed along the southern boundary of the mine. A vent was located 800 feet south east from the Yapany residence and has been filled in with trash. Other vents are reported to be located in the vicinity of the mine property. No other mine features were observed during the site visit.

Photo 1. Ruby 1 Mine site, towards the west

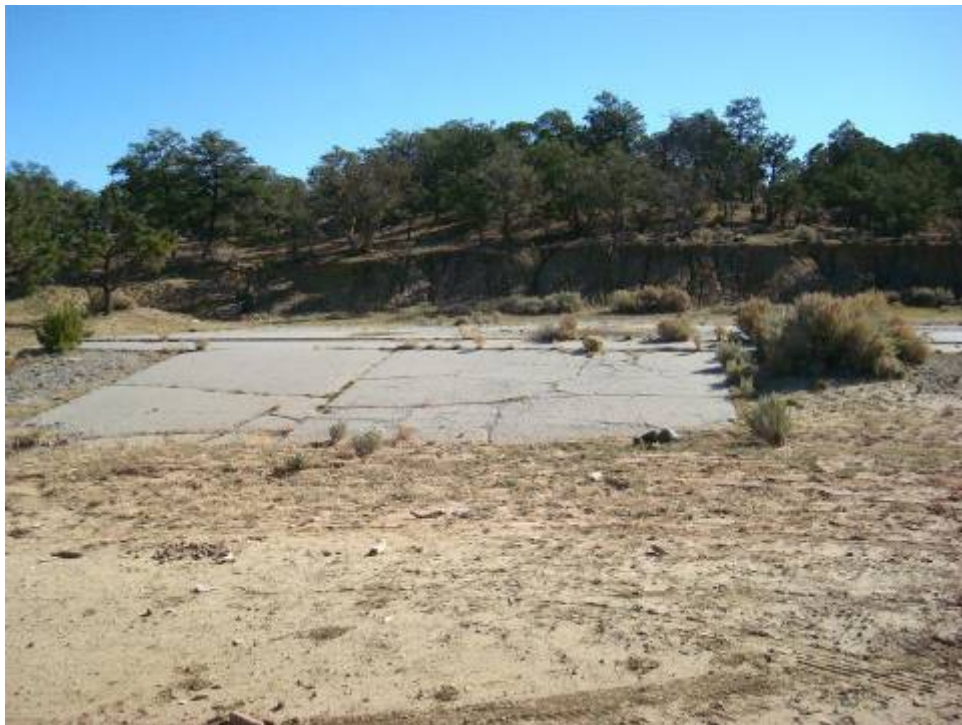
Photo 2. Ruby 1 Mine site, concrete slab on eastern portion of the site

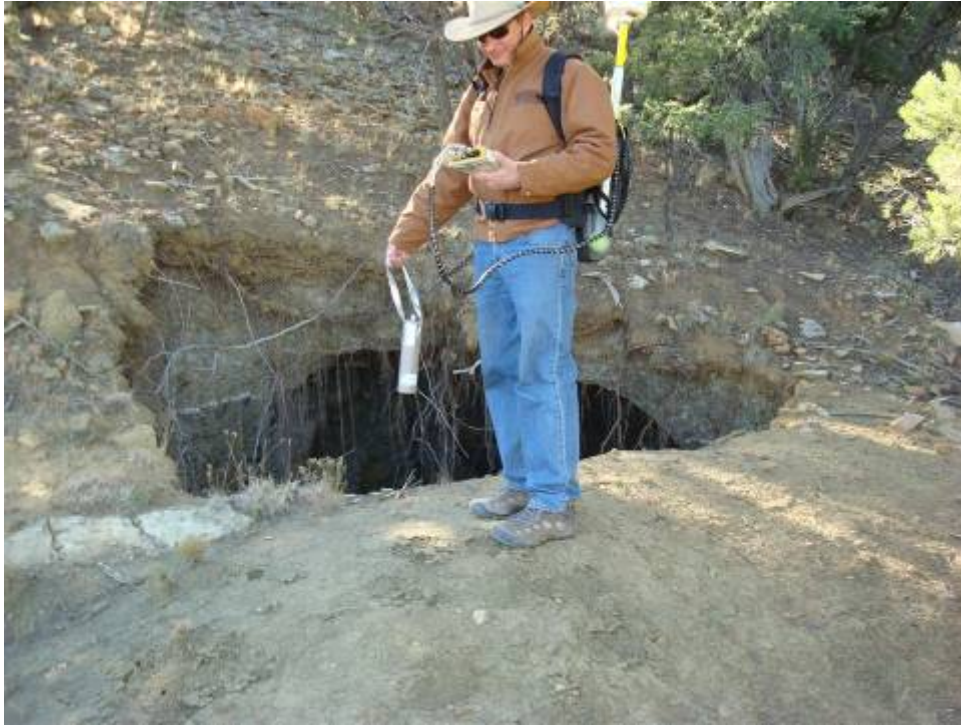
Photo 3. Ruby 1 Mine site, adit located on southern hillside

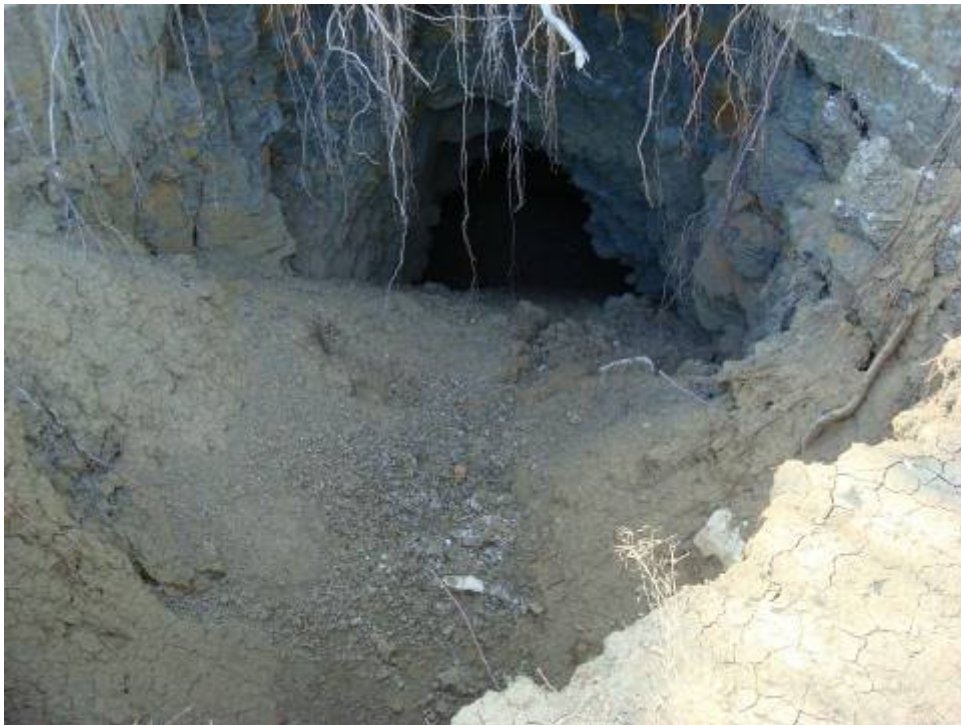
Photo 4. Ruby 1 Mine site, interior view of adit
