# **Navajo Abandoned Uranium Mine Site Screen Report**

## **Elkins AUM Sites**

### **Navajo AUM Eastern Region**

**May 2009**

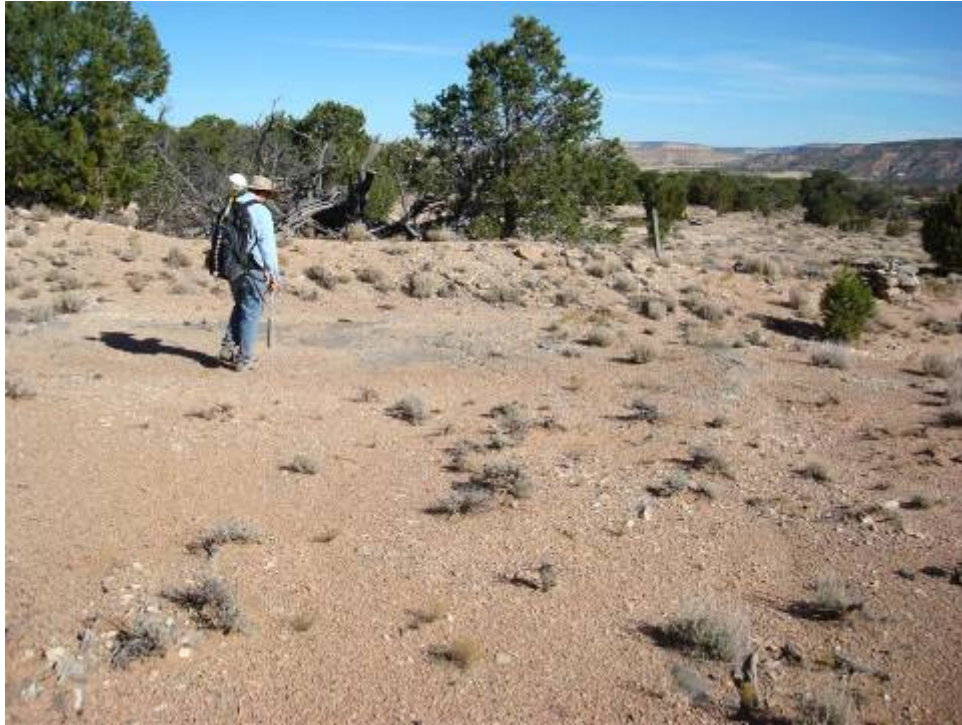
Photo 1. Elkins 326 Mine site, towards the north

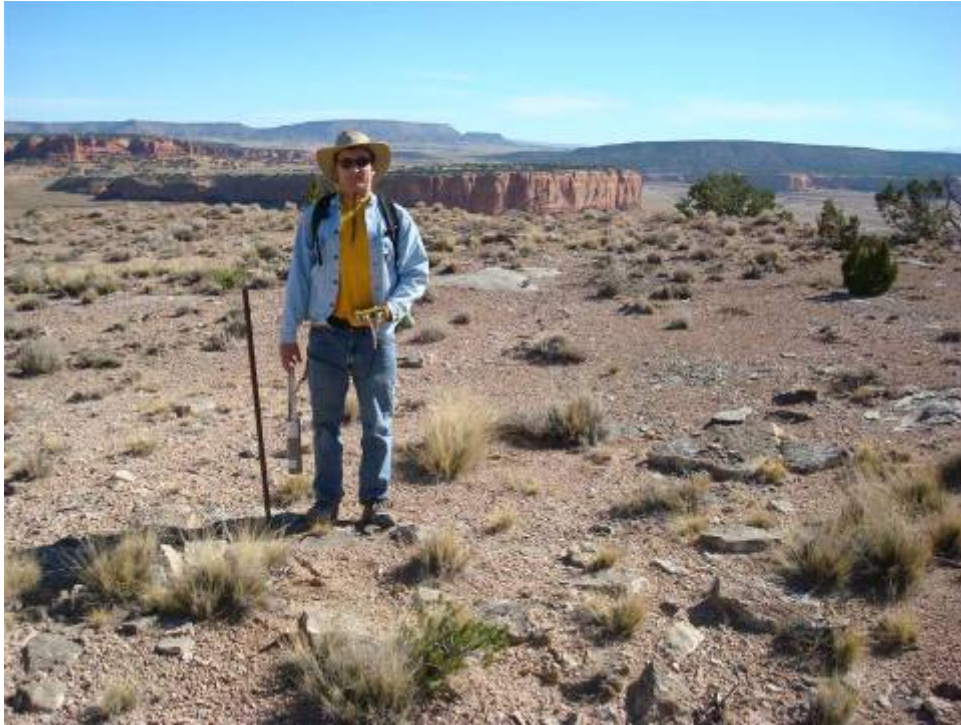
Reclamation status of the mine sites are currently unknown. No visible signs of reclamation were observed. Mining operations appear to be surface by drilling into bedrock and blasting rock from the top of the mesa. Waste piles were observed adjacent to the mines. No adits or other mine features were observed during the site visit.

Photo 3. Elkins 326 Mine site, drill steel stuck in bedrock, towards north

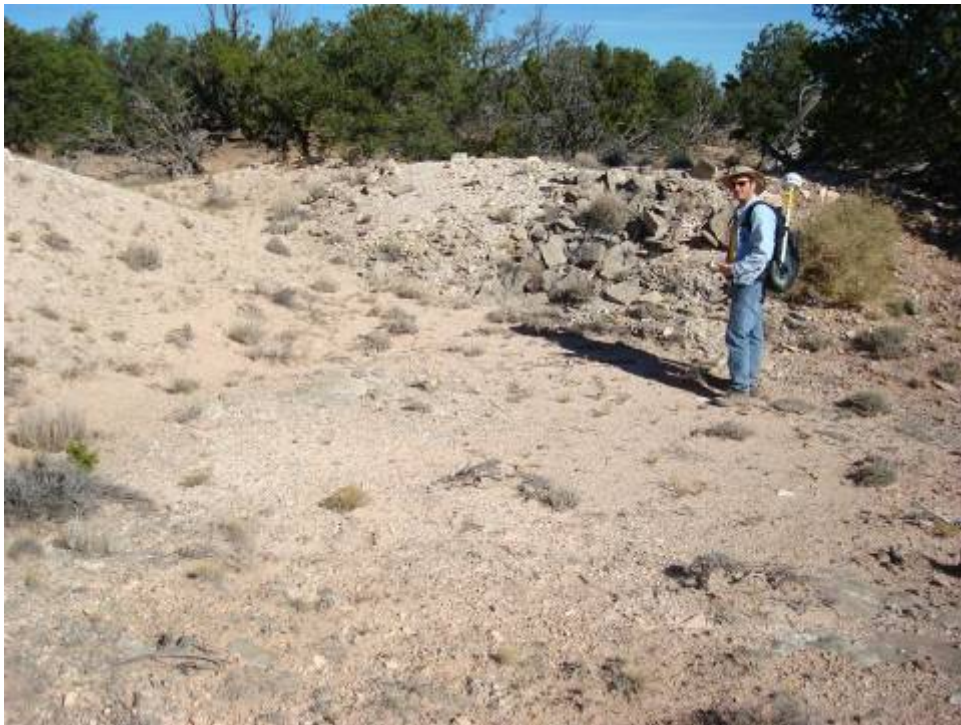
Photo 4. Elkins 327 Mine site, waste rock piles

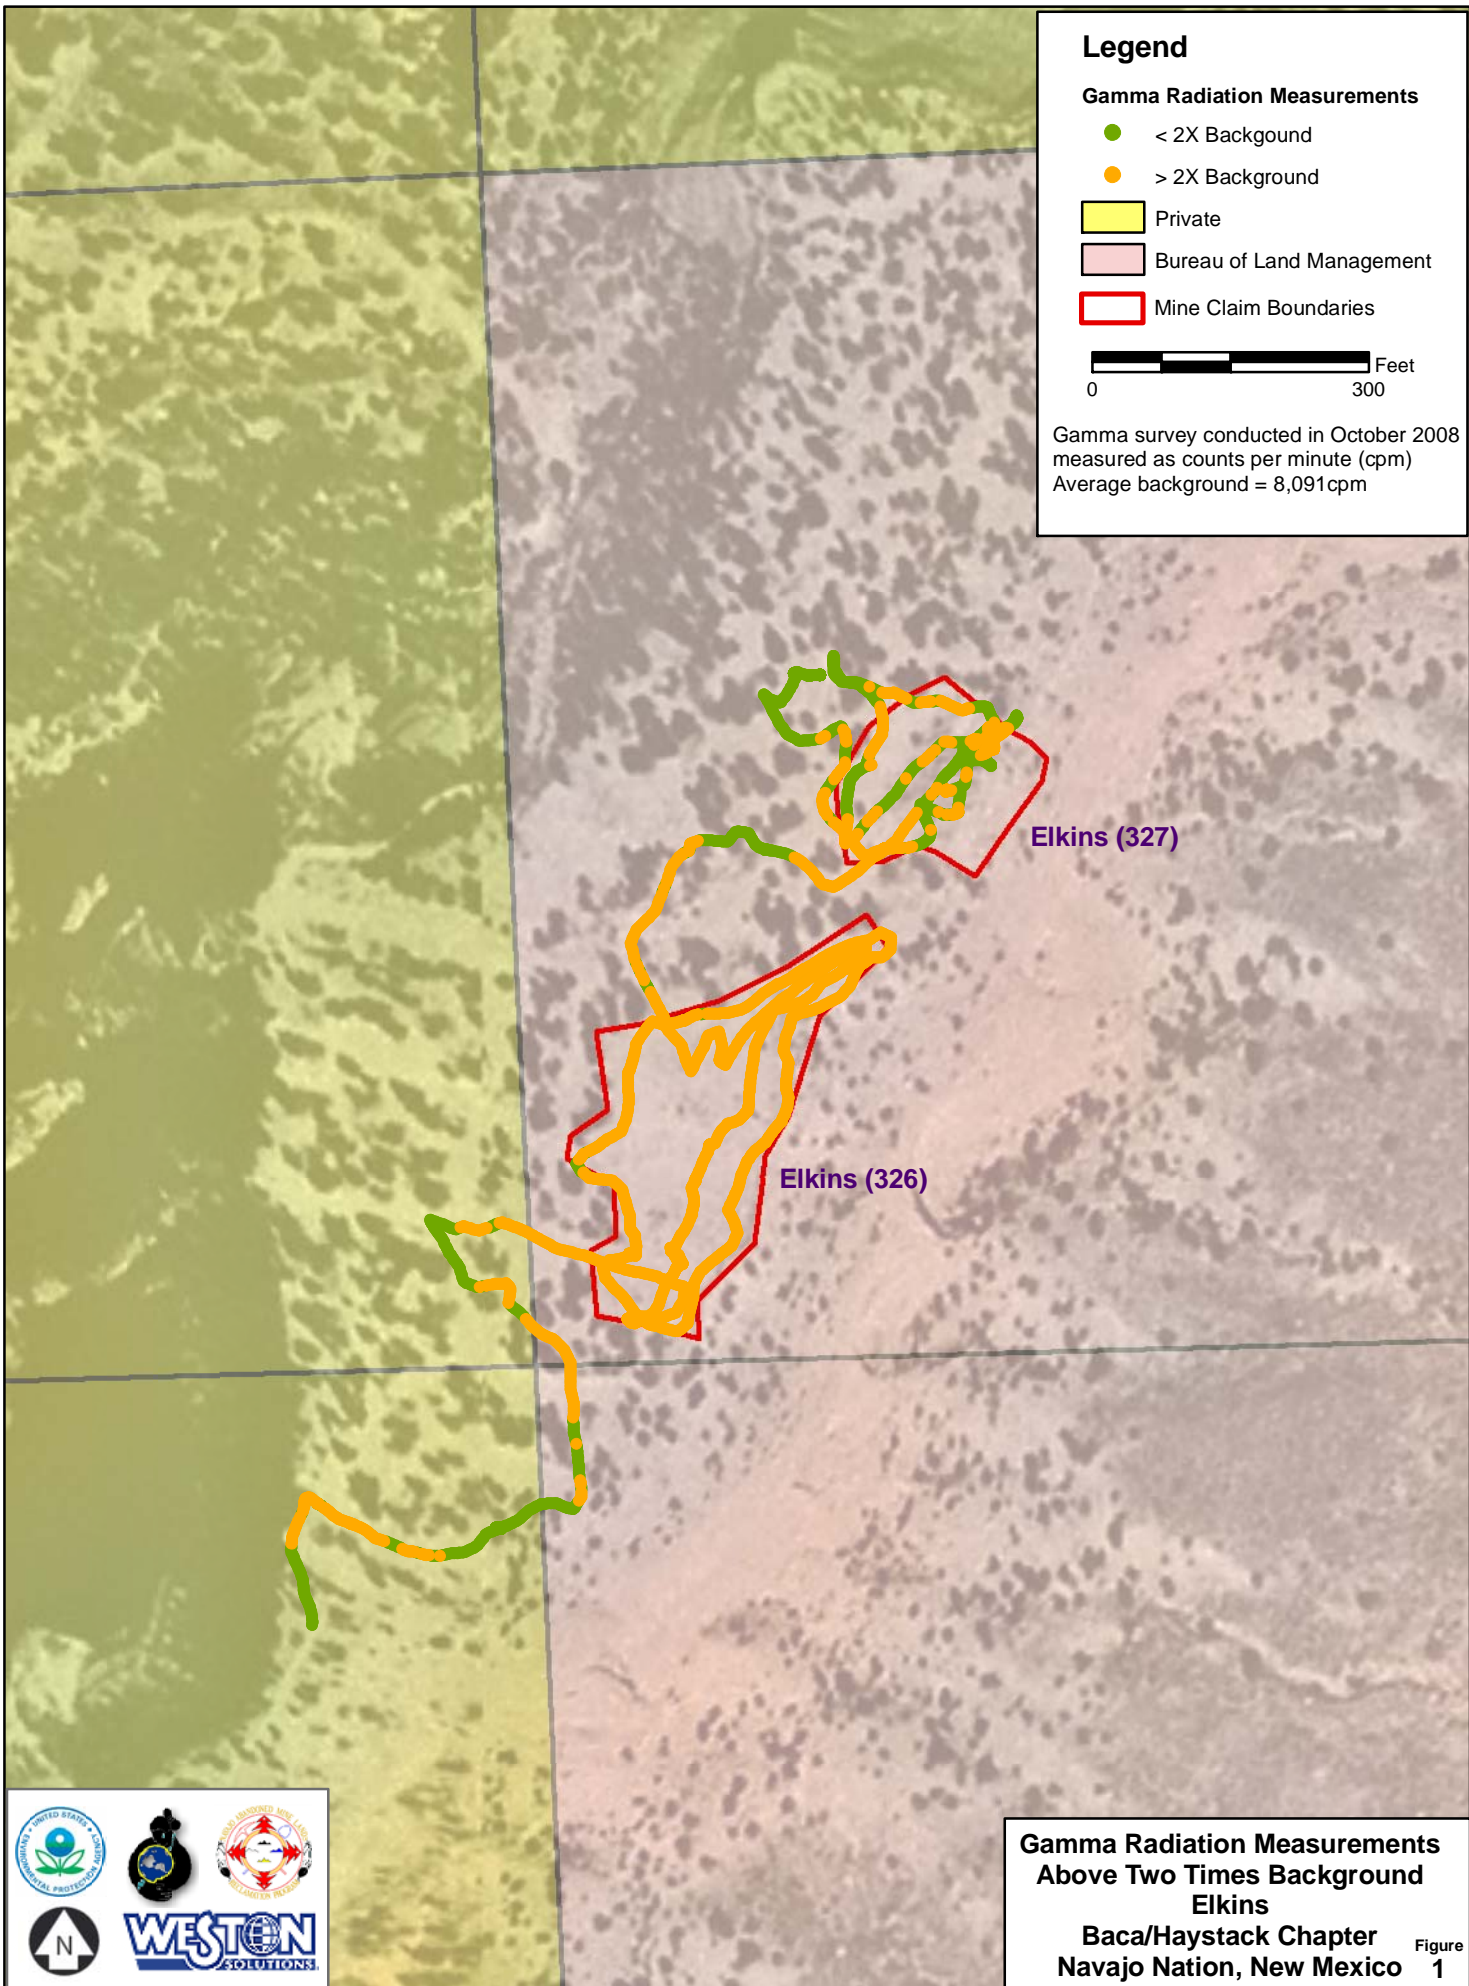
A total of 3,143 gamma radiation measurements were collected from the mine sites, ranging from 4,416 cpm to 423,104 cpm. The measurements are represented in Figures 1 and 2.

Gamma survey conducted in October 2008  
measured as counts per minute
