Navajo Abandoned Uranium Mine

Site Screen Report

Tohe Thlany Begay AUM Site

March 2010

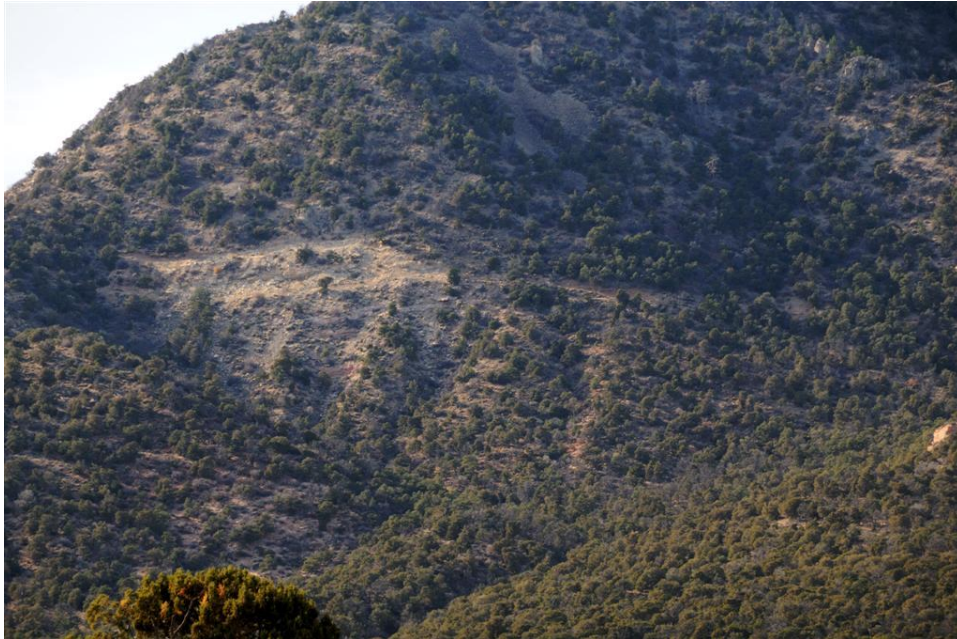
Photo 1. Down slope waste debris in the distance

Large waste pile off the side of cliff face, 350' x 100', with a total estimated volume of 6,480 yd³

Large unreclaimed waste pile down cliff side

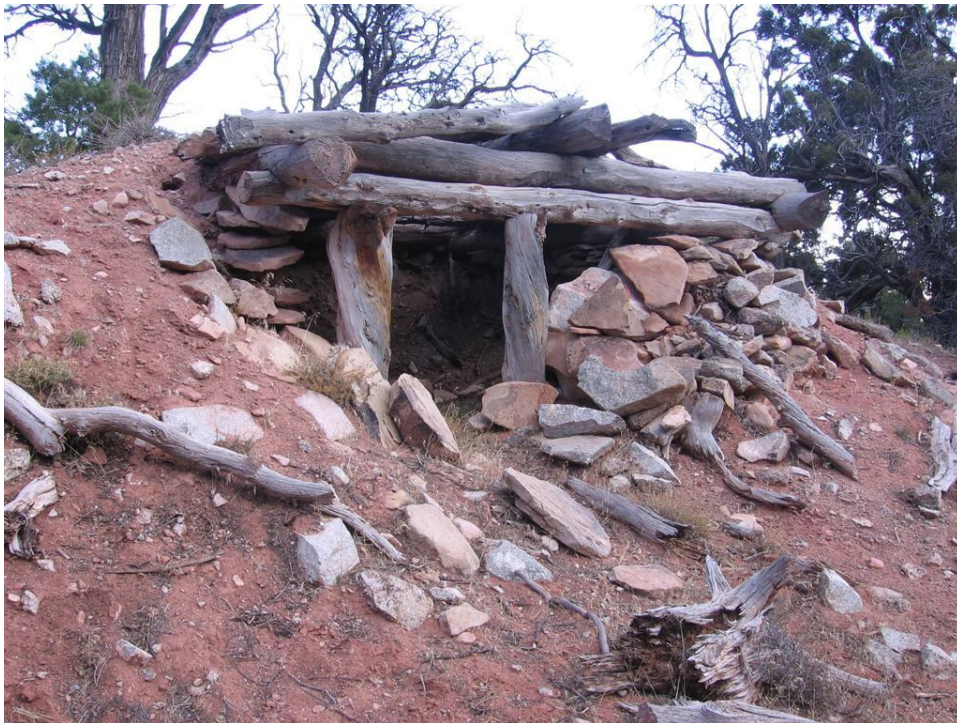
Photo 4. Small wood / stone structure offsite

Site appeared to be a rim strip operation; small wood and stone structure offsite
