Navajo Abandoned Uranium Mine Site Screen Report

Junior AUM Site

Navajo AUM Eastern Region

May 2009

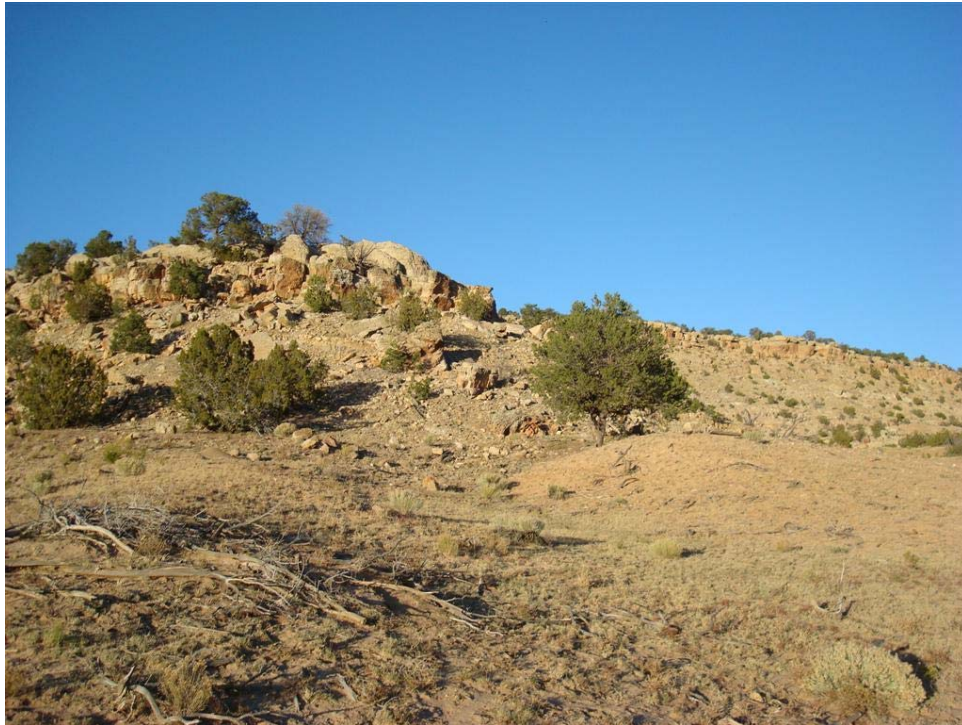
Photo 1. Junior Mine site, towards the north

Reclamation status of the mine sites are currently unknown. No visible signs of reclamation were observed. Some indication of excavation occurring along the base of the bluffs. No waste piles, adits, or other mine features were observed during the site visit.
