# **Navajo Abandoned Uranium Mine**

## **Site Screen Report**

## **Mel Gardner AUM Site**

**January 2011**

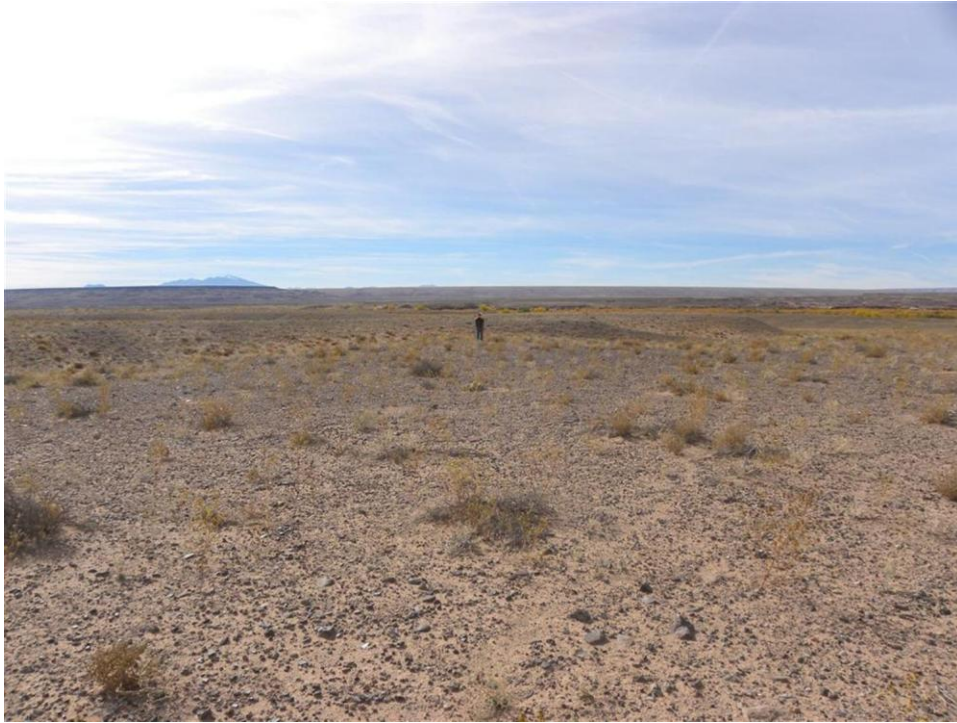
Photo 1. Mel Gardner mine site

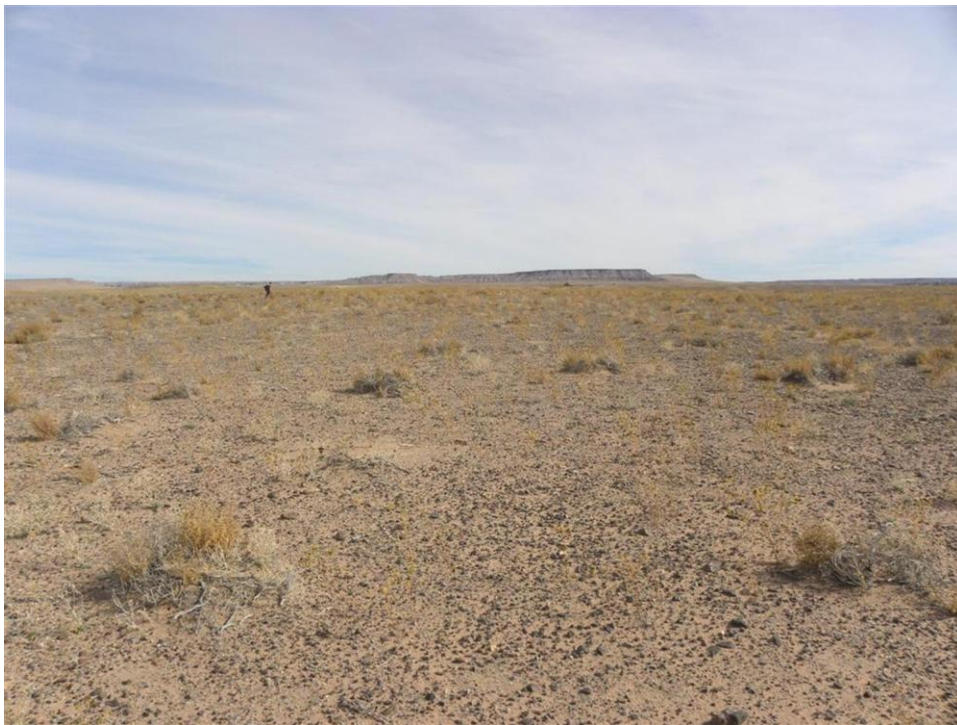
Photo 2. Mel Gardner mine site

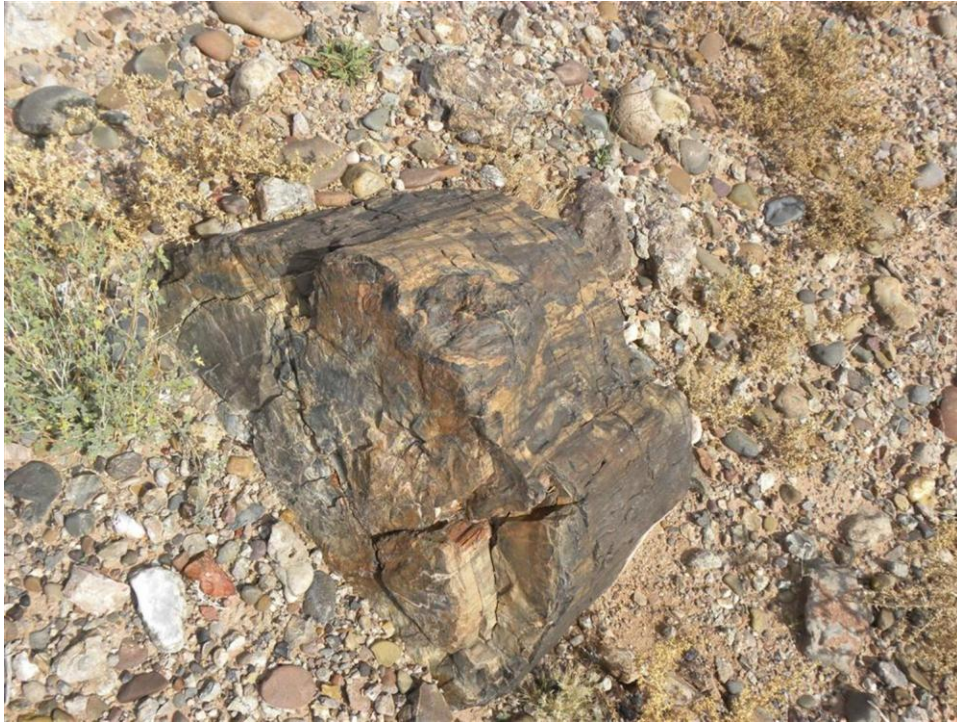
A total of 857 gamma radiation measurements were collected from the mine site, ranging from 8,925 cpm to 78,011 cpm. The measurements collected at an isolated piece of petrified wood were found at a maximum level of approximately 75,000 cpm. The measurements are represented in Figures 1 and 2.

Photo 3. Mel Gardner mine site, petrified wood, with elevated gamma readings

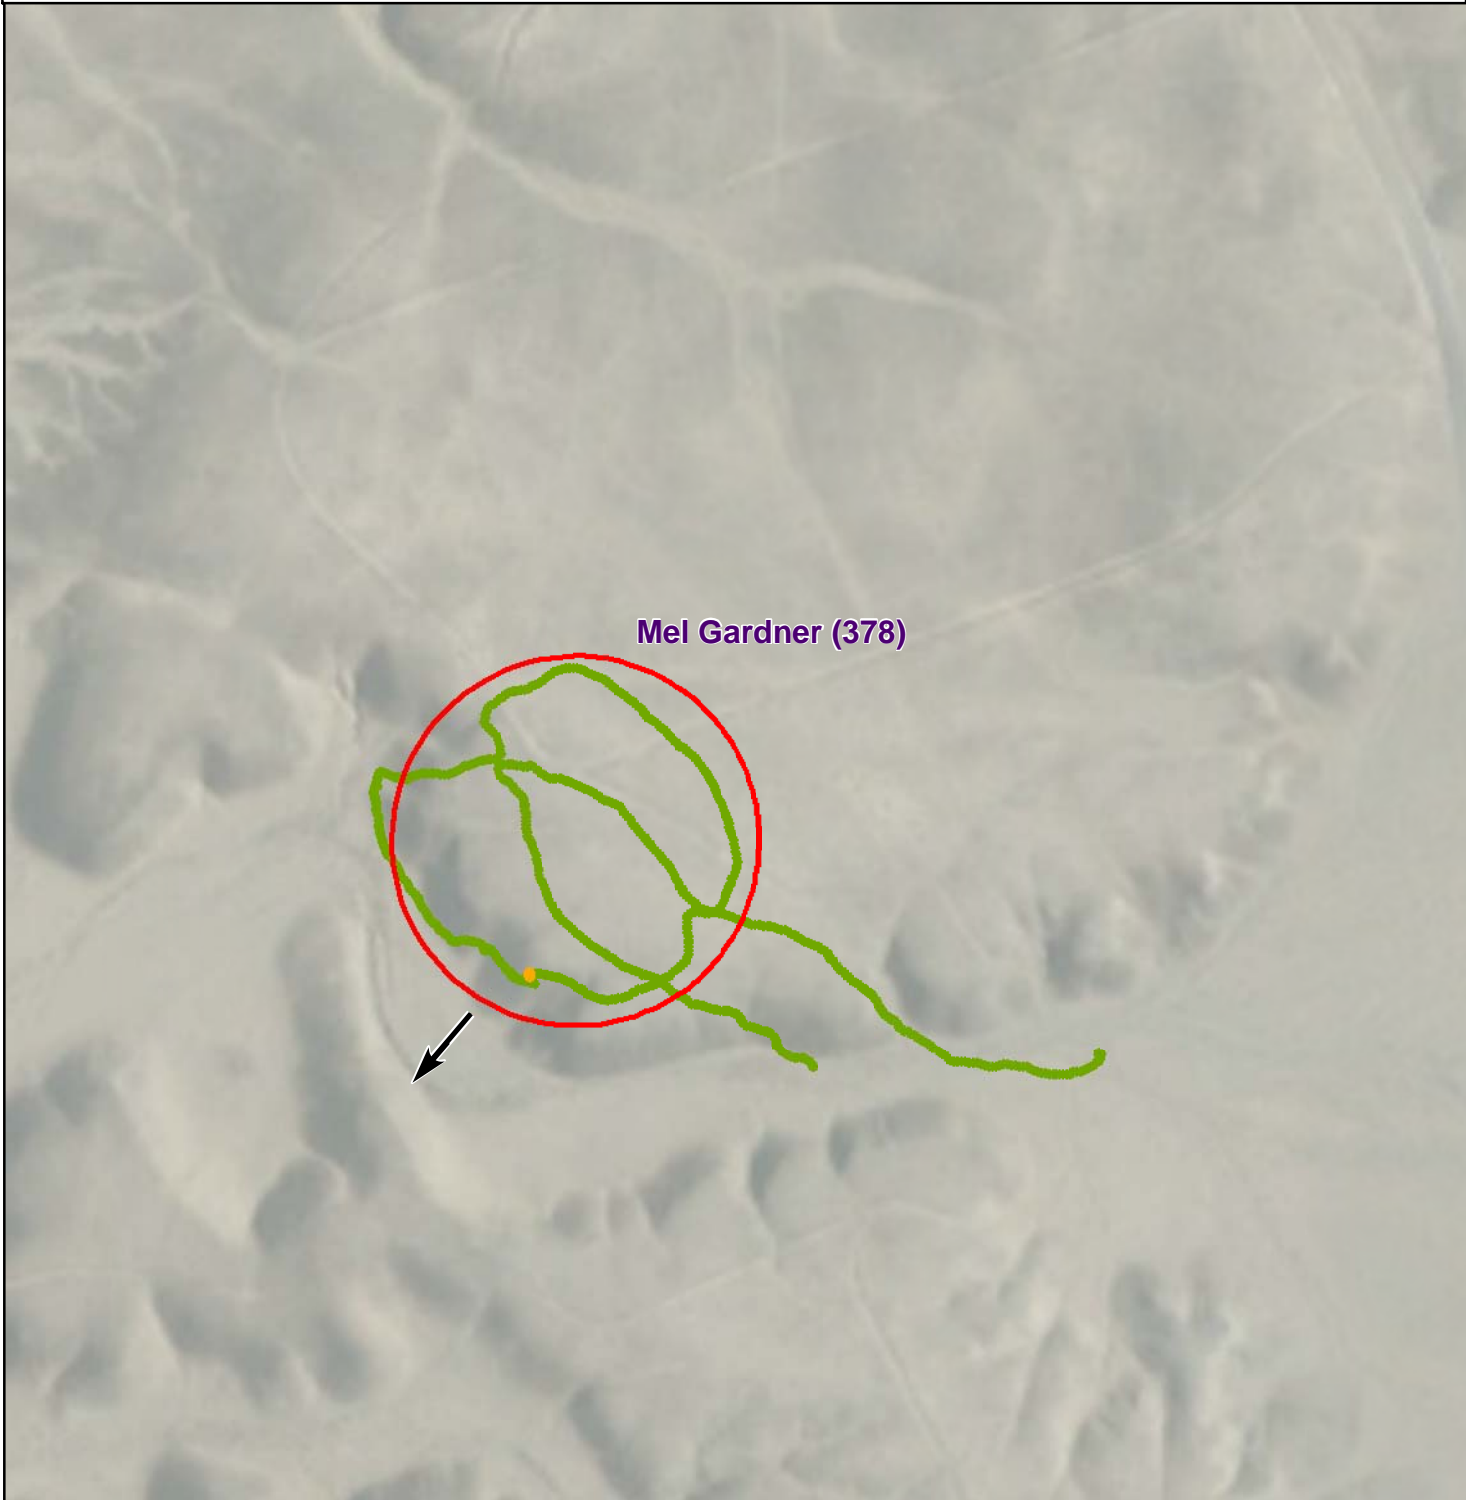
**Figure 1 - Gamma Radiation Measurements, Above Two Times  
Mel Gardner (378)  
Coalmine Mesa Chapter, Navajo Nation**

Gamma survey conducted 11/2010  
Measured as counts per minute (cpm)

Average background 10,540 cpm

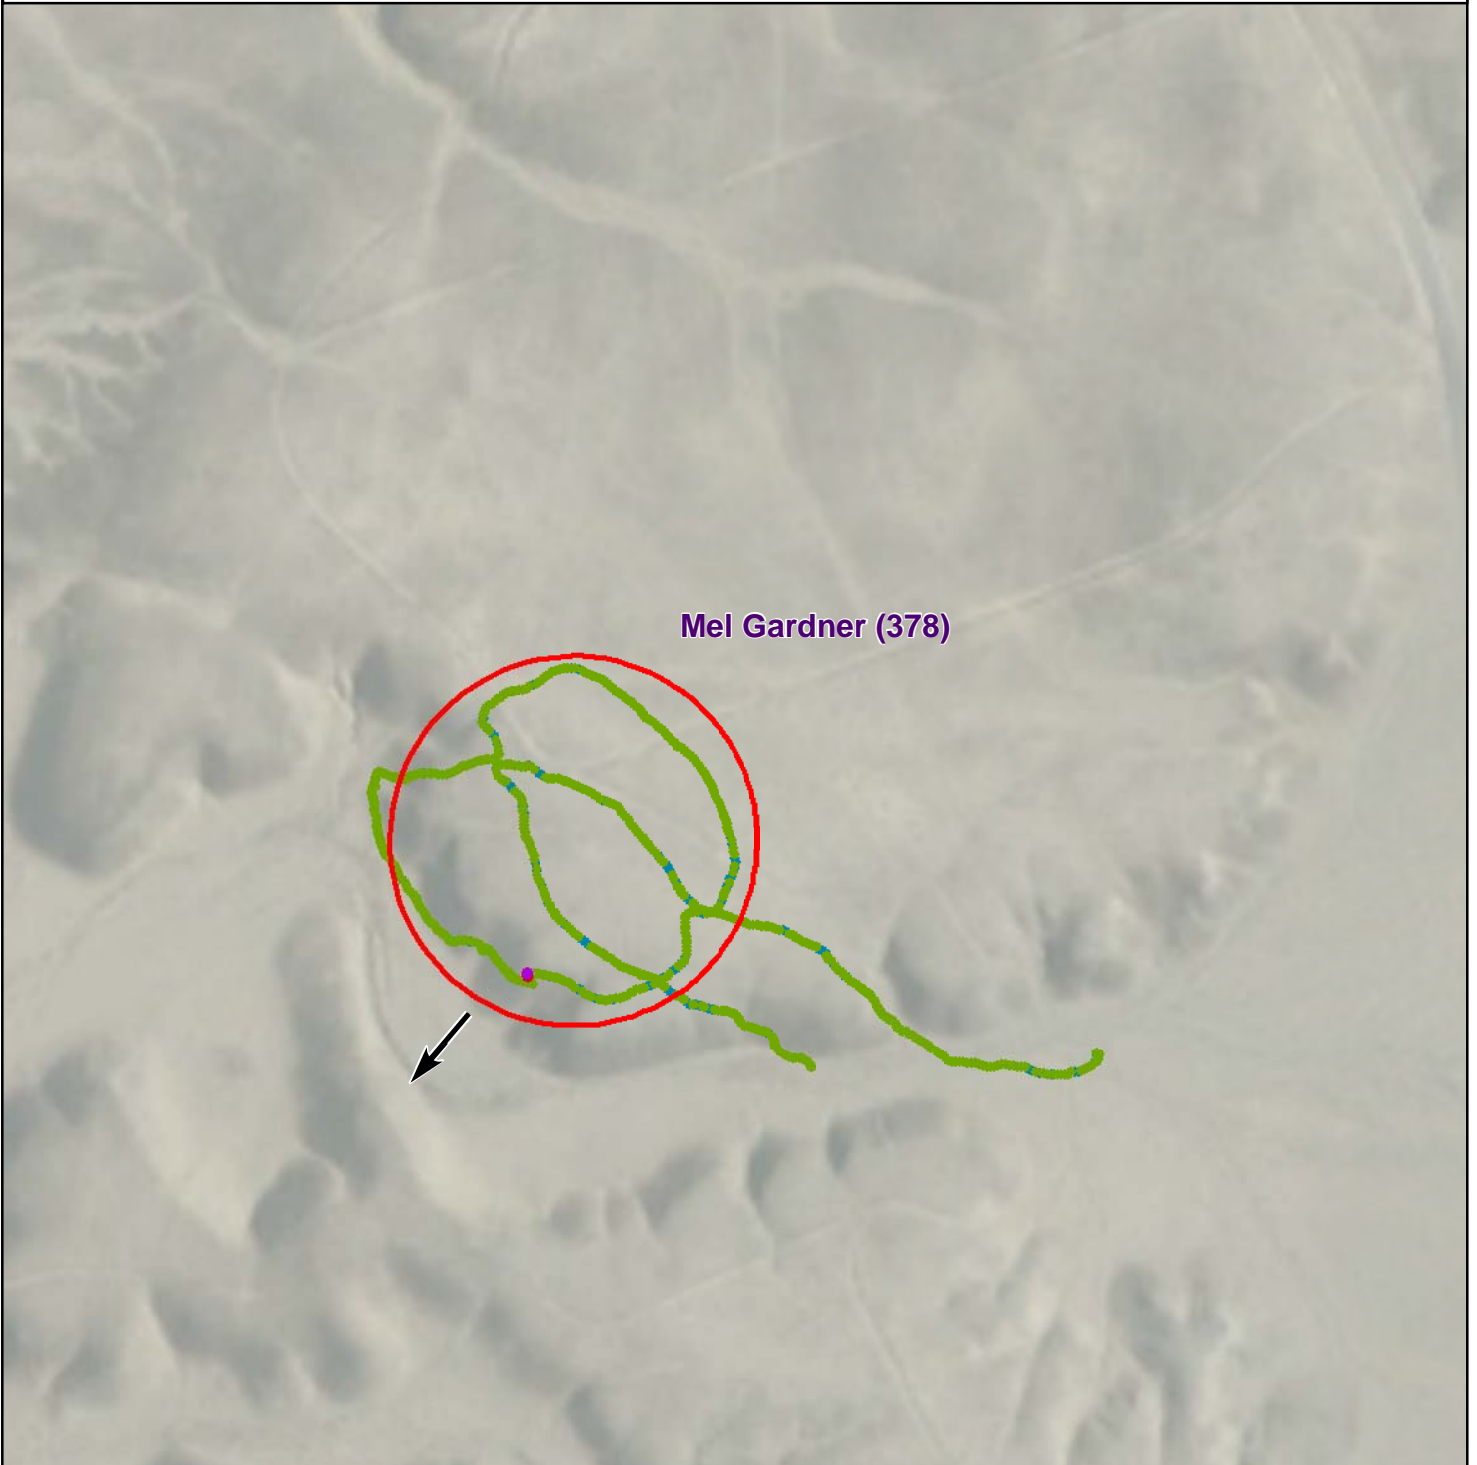
**Figure 2 - Gamma Radiation Measurements  
Mel Gardner (378)  
Coalmine Mesa Chapter, Navajo Nation**

**Gamma survey conducted 11/2010  
Measured as counts per minute (cpm)**

**Average background 10,540 cpm**
