Navajo Abandoned Uranium Mine

Site Screen Report

Pat Lynch AUM Site

January 2011

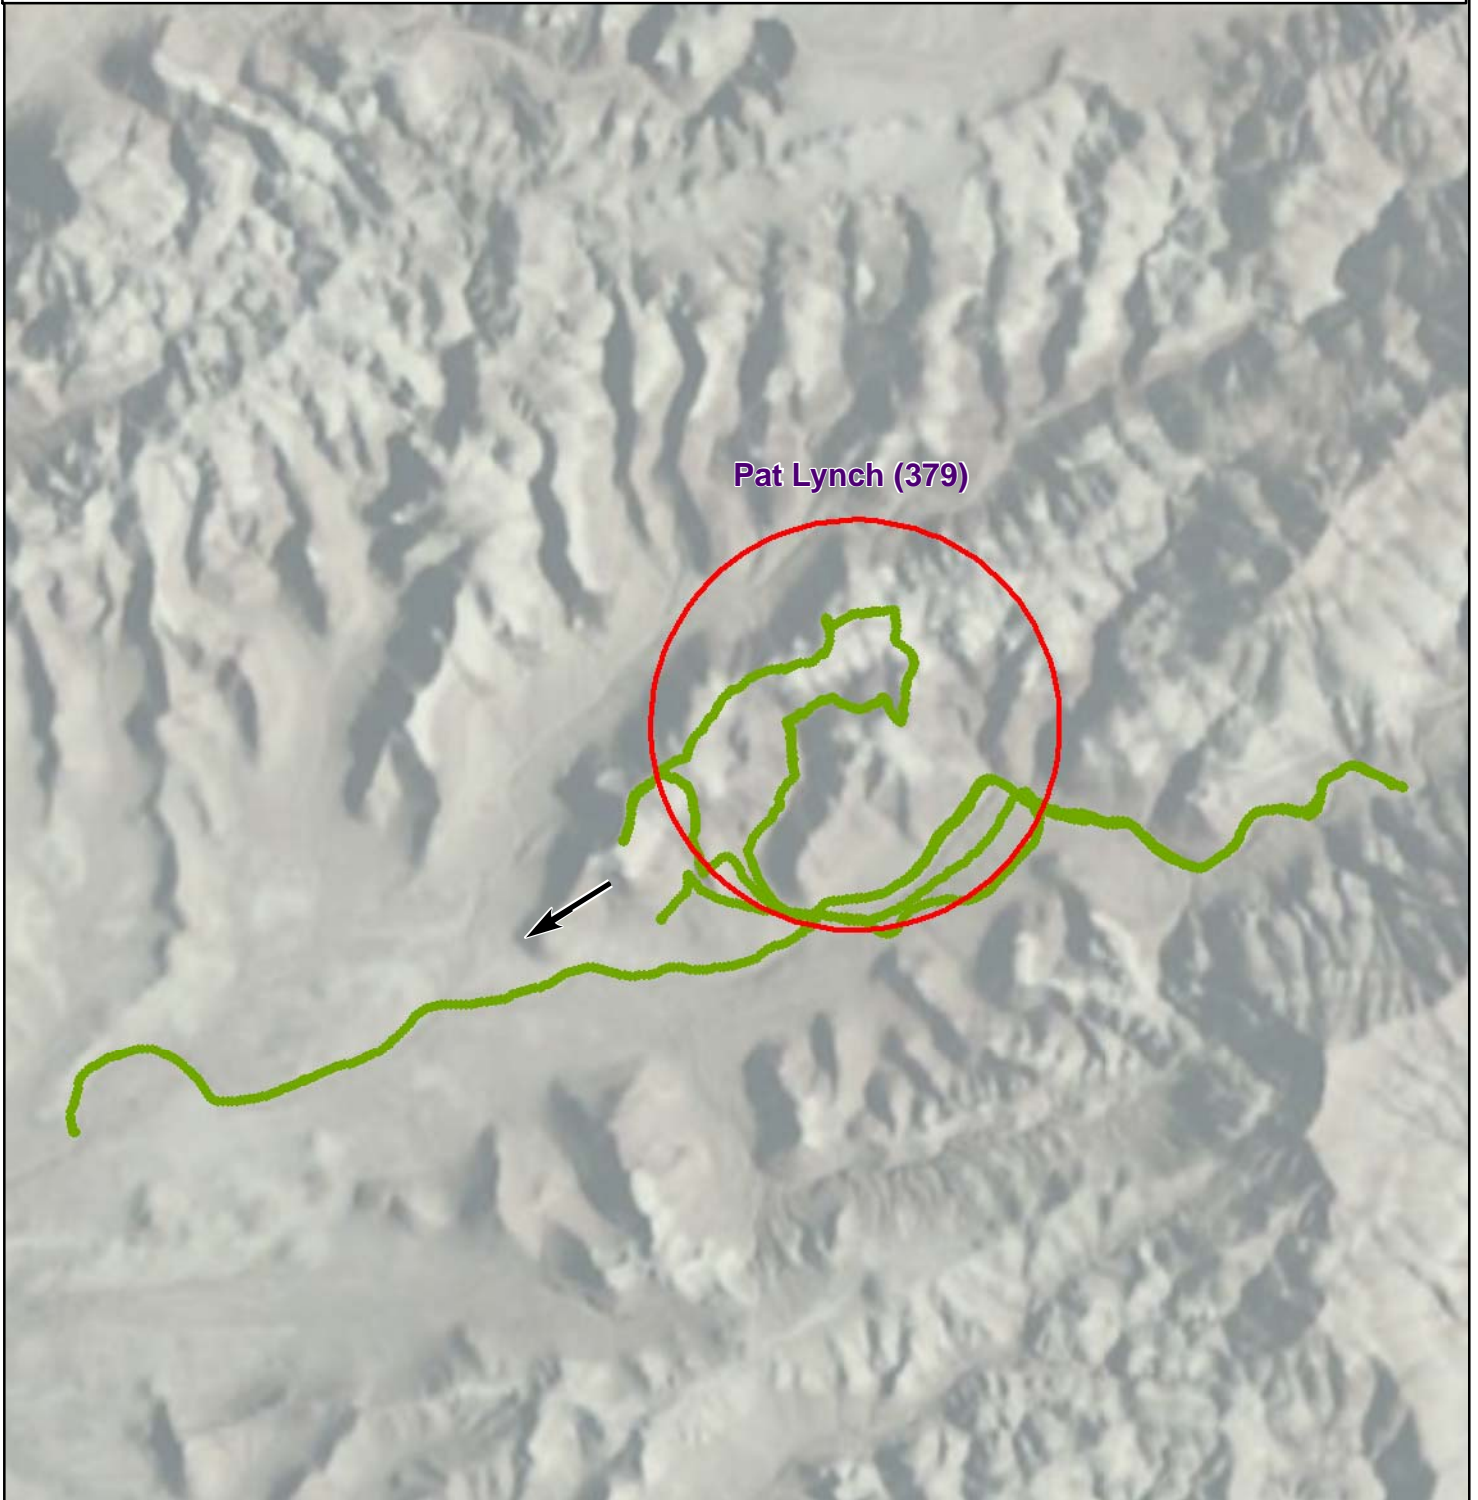
**Figure 1 - Gamma Radiation Measurements, Above Two Times
Pat Lynch (379)
Coalmine Mesa Chapter, Navajo Nation**

Gamma survey conducted 11/2010
Measured as counts per minute (cpm)

Average background 15,788 cpm

A total of 1,679 gamma radiation measurements were collected from the mine site, ranging from 9,640 cpm to 22,069 cpm. The measurements are represented in Figures 1 and 2.
