Navajo Abandoned Uranium Mine

Site Screen Report

Cam061 AUM Site

January 2011

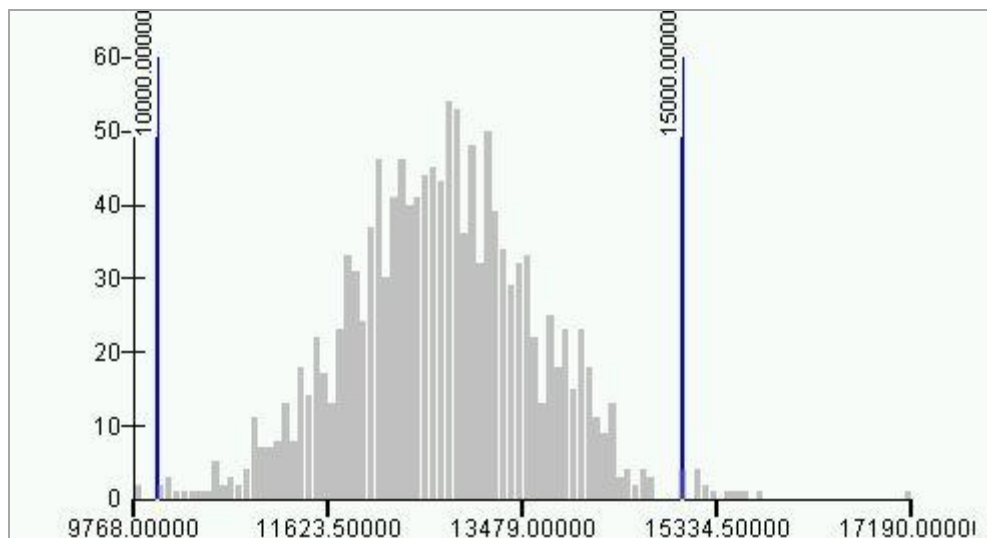
The following chart and statistics were generated by ESRI ArcGIS 9.3.1, and show the general distribution of the site gamma radiation measurements. The horizontal X axis represents the gamma radiation reading levels in cpm (lowest levels to the left). The vertical Y axis represents the frequency of each gamma radiation level.

Count:	1352
Minimum:	9768.00000
Maximum:	17190.00000
Sum:	17177366.00000
Mean:	12705.15237
Median:	12716.50000
Standard Deviation:	906.09844

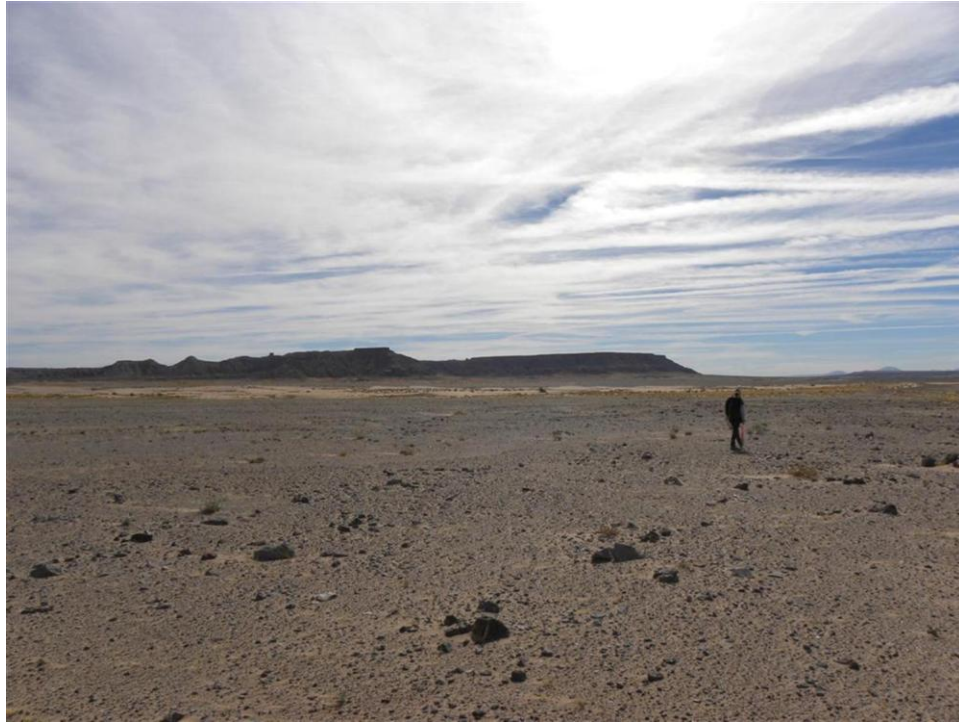
Photo 1. Cam061 mine site

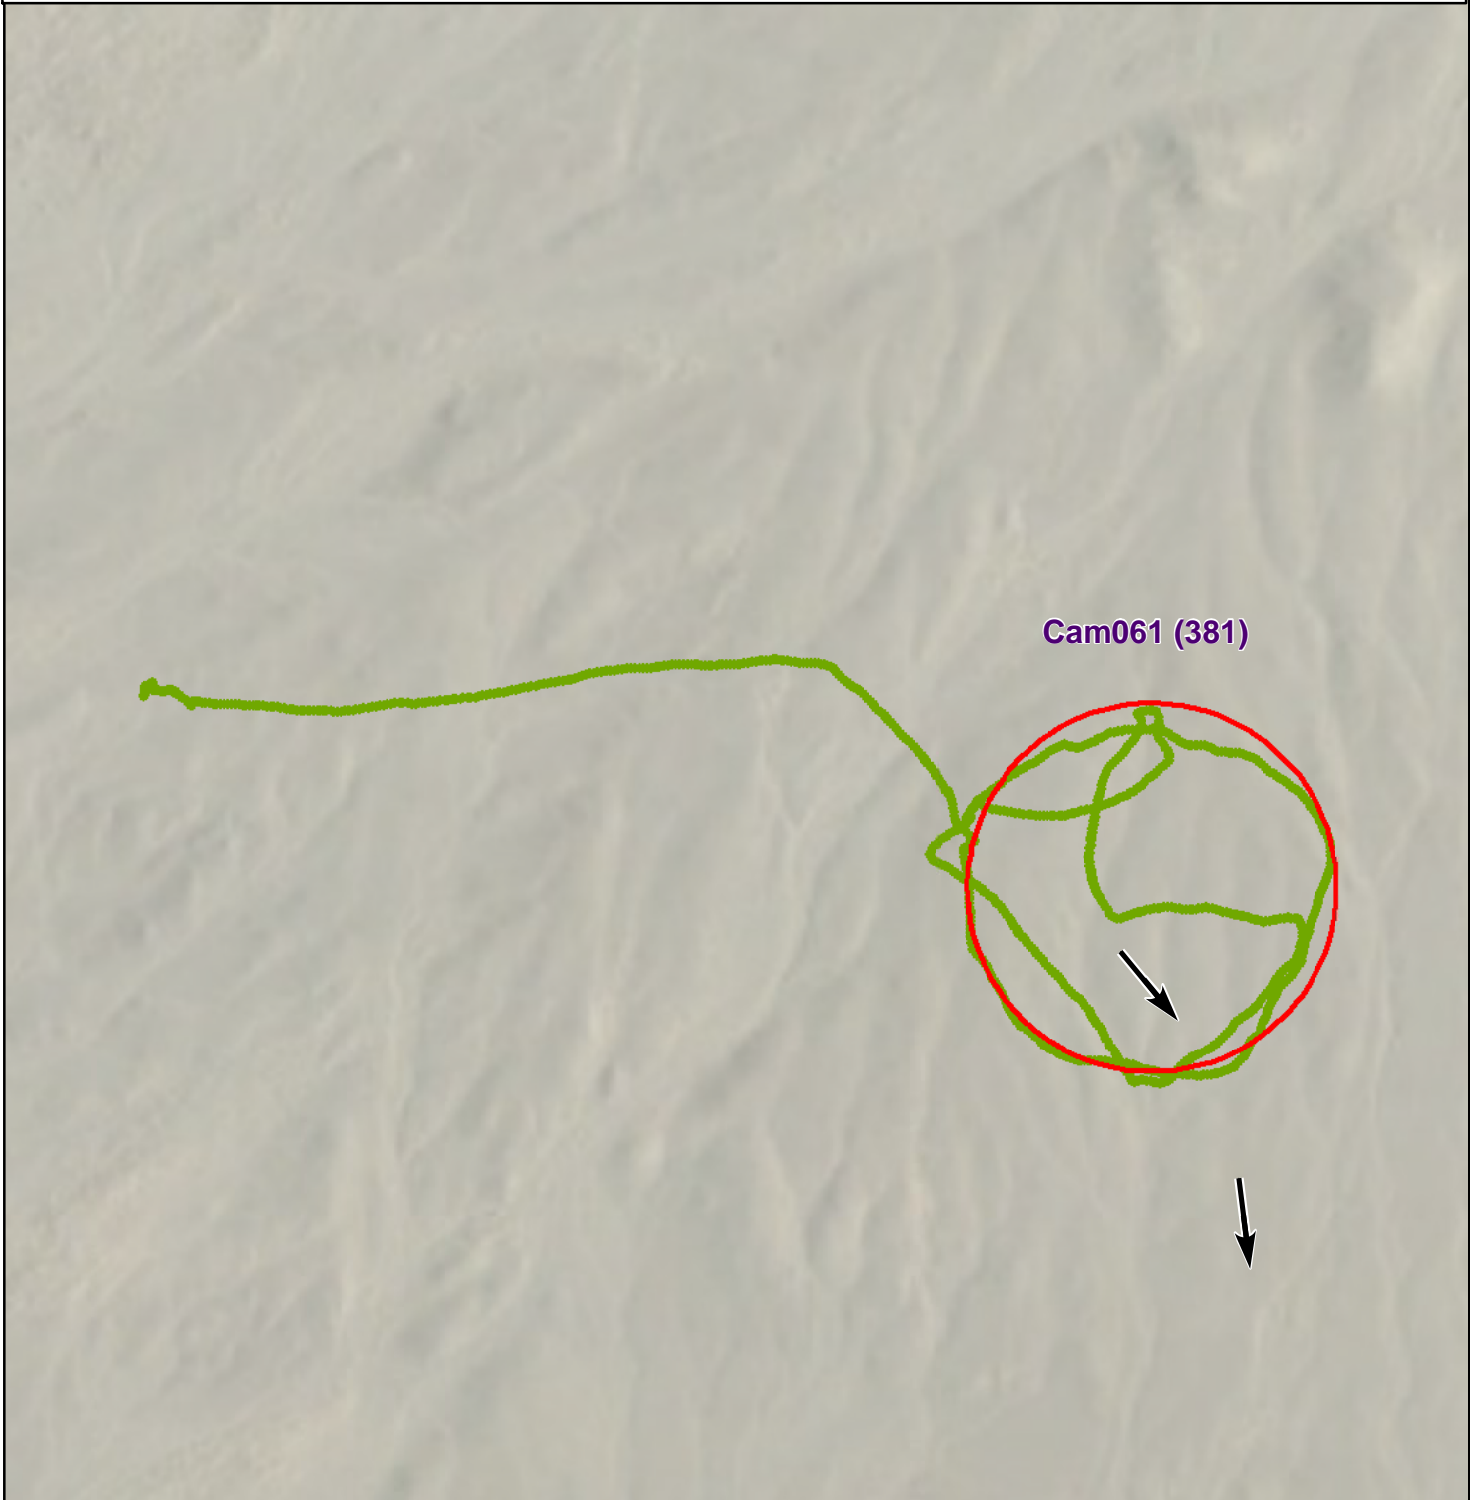
**Figure 1 - Gamma Radiation Measurements, Above Two Times
Cam061 (381)
Coalmine Mesa Chapter, Navajo Nation**

Gamma survey conducted 11/2010
Measured as counts per minute (cpm)

Average background 12,457 cpm

A total of 1,352 gamma radiation measurements were collected from the mine site, ranging from 9,768 cpm to 17,190 cpm. The measurements are represented in Figures 1 and 2.

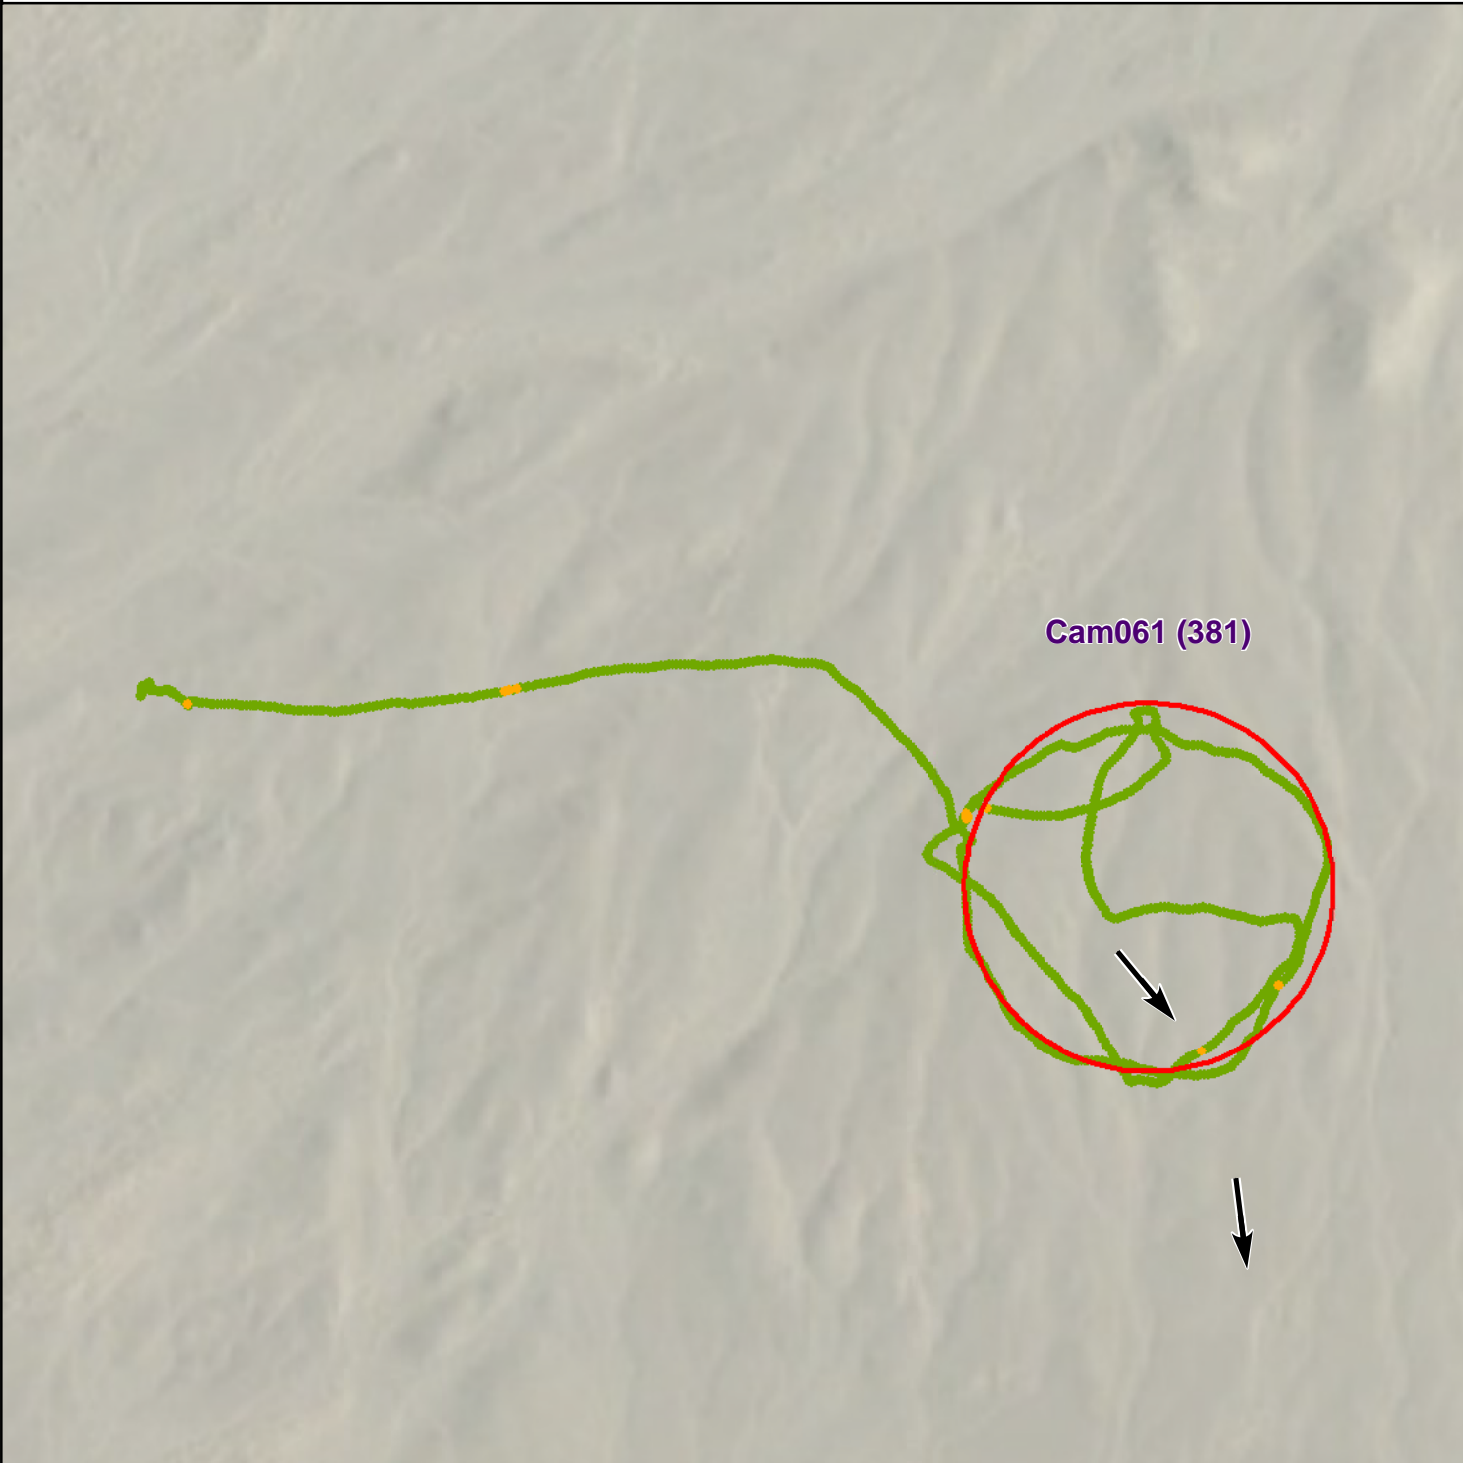
**Figure 2 - Gamma Radiation Measurements
Cam061 (381)
Coalmine Mesa Chapter, Navajo Nation**

**Gamma survey conducted 11/2010
Measured as counts per minute (cpm)**

Average background 12,457 cpm
