Navajo Abandoned Uranium Mine

Site Screen Report

Charles Huskon No. 14 AUM Site

January 2011

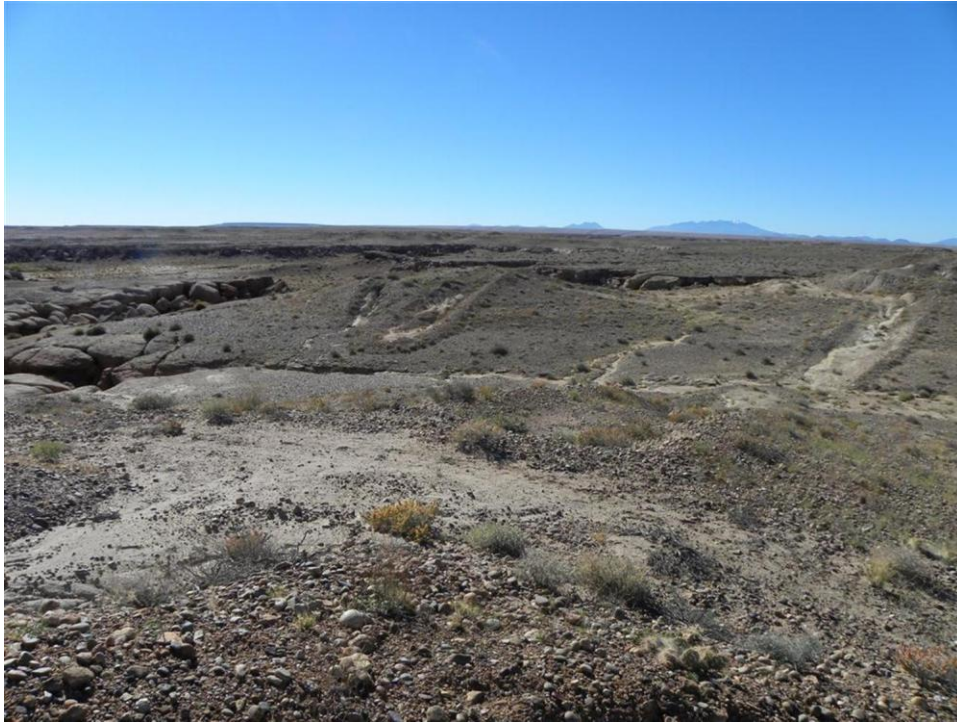
Photo 1. Charles Huskon No. 14 mine site

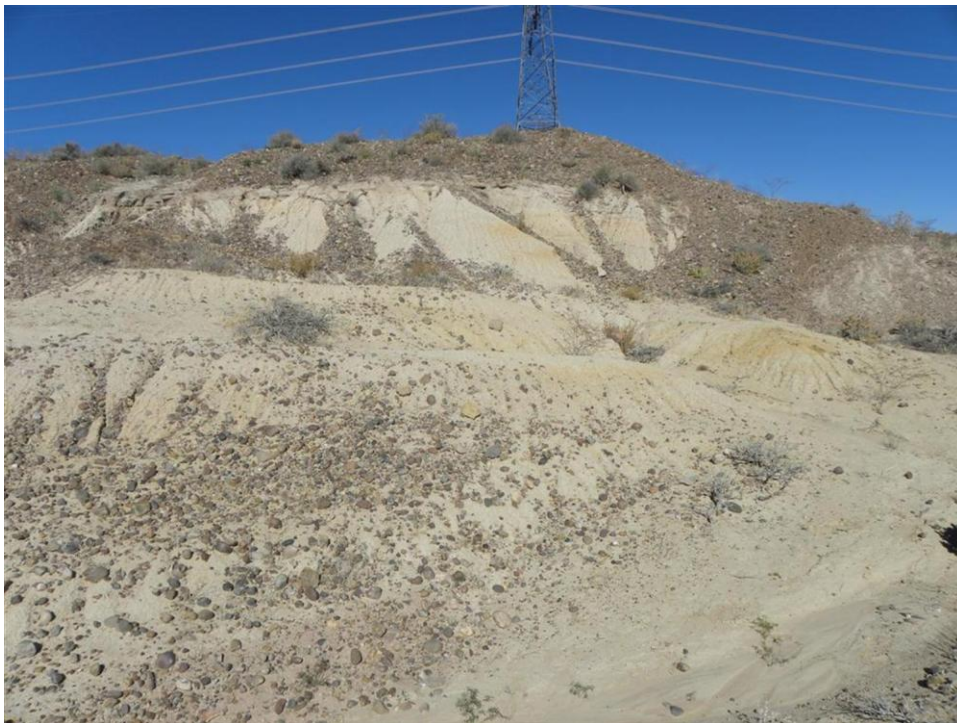
Photo 2. Charles Huskon No. 14 mine site, waste piles and powers line

2 Waste piles: 1 - 15' x 20' x 2' fine yellow-brown material along with multiple ambiguous piles;
2 - 10' x 30' x 2.5' fine yellow-brown material along with exposed material in sidewalls and drainages

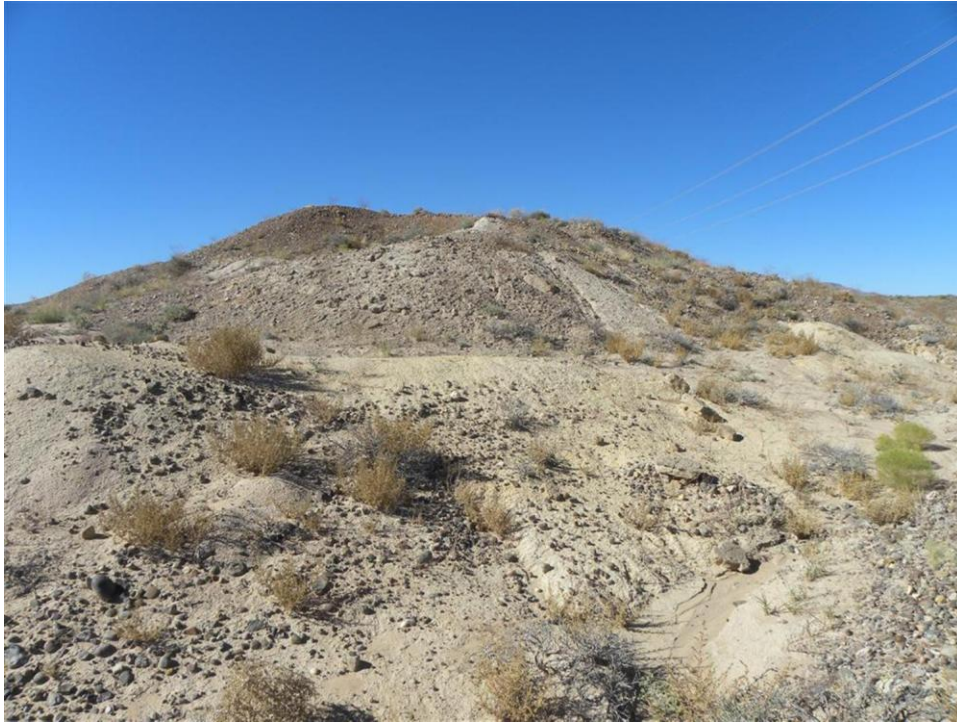
Photo 3. Charles Huskon No. 14 mine site, waste piles

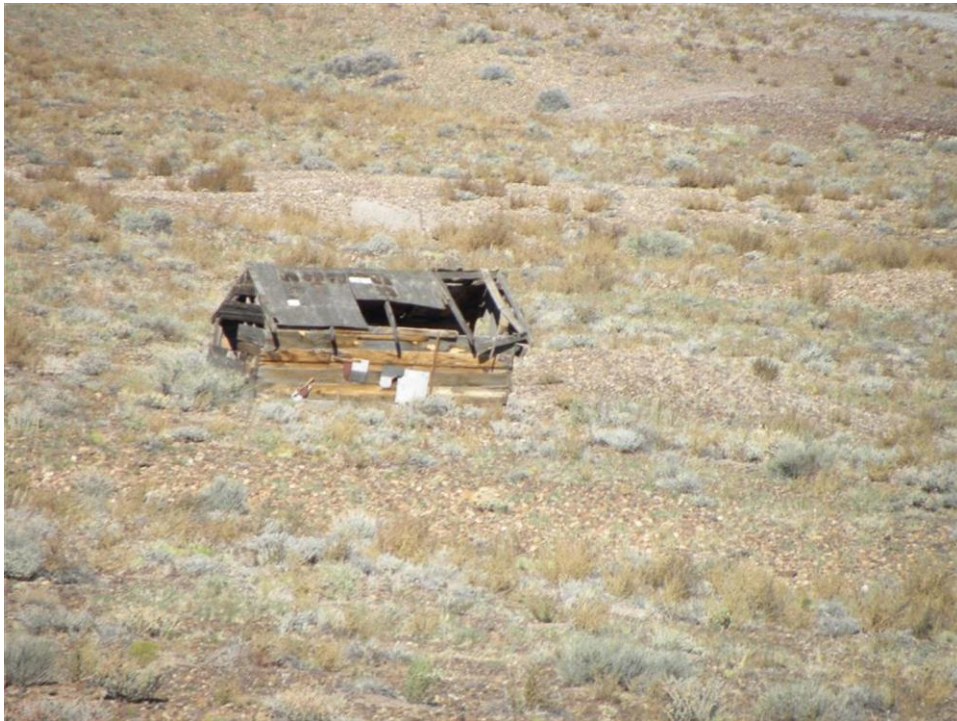
Photo 3. Charles Huskon No. 14 mine site, nearby collapsed wood structure

200 feet to 0.25 mile: Uninhabited collapsed wooden structure

Background levels near structure
