Navajo Abandoned Uranium Mine

Site Screen Report

Paul Huskie No. 20 AUM Site

January 2011

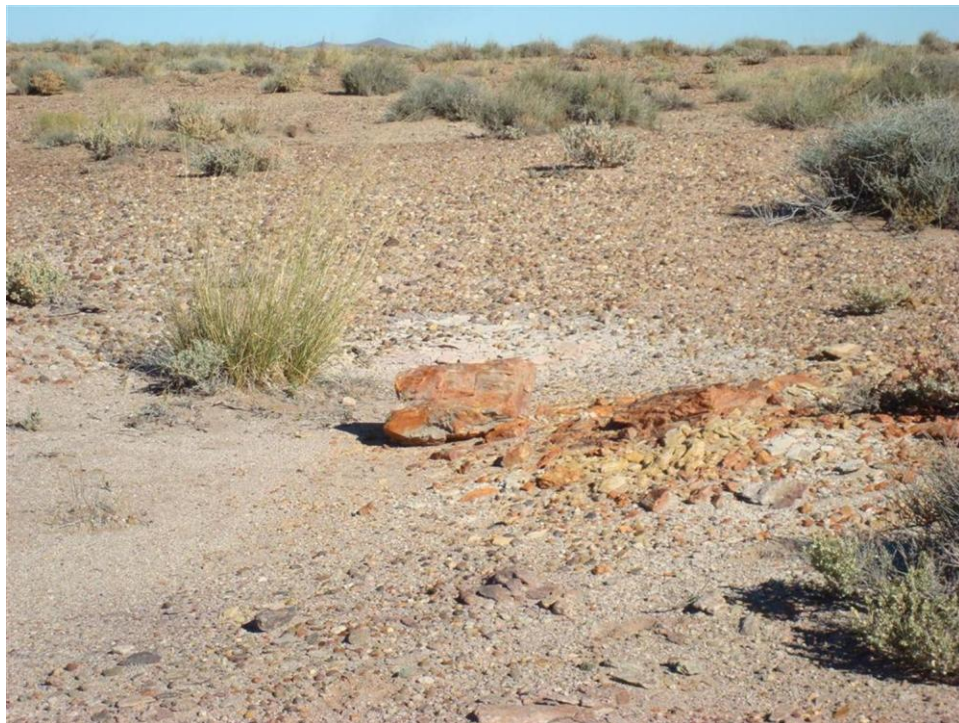
A total of 1,648 gamma radiation measurements were collected from the mine site, ranging from 9,139 cpm to 247,089 cpm. The measurements collected at an isolated pile of petrified wood were found at a maximum level of approximately 250,000 cpm. The measurements are represented in Figures 1 and 2.

Photo 2. Paul Huskie No. 20 mine site, petrified wood with elevated gamma readings

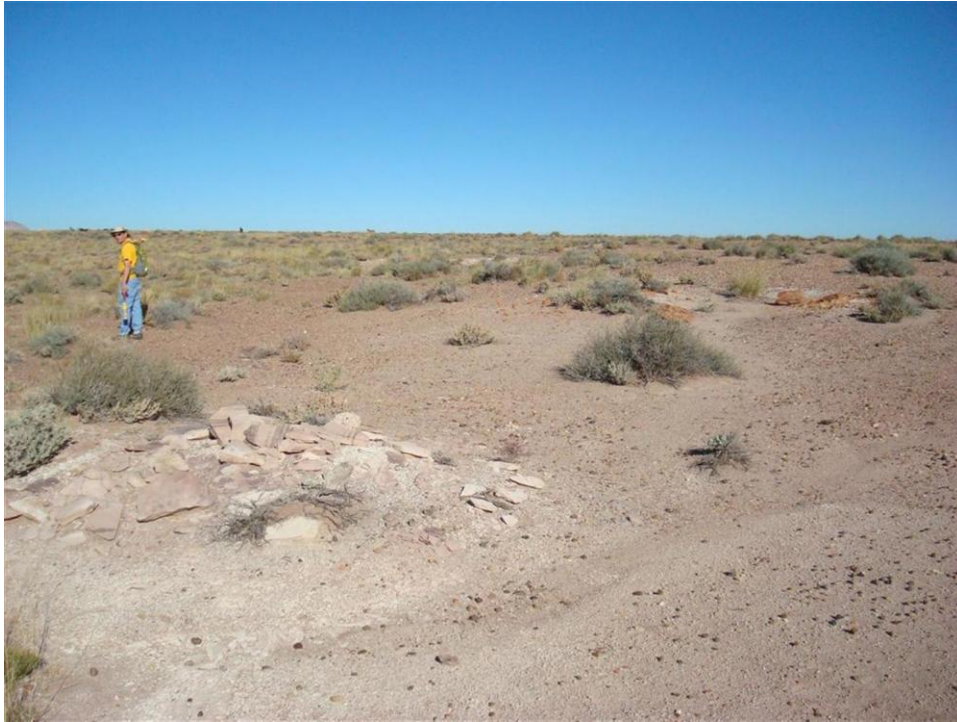
Photo 3. Paul Huskie No. 20 mine site, area of elevated gamma readings
