Navajo Abandoned Uranium Mine

Site Screen Report

Black Hair No. 4 AUM Site

Navajo AUM Western Region

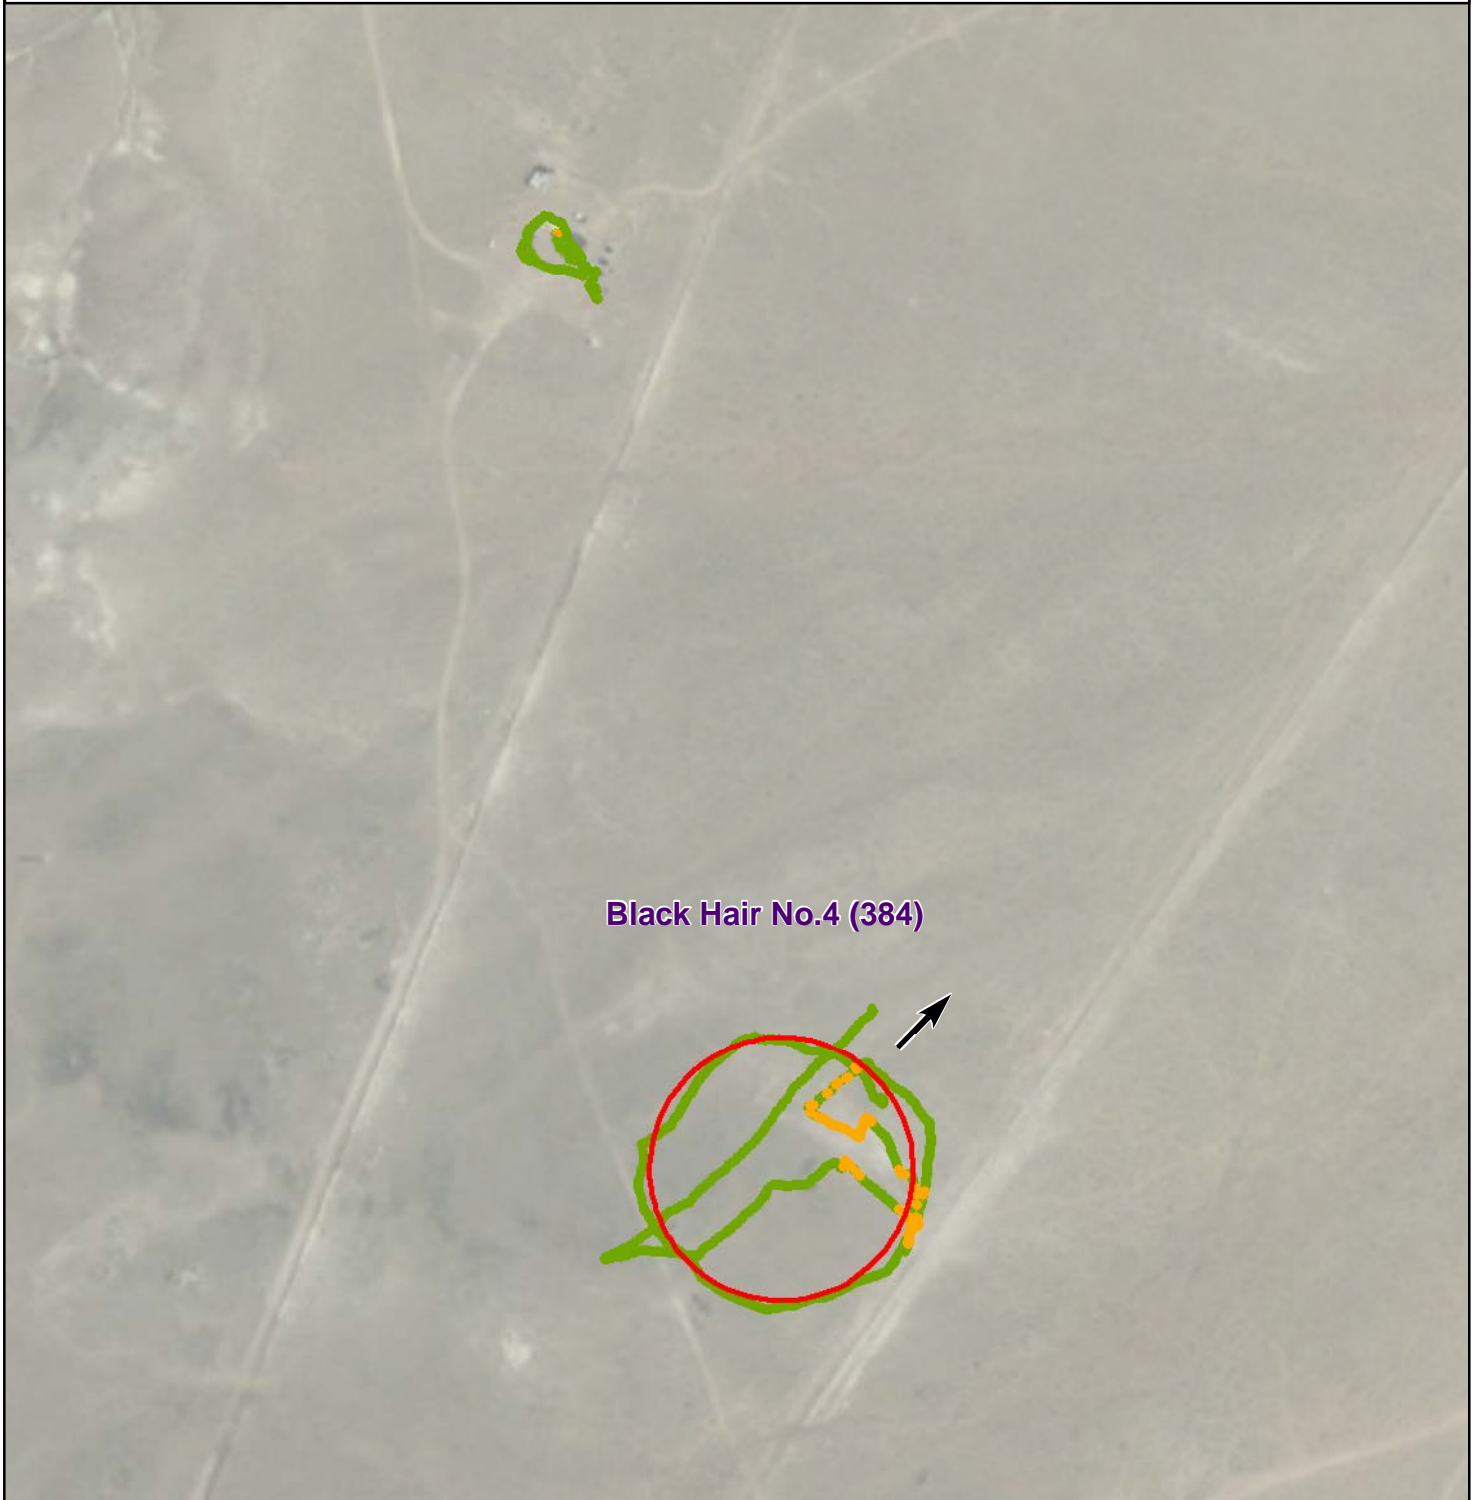
**Figure 1 - Gamma Radiation Measurements, Above Two Times Background
Black Hair No.4 (384)
Cameron Chapter, Navajo Nation**

A total of 1,642 gamma radiation measurements were collected from the mine site, ranging from 8,402 cpm to 46,385 cpm. The measurements collected at an isolated piece of petrified wood on front porch of the nearby house were found at a maximum level of approximately 45,000 cpm. The measurements are represented in Figures 1 and 2.

Gamma survey conducted 11/2010
Measured as counts per minute (cpm)

Average background 11,333 cpm

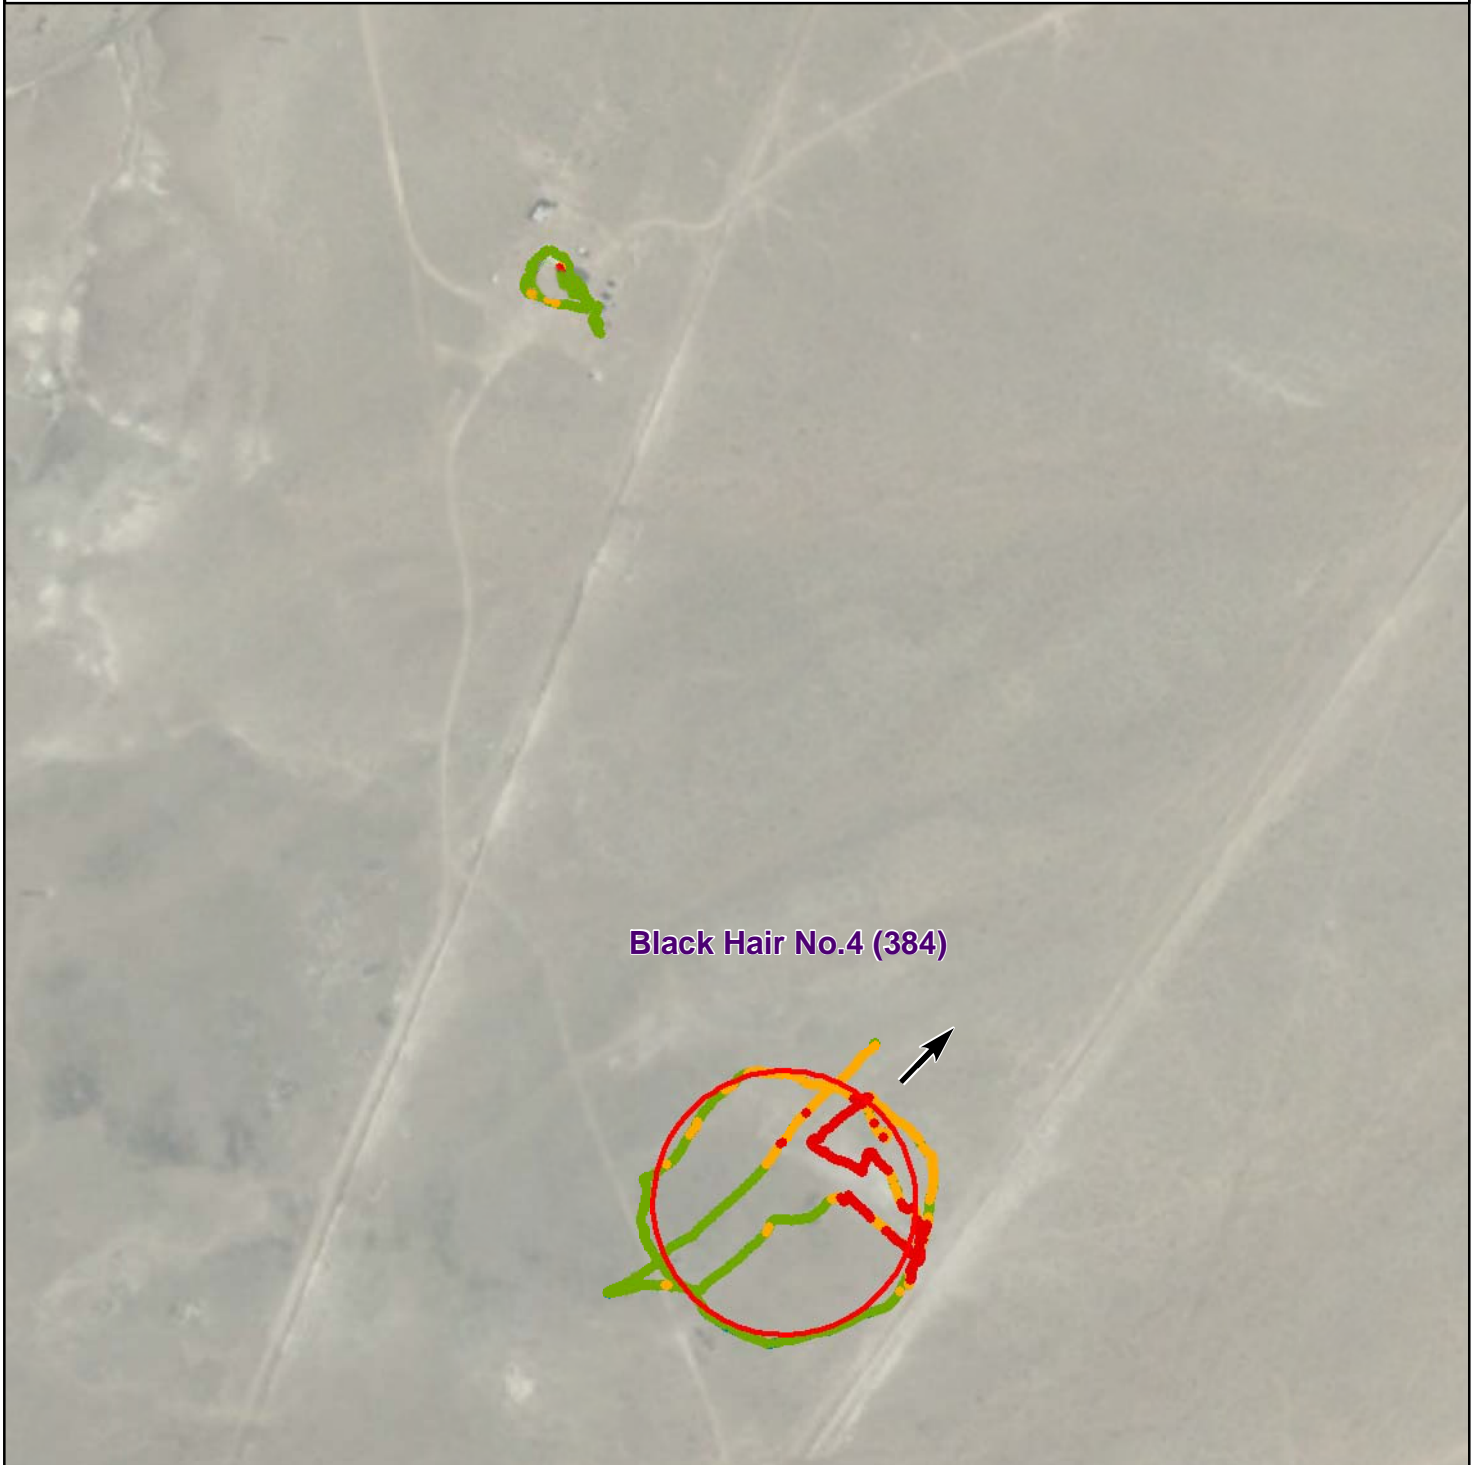
**Figure 2 - Gamma Radiation Measurements
Black Hair No.4 (384)
Cameron Chapter, Navajo Nation**

**Gamma survey conducted 11/2010
Measured as counts per minute (cpm)**

Average background 11,333 cpm
