# Navajo Abandoned Uranium Mine

## Site Screen Report

### Carl Yazzie 1 AUM Site

**March 2010**

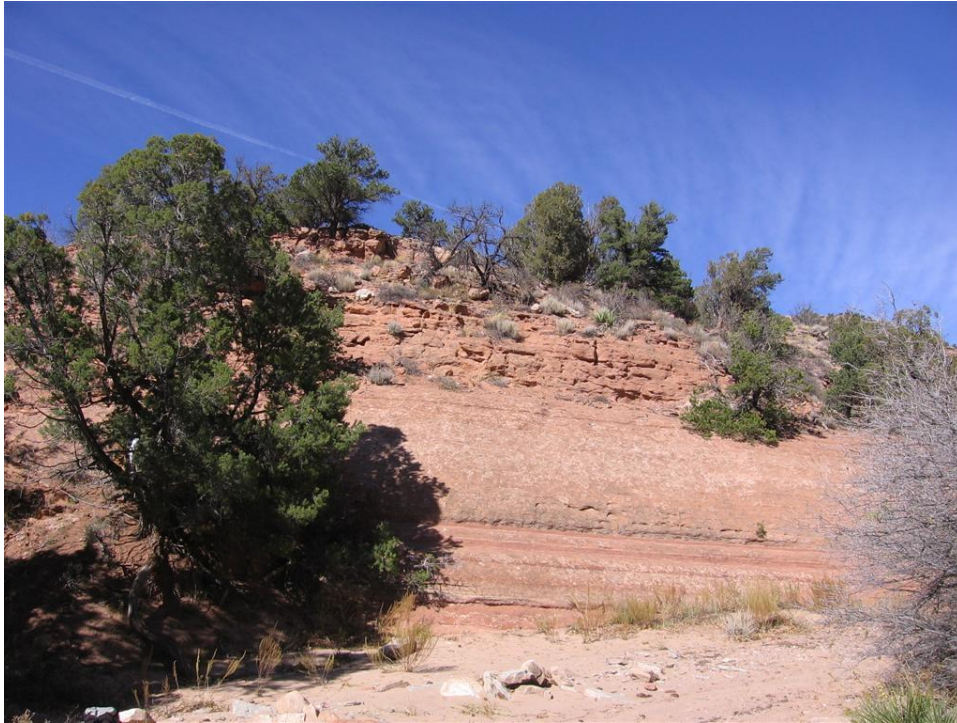
Rock debris from cliff above, two waste piles: 50' x 150'; 30' x 30'; with a total estimated volume of 1,556 yd<sup>3</sup>

Photo 5. Waste rock

2 unreclaimed waste piles
