Navajo Abandoned Uranium Mine

Site Screen Report

Mesa IV 1/4 Mine AUM Site

March 2010

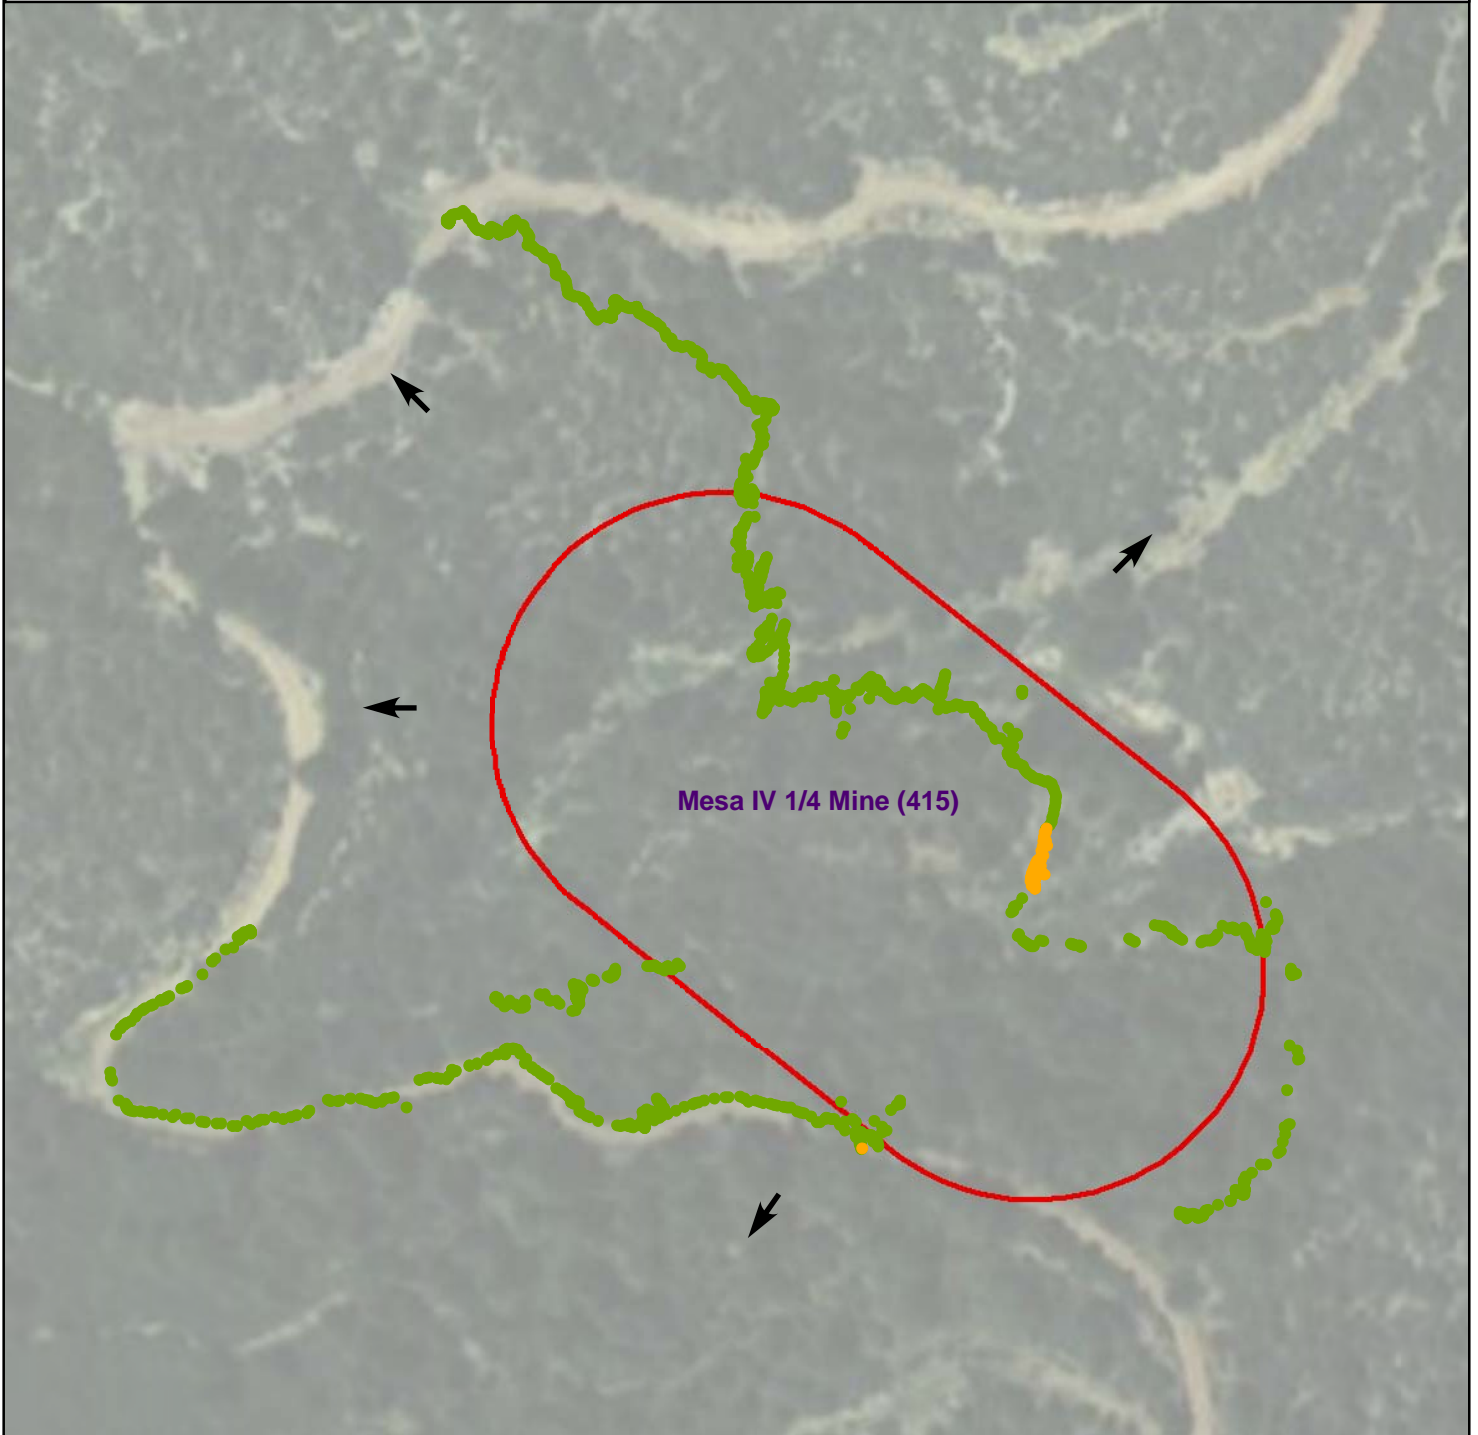
**Figure 1 - Gamma Radiation Measurements, Above Two Times Background
Mesa IV 1/4 Mine (415)
Cove Chapter, Navajo Nation, Arizona**

Note: Due to heavy vegetation, poor satellite coverage was encountered throughout the site.

Gamma survey conducted 10/2009
Measured as counts per minute (cpm)

Average background = 13,629 cpm

A total of 1,776 gamma radiation measurements were collected from the mine site, ranging from 8,559 cpm to 411,359 cpm. Measurements in the vicinity of the waste debris were found at levels in up to 120,000 cpm. The measurements are represented in Figures 1 and 2.
