# Navajo Abandoned Uranium Mine

## Site Screen Report

### **Cov068 AUM Site**

#### **Navajo AUM Northern Region**

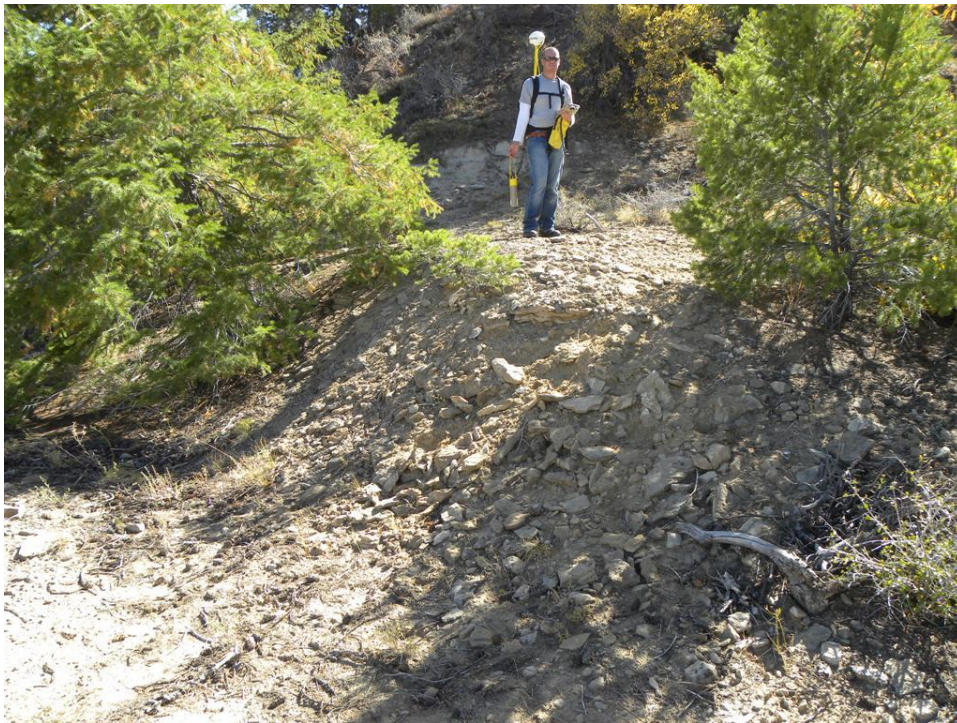
A total of 1,337 gamma radiation measurements were collected from the mine site, ranging from 7,536 cpm to 353,622 cpm. Measurements in the vicinity of the waste debris south of the site boundary were found at levels of approximately 160,000 cpm, and in the pile at the southern portion of the site at approximately 220,000 cpm. The measurements are represented in Figures 1 and 2.

Photo 2. Waste pile south of site boundary

2 unreclaimed waste piles

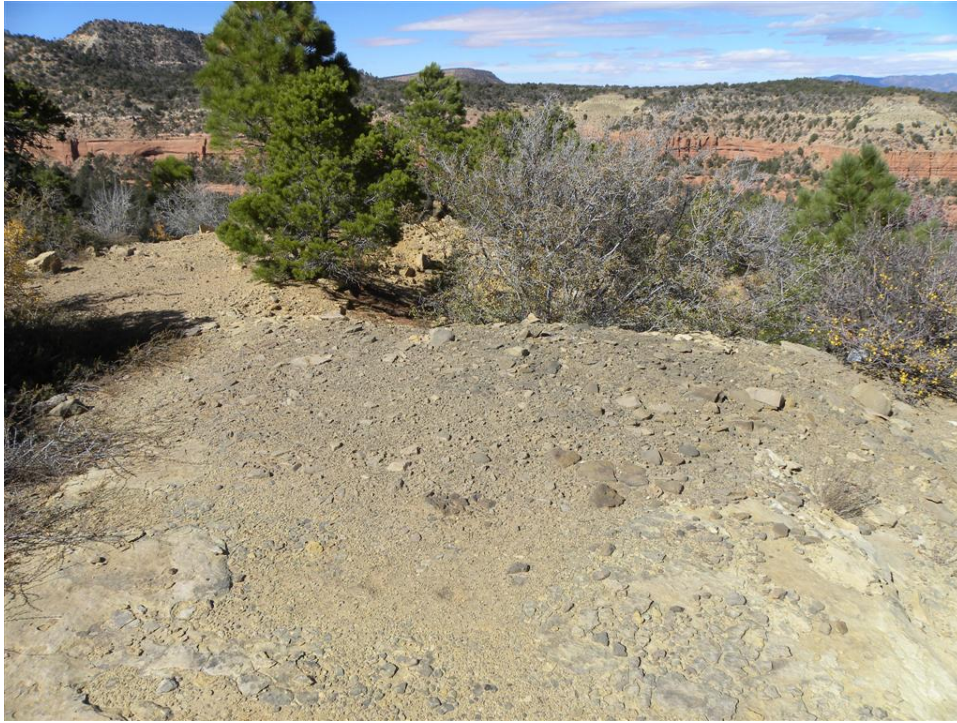
Photo3. Waste pile in southern portion of site

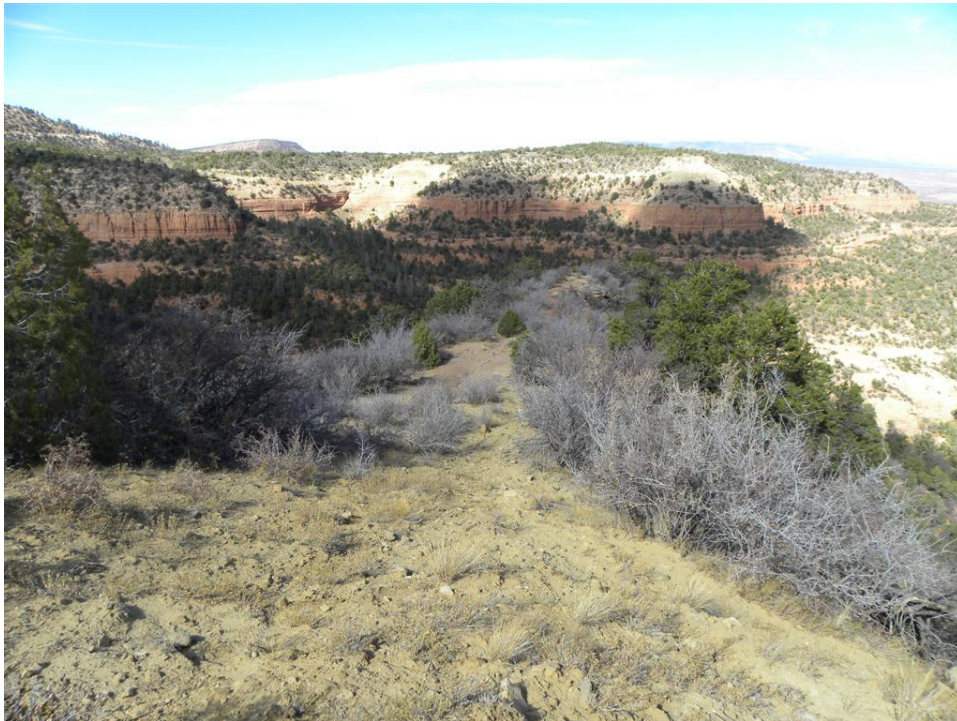
Photo 4. Steep grades on all sides of site
