Navajo Abandoned Uranium Mine

Site Screen Report

Frank Jr. Mine AUM Site

Weston Solutions, Inc.

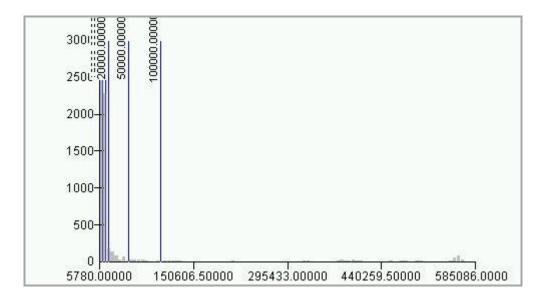
The following chart and statistics were generated by ESRI ArcGIS 9.3.1, and show the general distribution of the site gamma radiation measurements. The horizontal X axis represents the gamma radiation reading levels in cpm (lowest levels to the left). The vertical Y axis represents the frequency of each gamma radiation level.

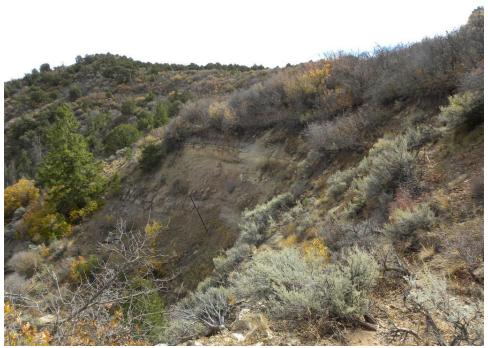
Photo 1. Mine site

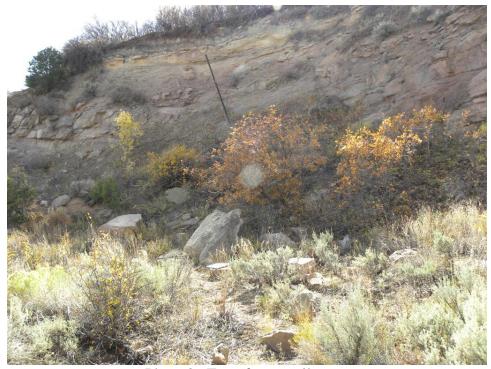
Waste pile falling down steep slope, 50' x 20', with a total estimated volume of 185 yd³

Photo 2. Top of waste pile area

Unreclaimed waste pile

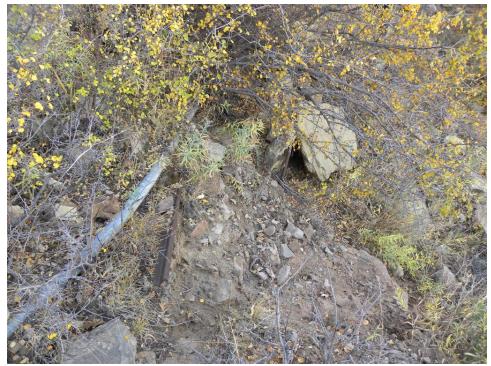
Survey markers, rails and timbers on benched hillside

Photo 3. Mining debris

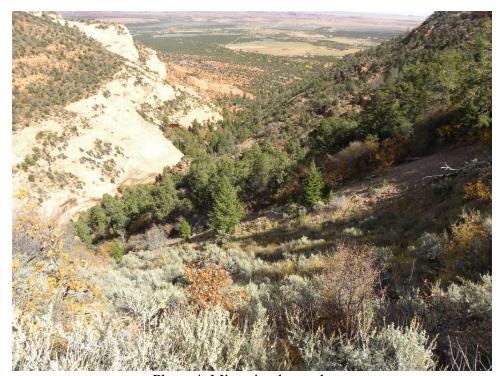
Photo 4. Mine site down slope.

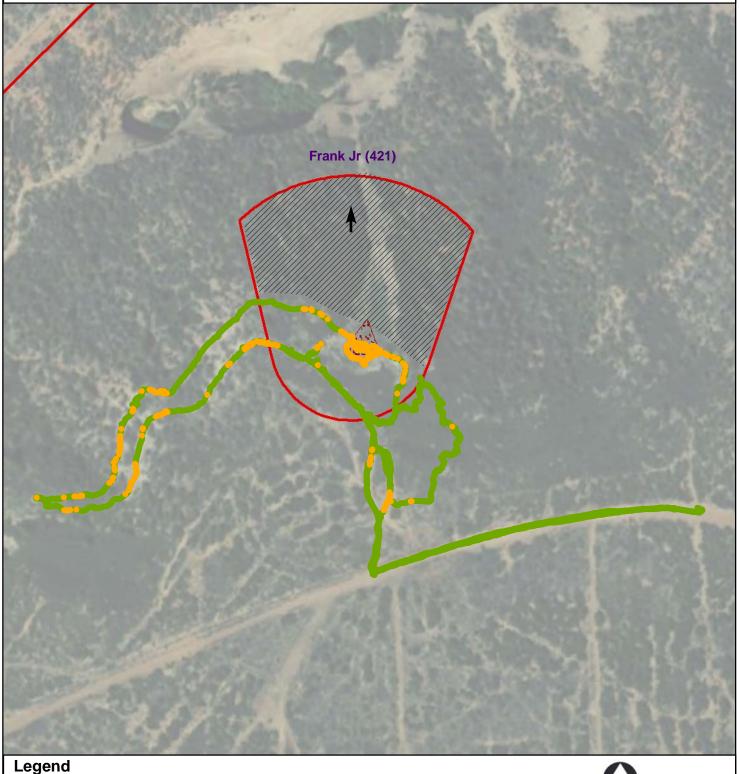
A total of 6,242 gamma radiation measurements were collected from the mine site, ranging from 5,780 cpm to 585,086 cpm. Measurements in the vicinity of the waste debris bench area were found at levels above 500,000 cpm. The measurements are represented in Figures 1 and 2.

Figure 1 - Gamma Radiation Measurements, Above Two Times Background Frank Jr (421) Cove Chapter, Navajo Nation, Arizona

Gamma survey conducted 10/2009 Measured as counts per minute (cpm)

Average background = 8,403 cpm

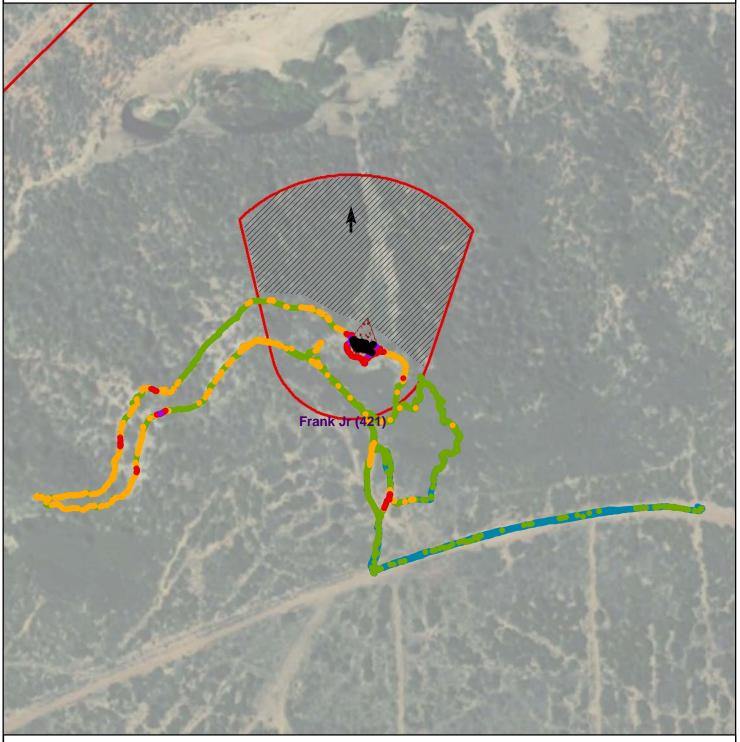
Figure 2 - Gamma Radiation Measurements Frank Jr (421) Cove Chapter, Navajo Nation, Arizona

Inaccessible due to steep grades

Gamma survey conducted 10/2009 Measured as counts per minute (cpm)

Average background 8,403 cpm
