Navajo Abandoned Uranium Mine

Site Screen Report

Billy Topaha Mine AUM Site

March 2010

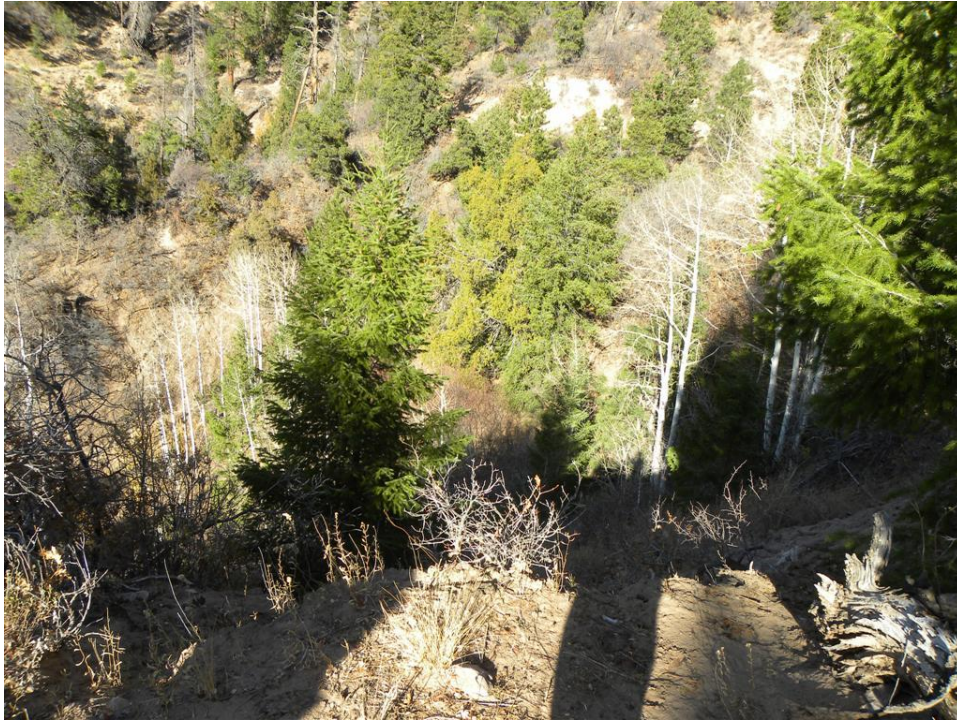
Photo 1. Inaccessible steep grades towards site

Weston was unable to access the site. All known paths leading towards the site were impassible due to steep grades and heavy vegetation. Measurements were collected in the general vicinity of the site, approximately 400’ south of the site boundary. A total of 2,497 gamma radiation measurements were collected near the mine site, ranging from 7,496 cpm to 16,886 cpm. The measurements are represented in Figures 1 and 2.
