Navajo Abandoned Uranium Mine

Site Screen Report

Melvin Benally No. 3 AUM Site

August 2010

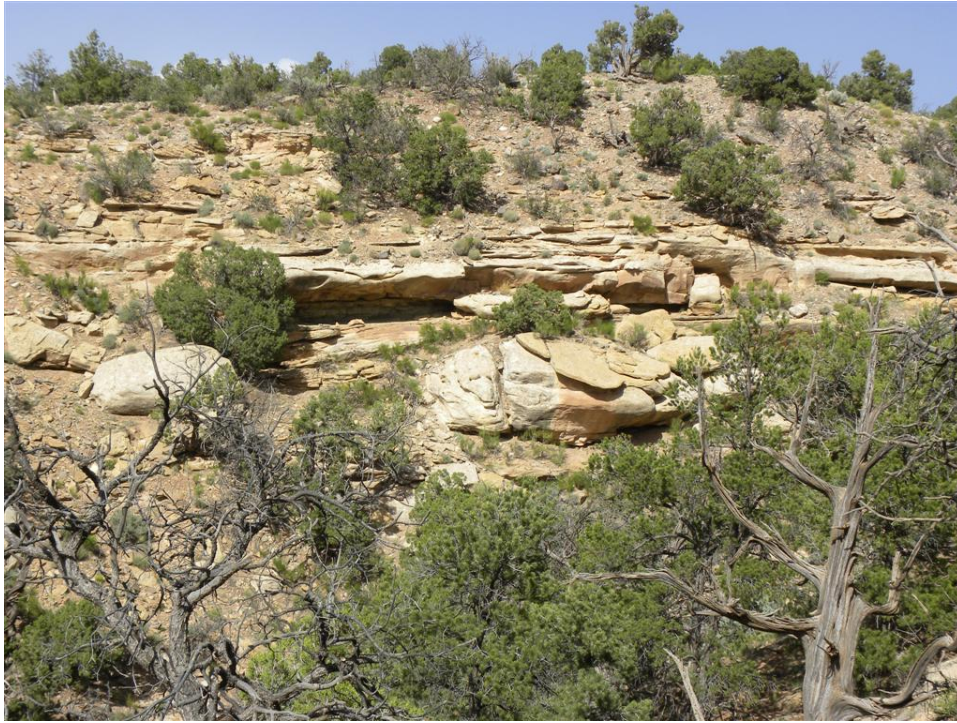
Photo 1. Melvin Benally No. 3 site

Various mining debris, metal cans, etc.
